DOES REDWOOD TIMBER HARVESTING

LEAD TO MASSIVE EROSION AND EARTH SLIDES?

PHOTOGRAPHIC LOCATIONS
Georgia-Pacific Big Lagoon
Area

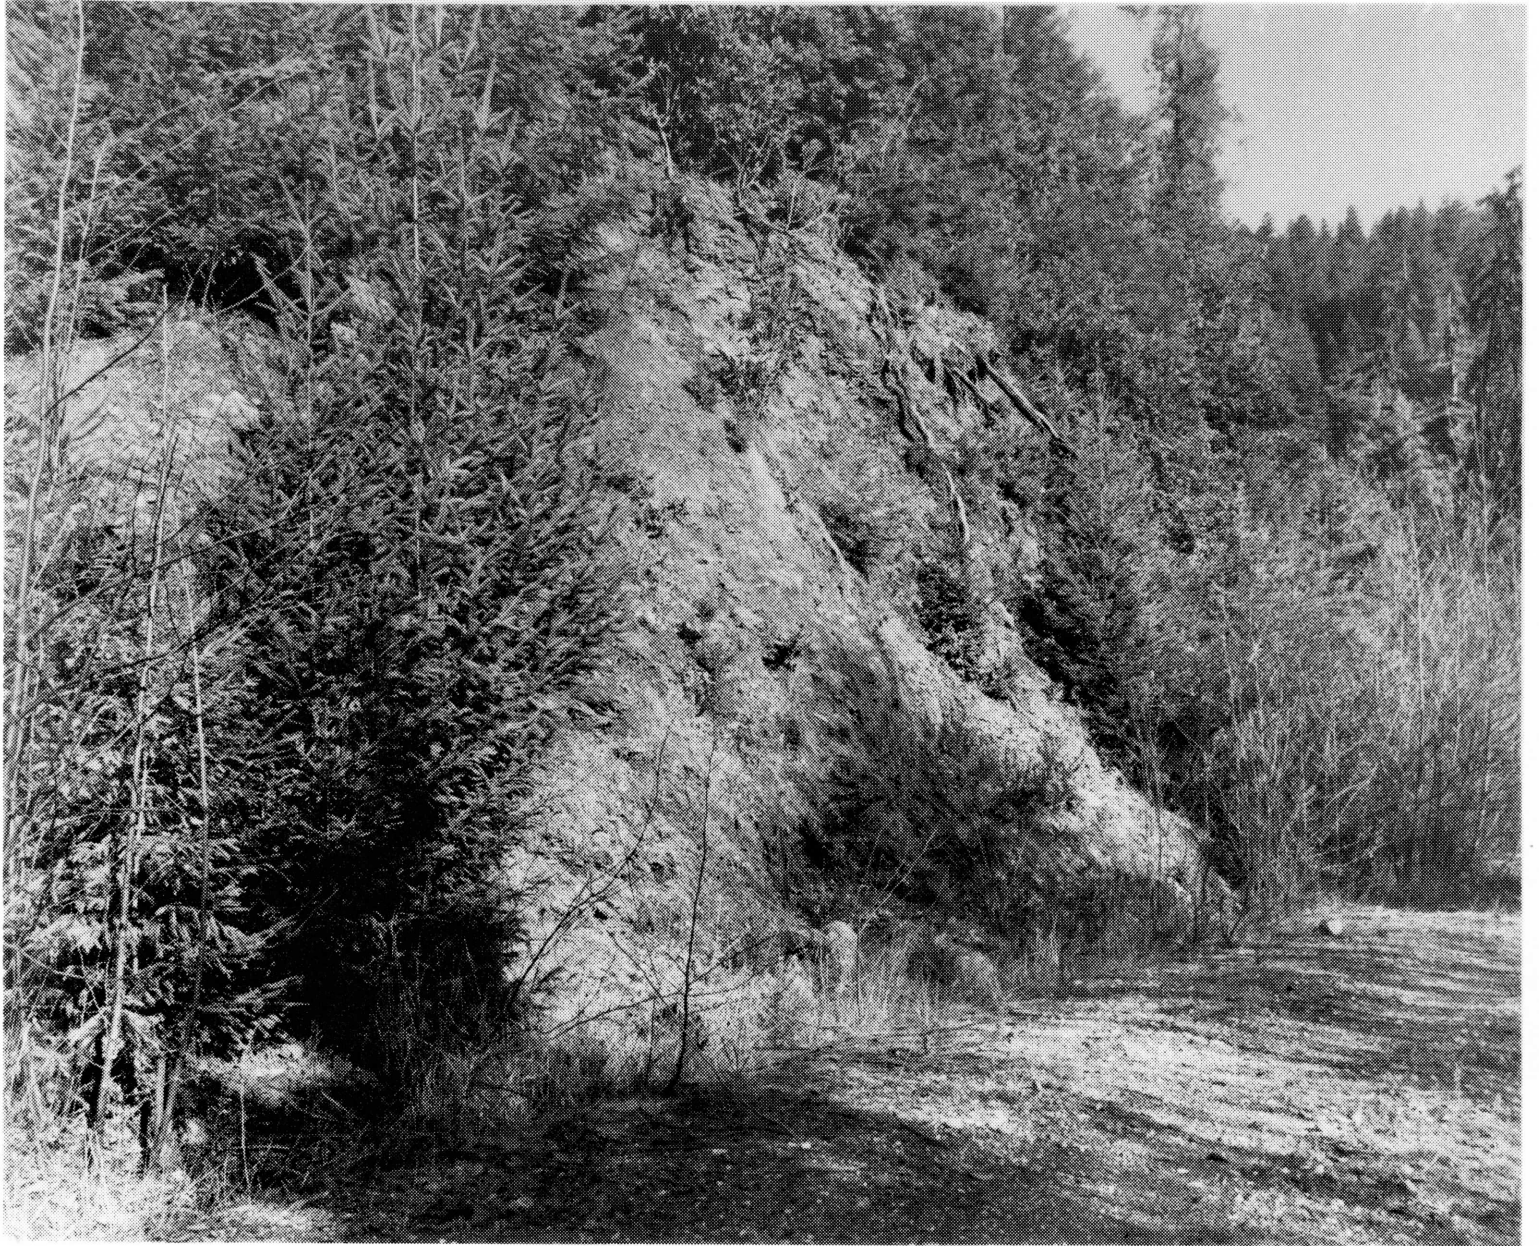
1. This section of the "M" line truck road, now in the Redwood National Park along the west bank of Redwood Creek, was constructed in 1951. The area above the high bank was logged in 1963, with a salvage logging follow-up in 1965. No erosion.

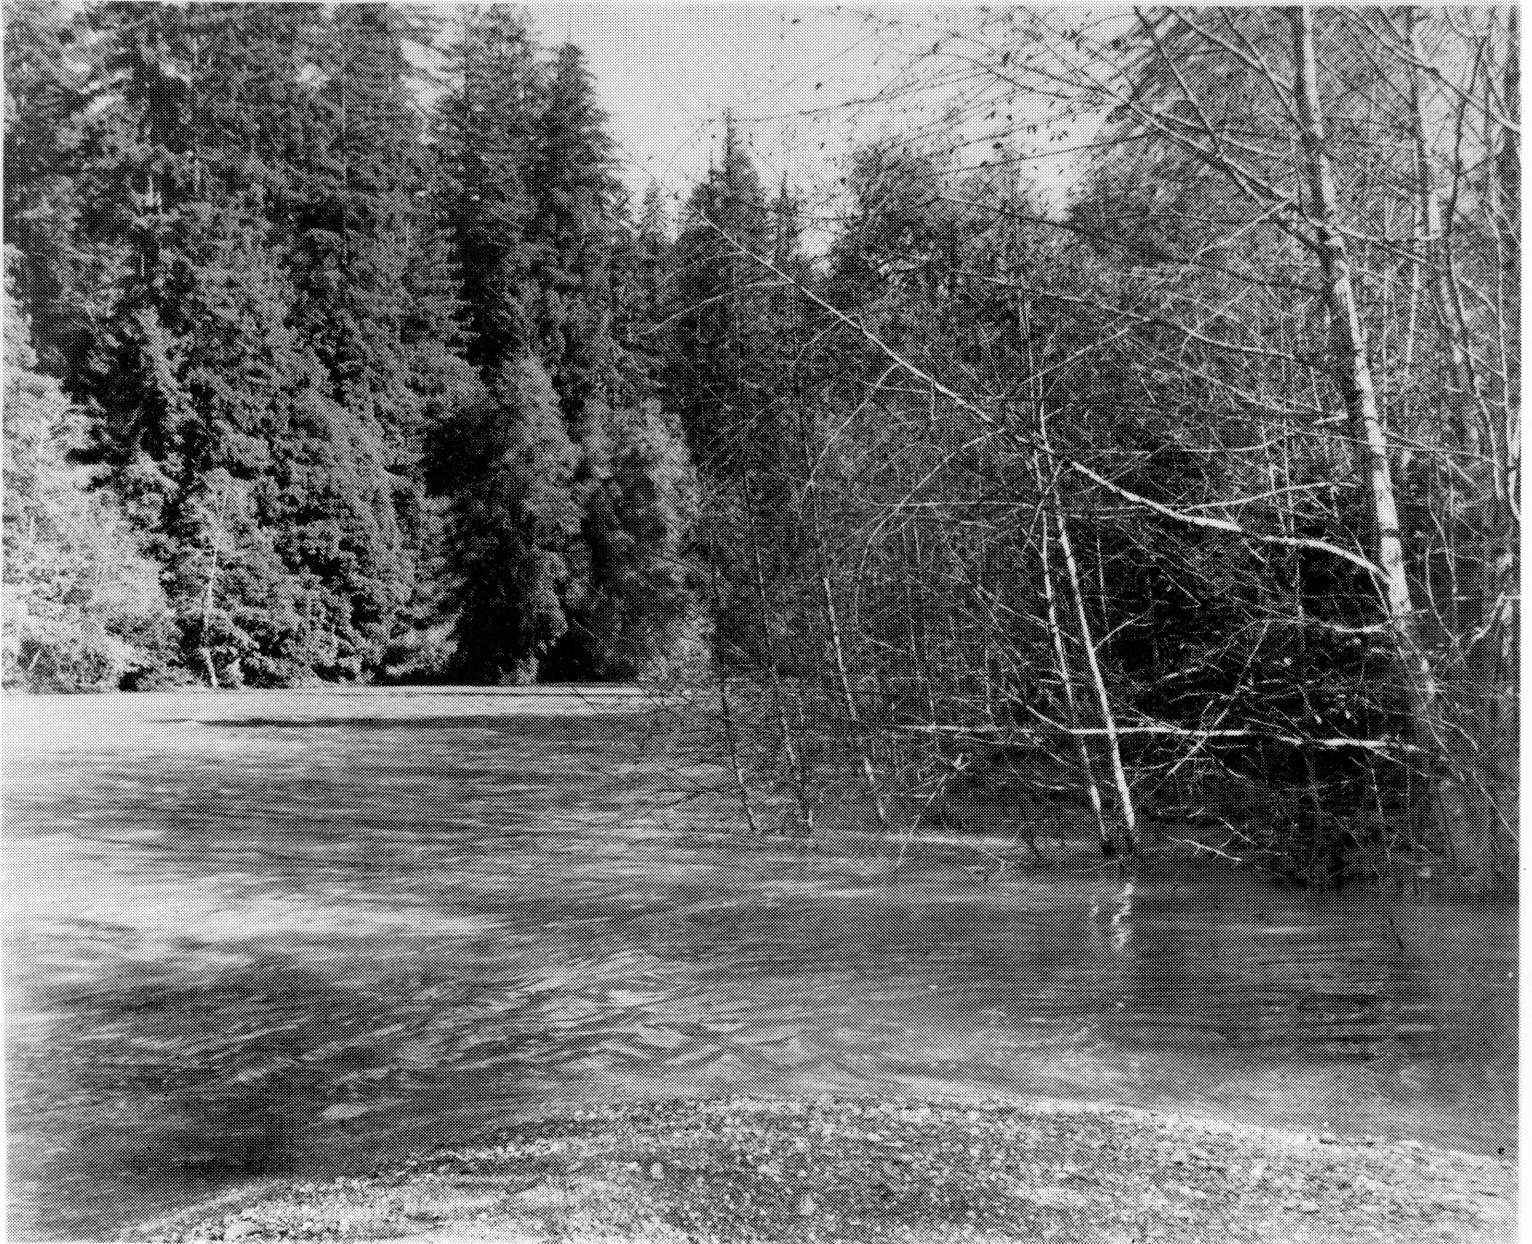
2-A. Looking up Redwood Creek from its west bank at the confluence with Tom McDonald Creek. The clear water in the foreground is Tom McDonald Creek, flowing from the west. Upper portions of the Tom McDonald Creek watershed have been the scene of logging activity, either prime logging or re-logging (salvage) every year from 1948 through 1971. After 2 days of hard rain it is clearer by far than Redwood Creek.

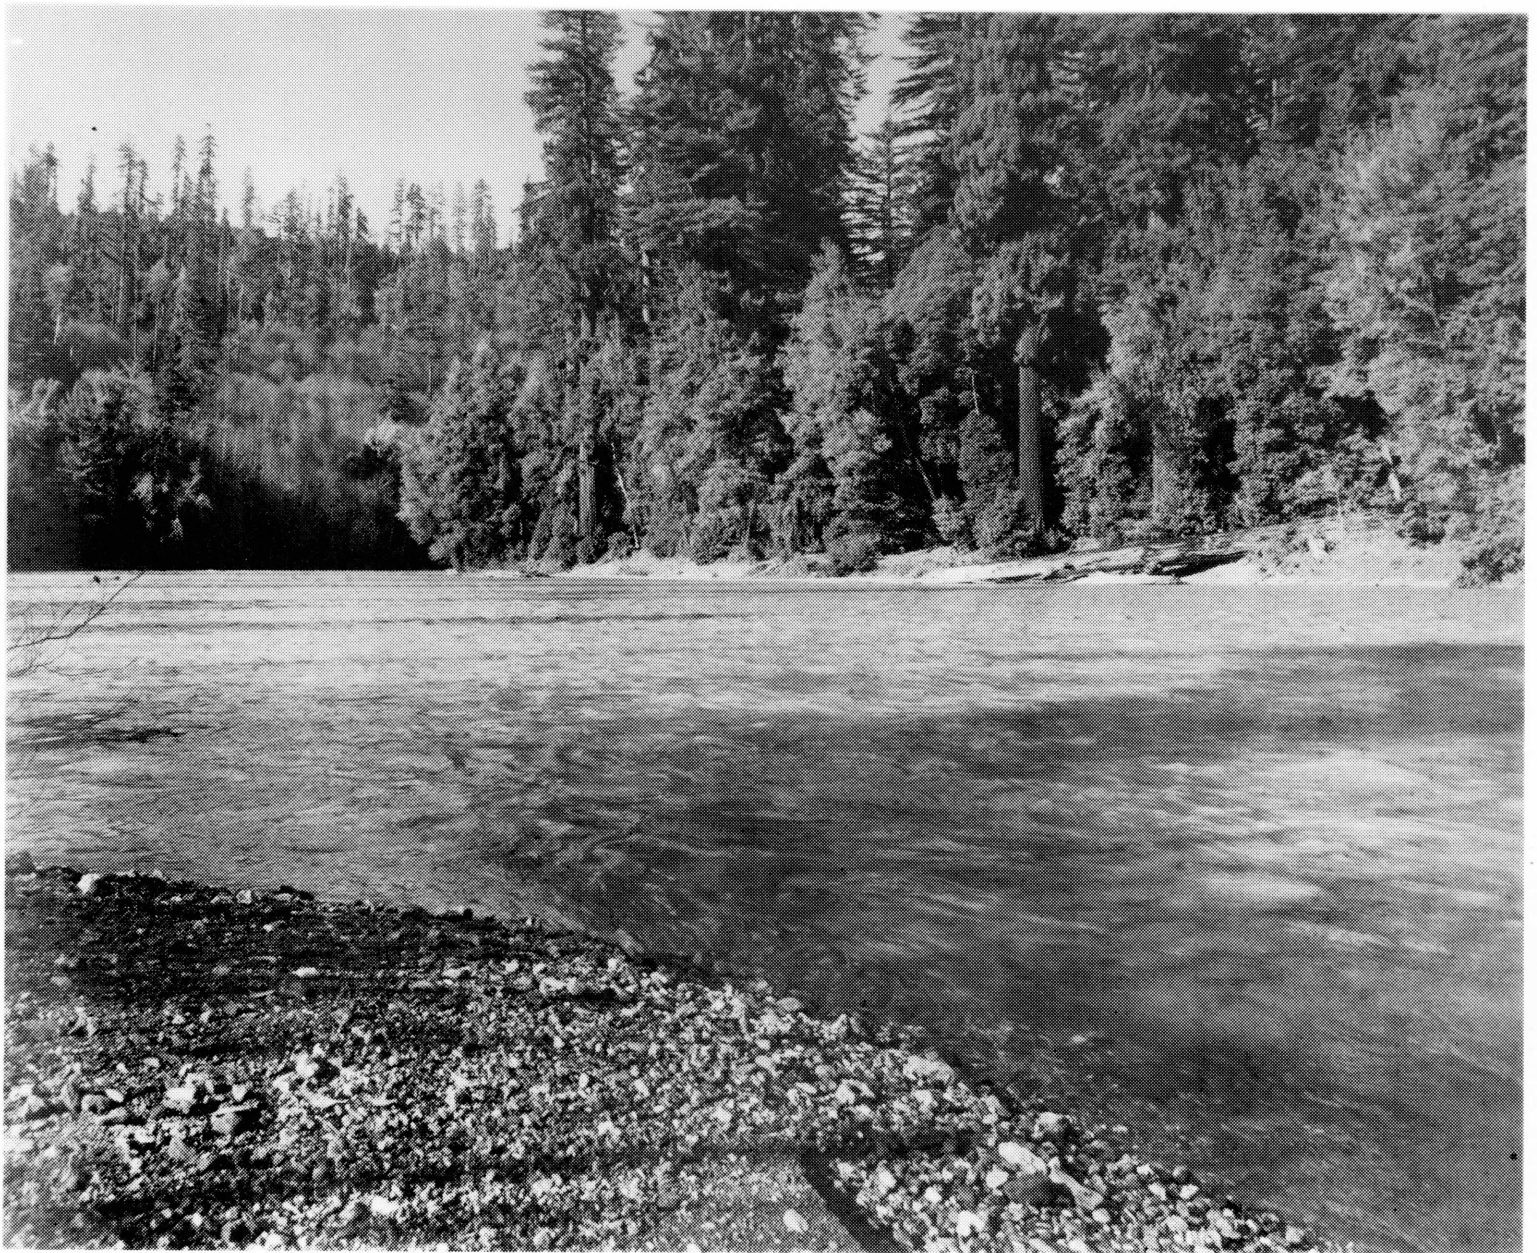
2-B. Looking downstream on Redwood Creek, from its west bank at its confluence with Tom McDonald Creek. Clear waters of Tom McDonald are seen in the foreground. This is taken from the same position as 2-A, only the camera is pointing downstream. Tall Trees area across stream.

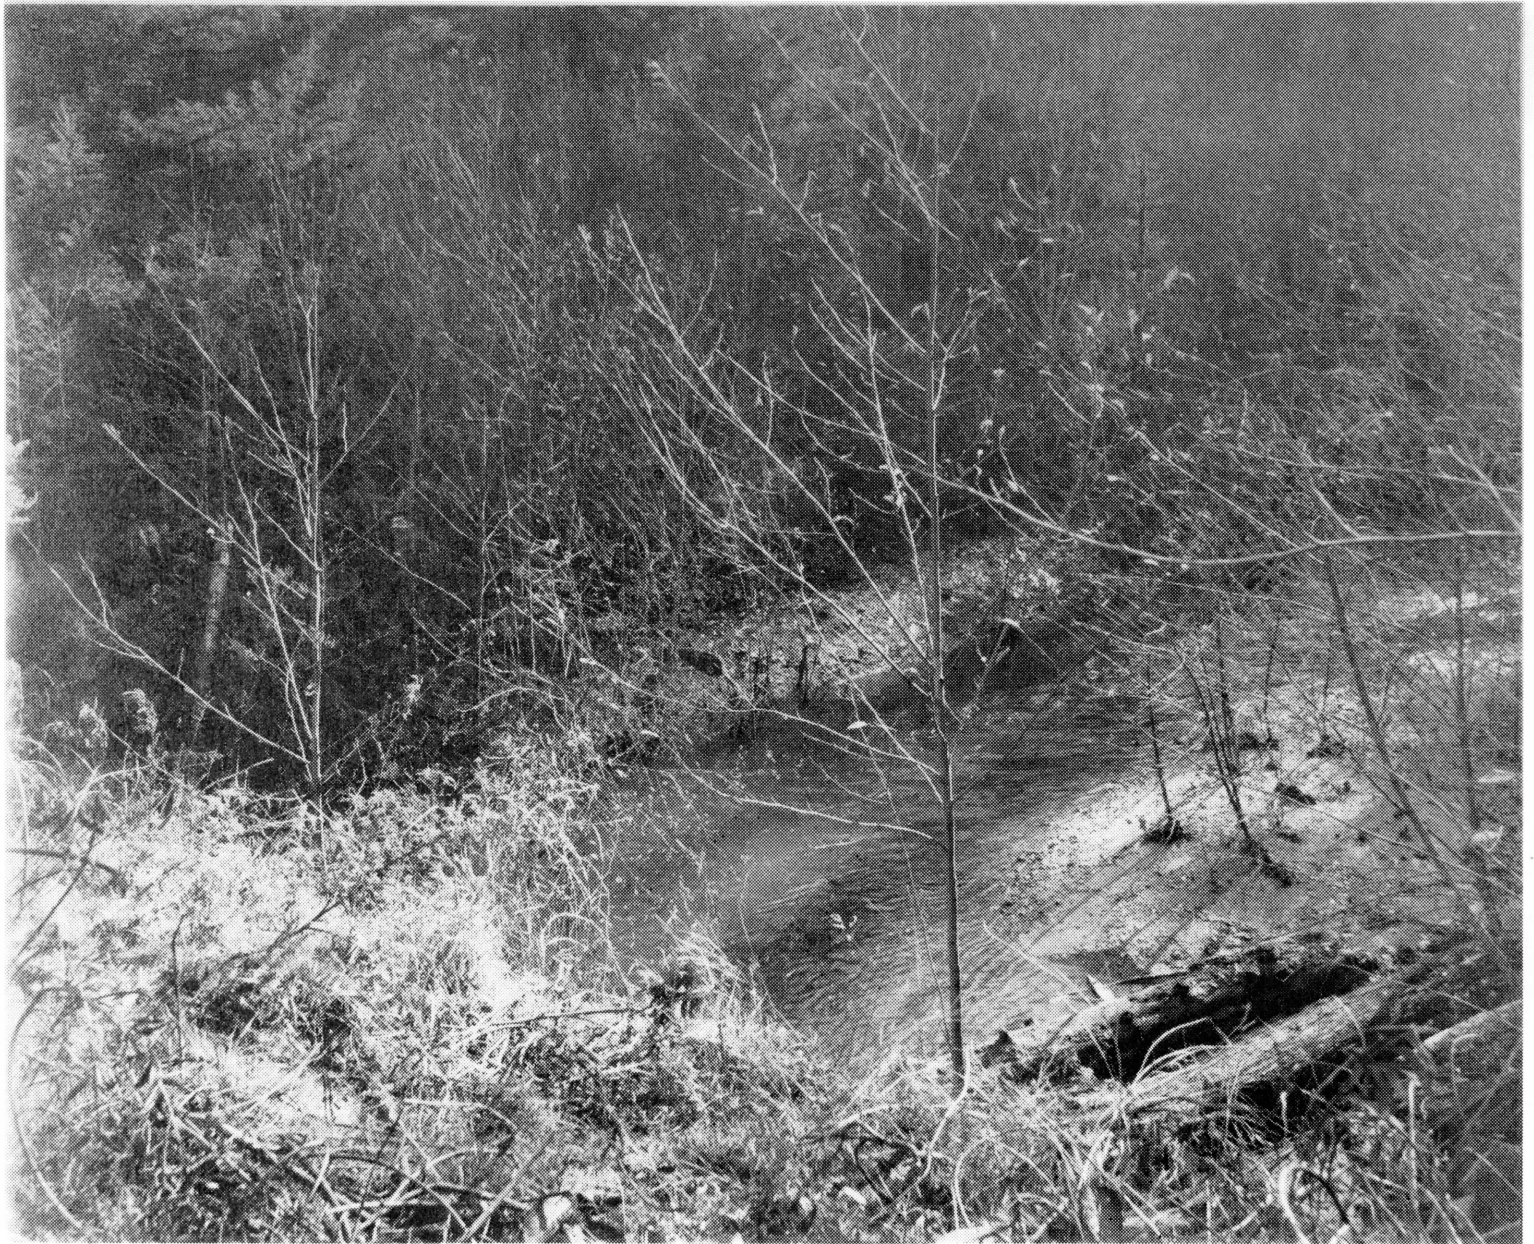
2-C. This view of Tom McDonald Creek was taken about 100 feet above its confluence with Redwood Creek. Quite clear after 2 days hard rain. In color you could see bottom.

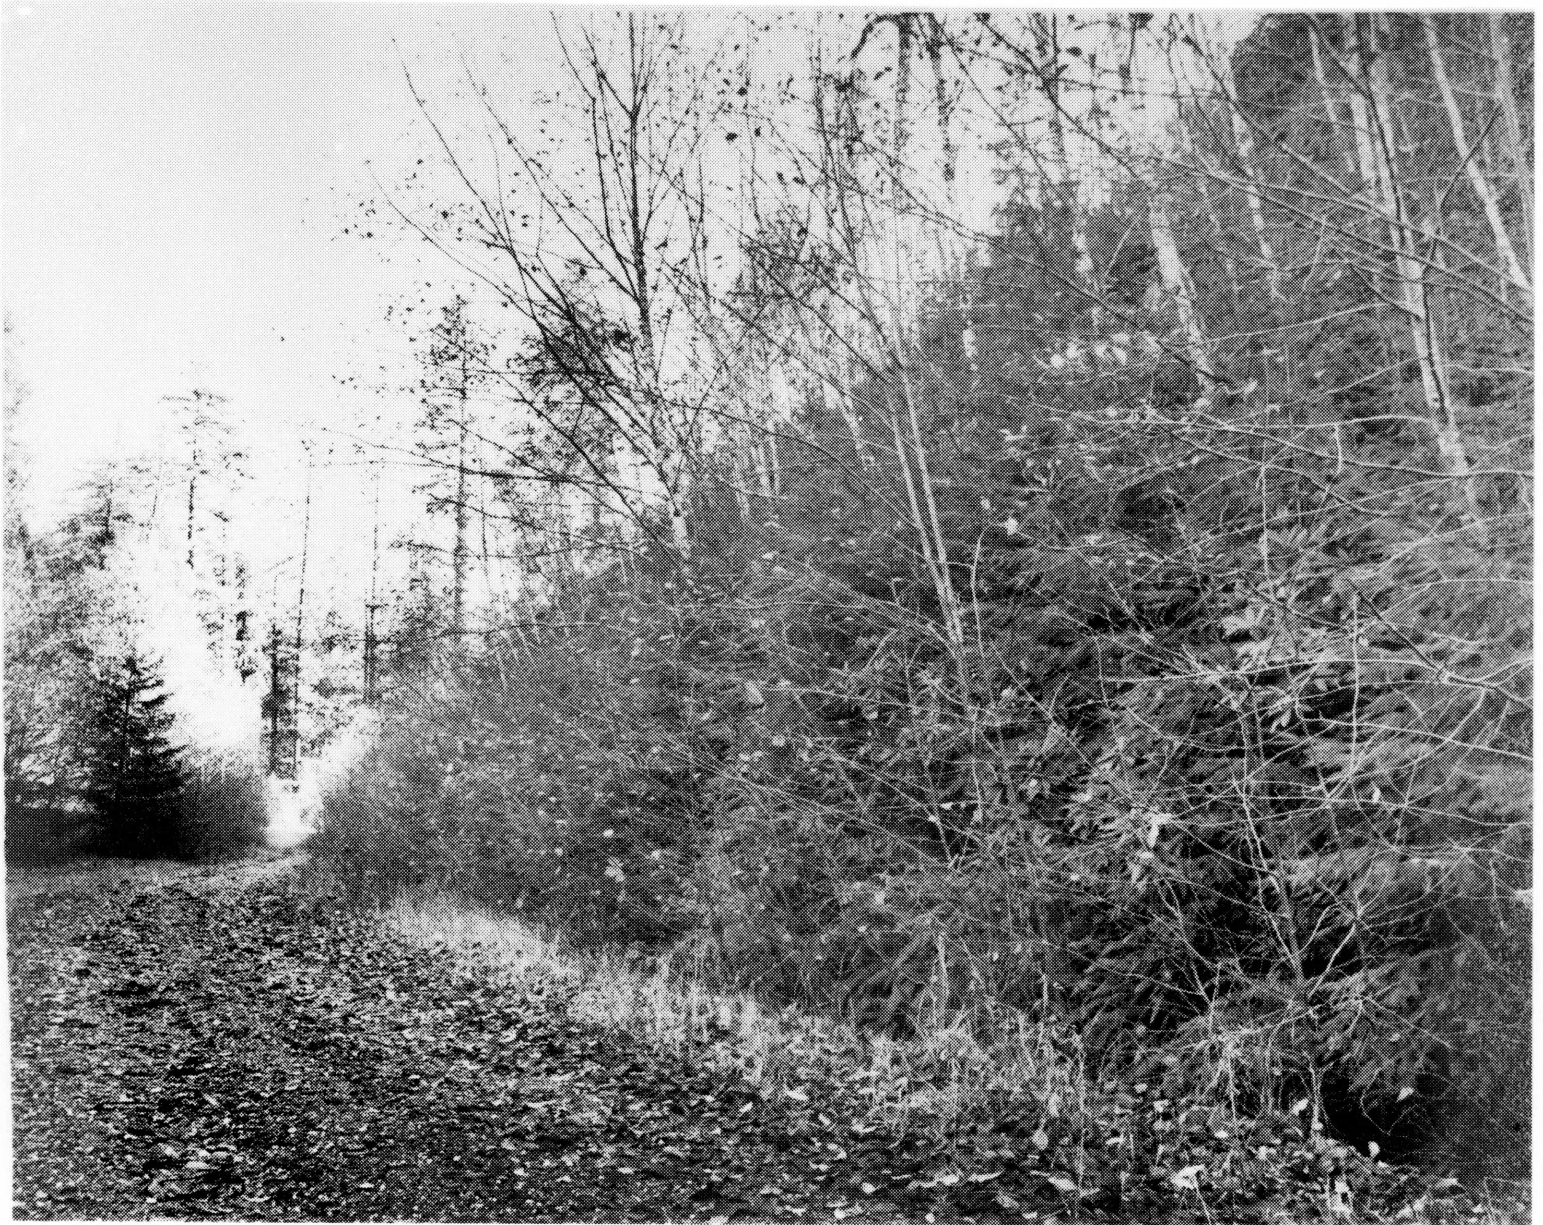
3. Another view of the M-Line road, which was built along the west bank of Redwood Creek, at this point, in 1951. The area above the road, beyond the young growth redwood and alder, was harvested in 1963 and relogged in 1965. This section of the road and adjoining property are in the Redwood National Park. No erosion.

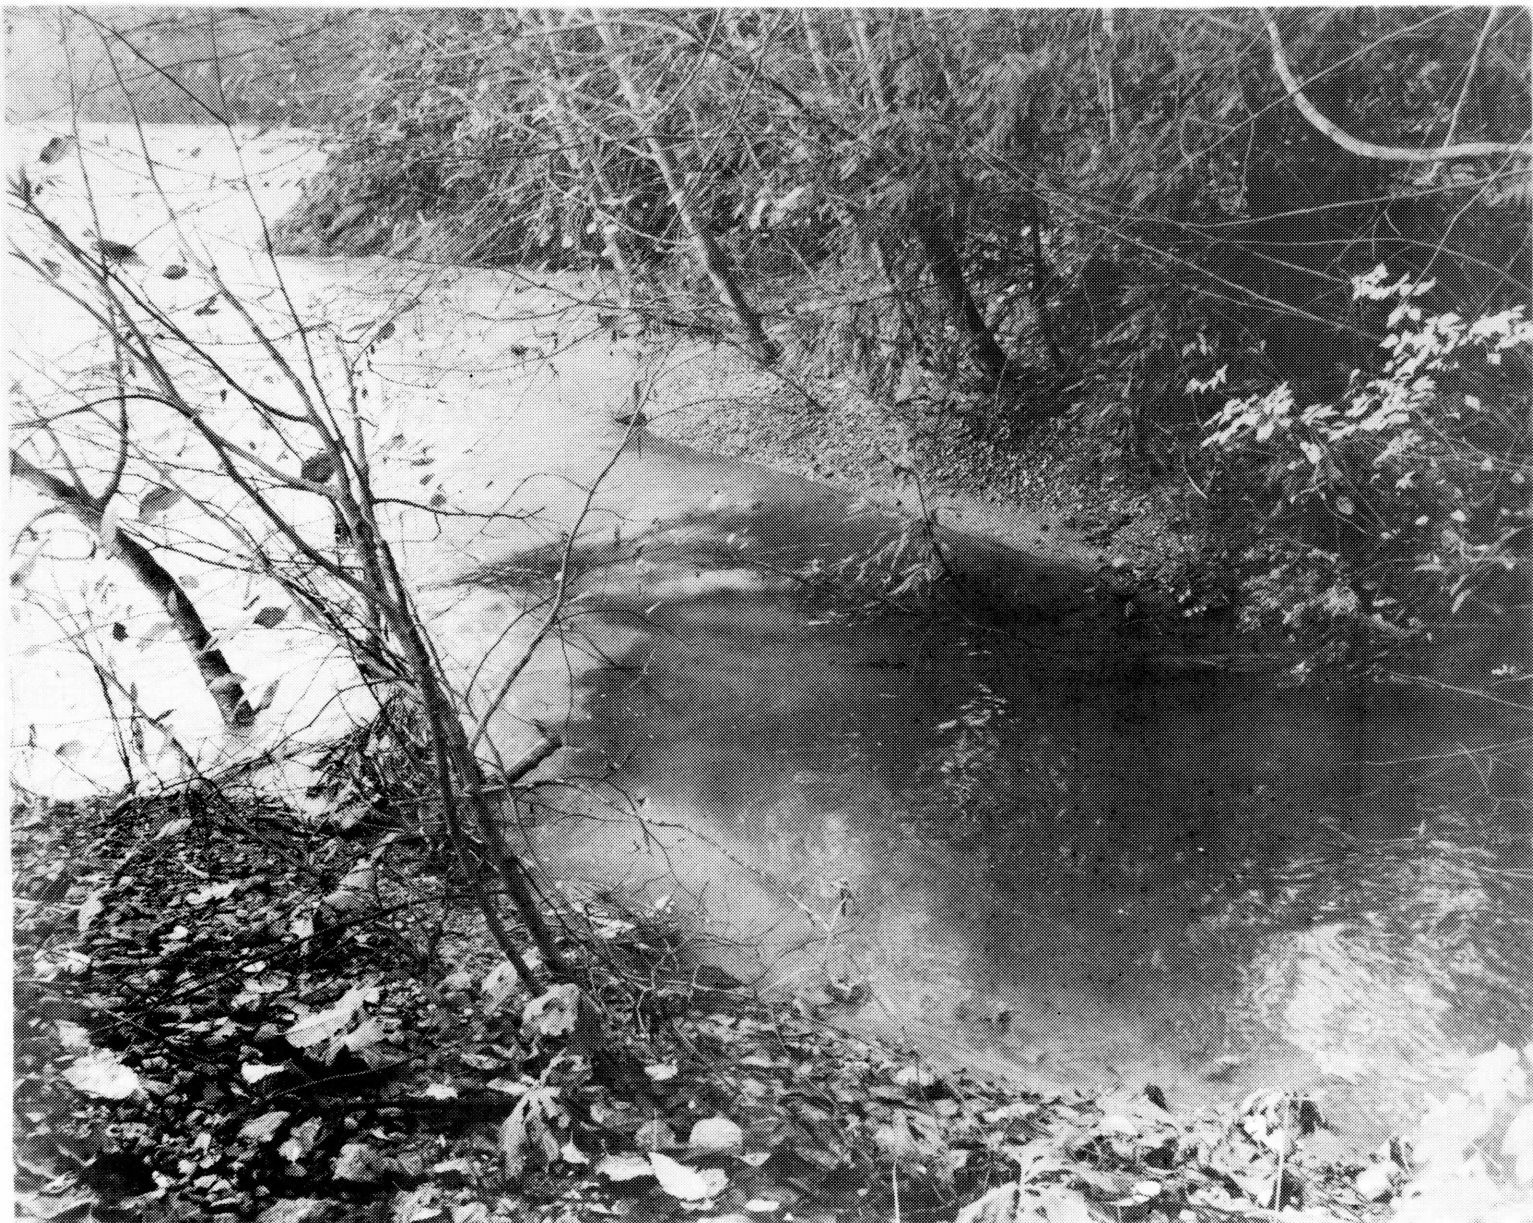
4. Clear waters of Bond Creek, flowing from the right or west, are shown as they join Redwood Creek in the Redwood National Park after 2 days hard rain. The upper portions of the Bond Creek watershed were logged or relogged in 1960, 1961, 1964, 1965, 1966, 1968, 1969, 1970 and 1971.

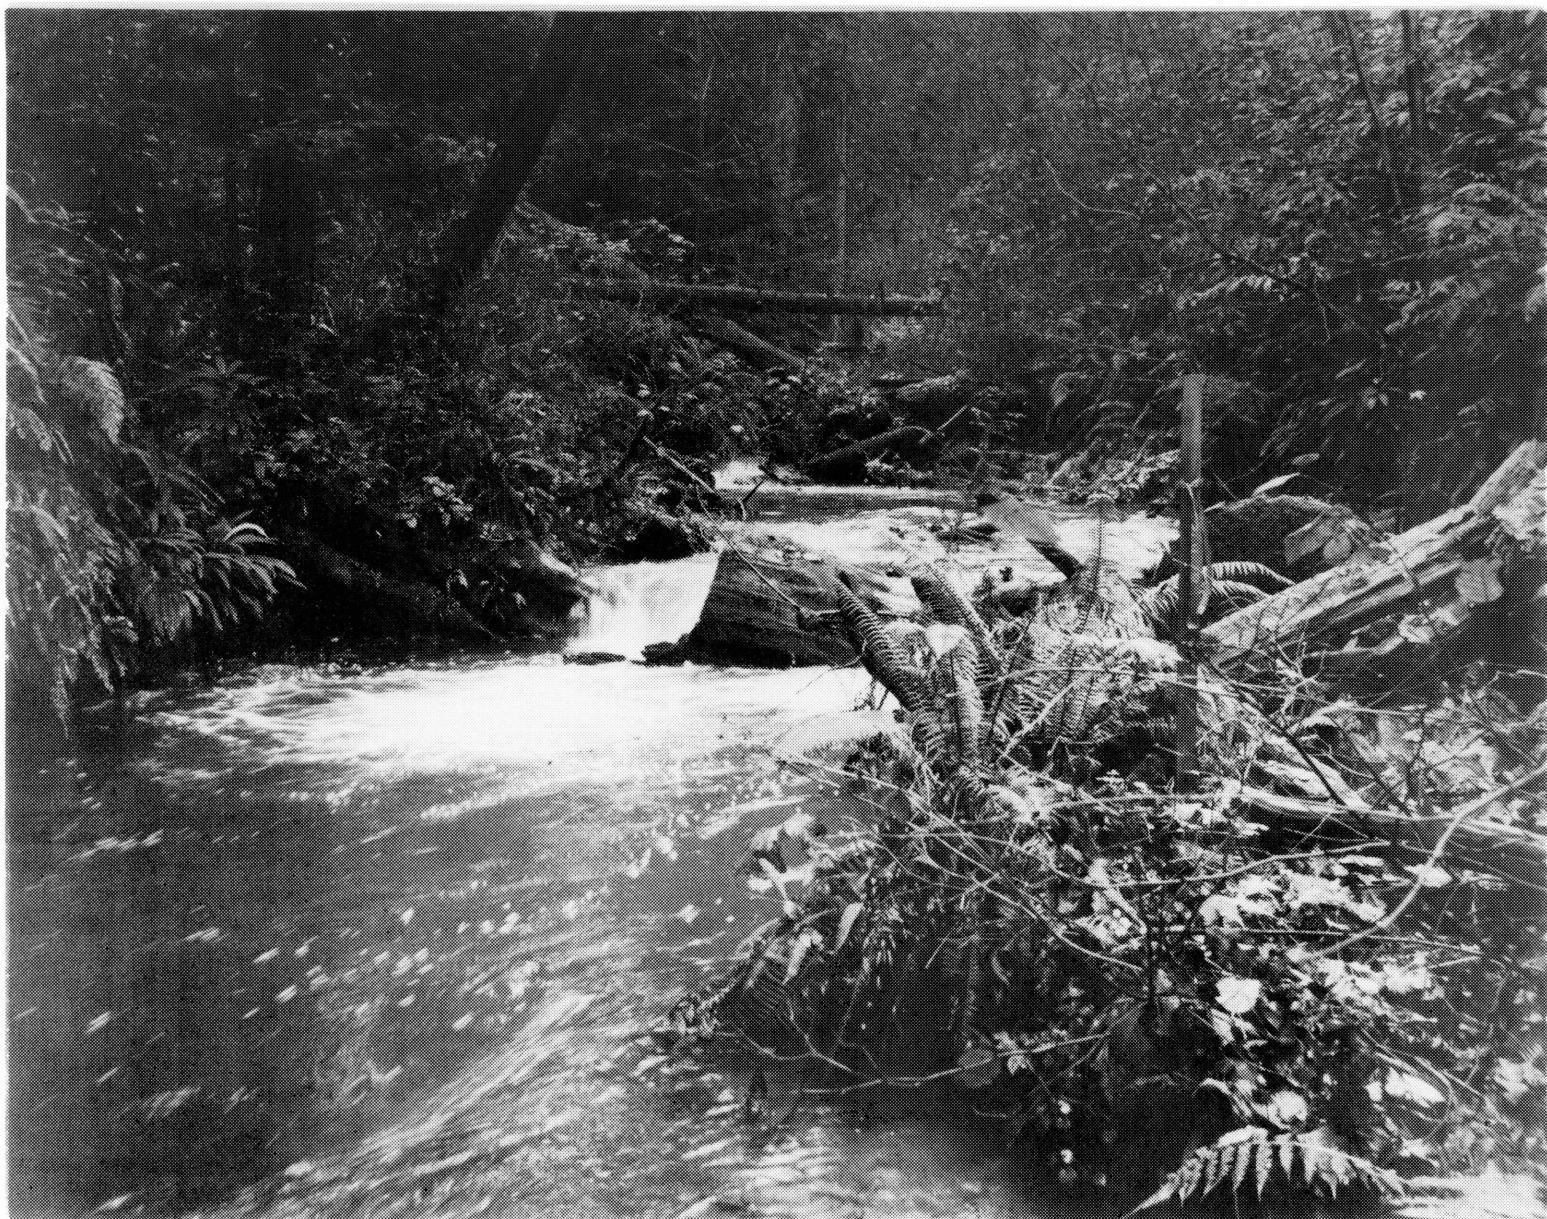
5. Here is Forty-four Creek, in the Redwood National Park, about 100 yards above the point it flows into Redwood Creek. The upper portion of Forty-four Creek watershed on G-P land was logged or relogged in 1953, 1954, 1955, 1959, 1960, 1962, 1963, 1964, 1966, 1967, 1968, 1969 and 1971. In good shape after 2 days hard rain.

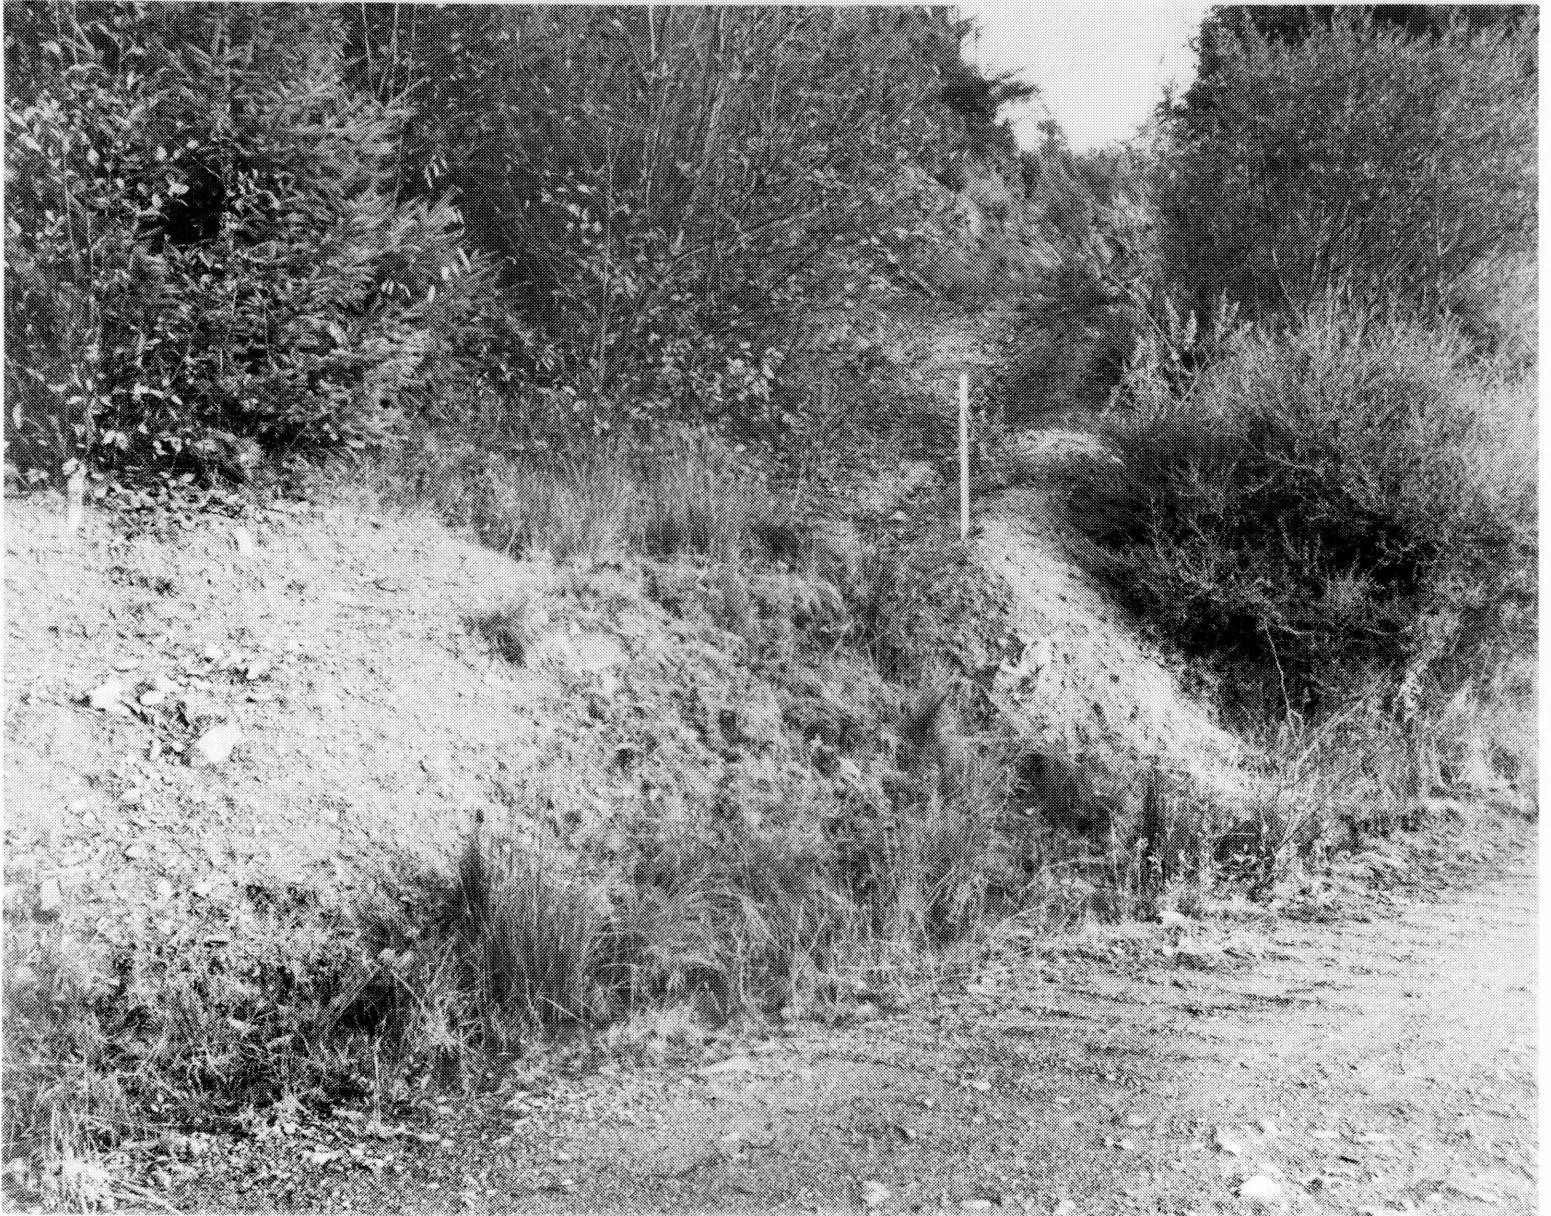
6. This is an old spur road joining the C-Line logging road. This spur was constructed in 1958. This area was logged in 1958 and relogged in 1965. Minimal erosion.

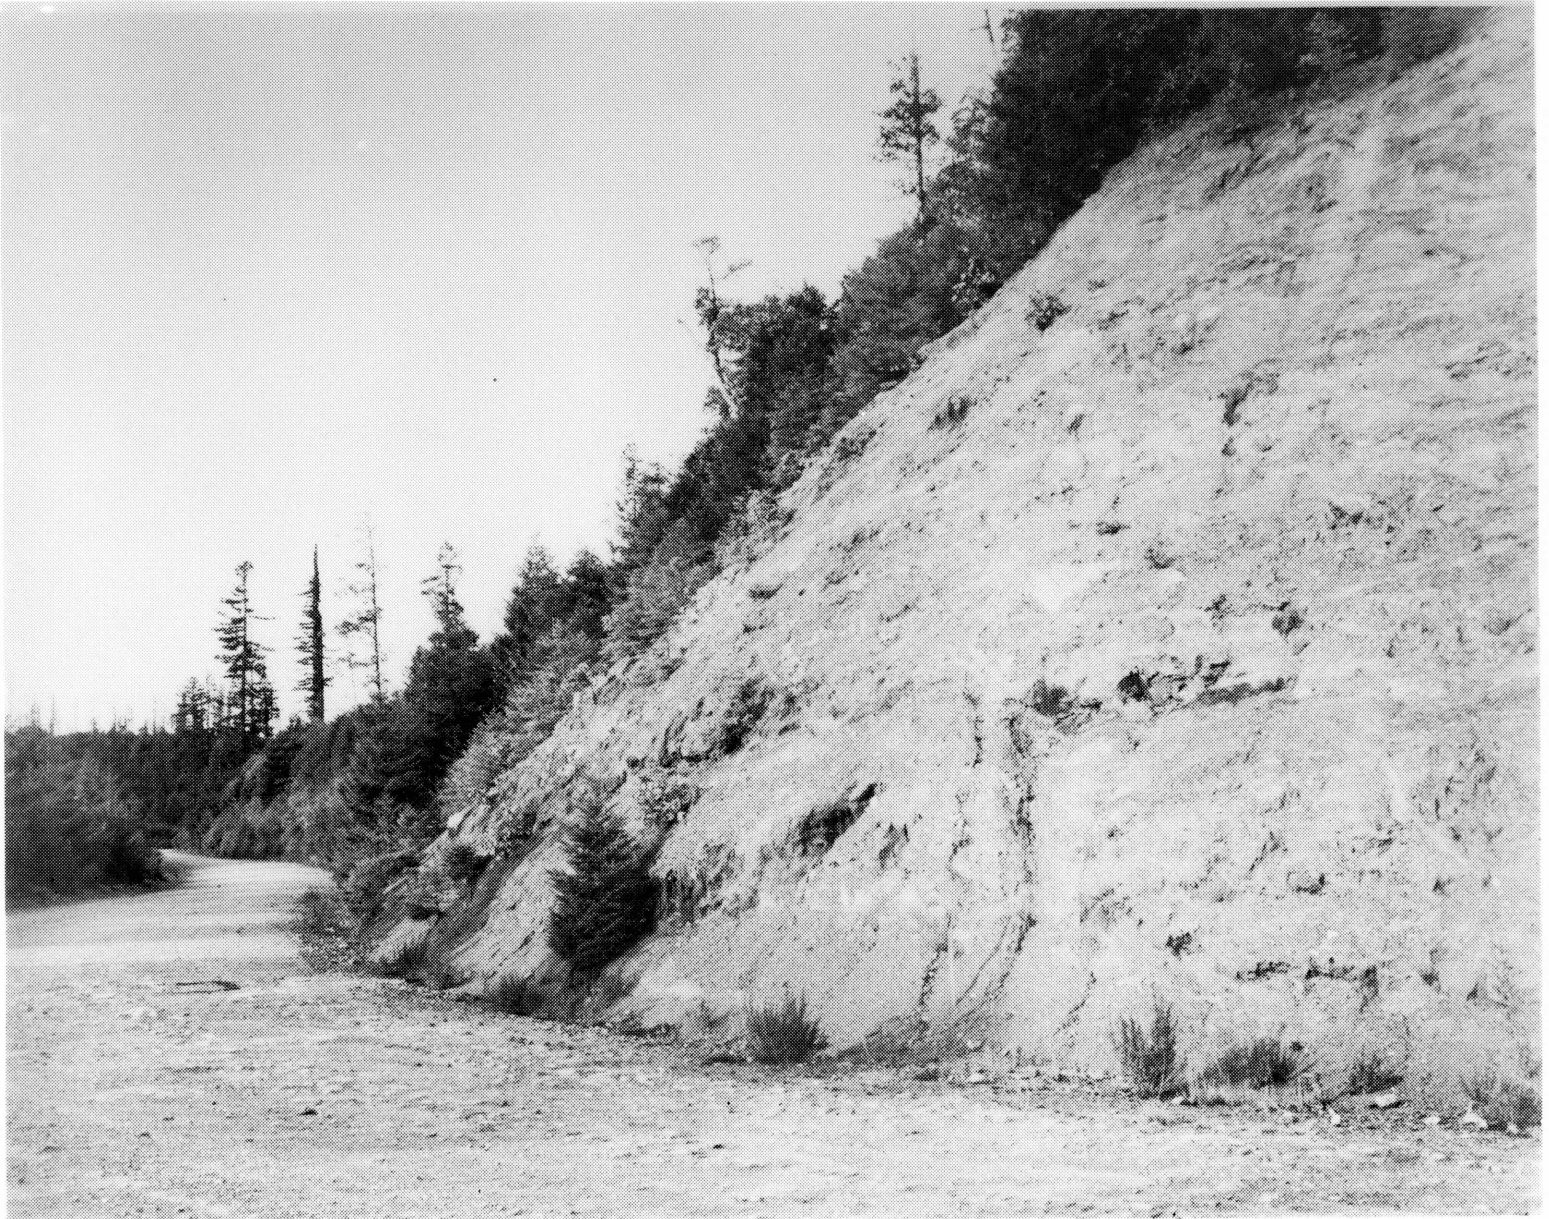
7. This is a portion of the C-Line logging road, built in 1949 and used continuously since for timber harvest, reforestation and fire protection. The area above the road was logged in 1958 and relogged in 1965. Bank is in good condition.

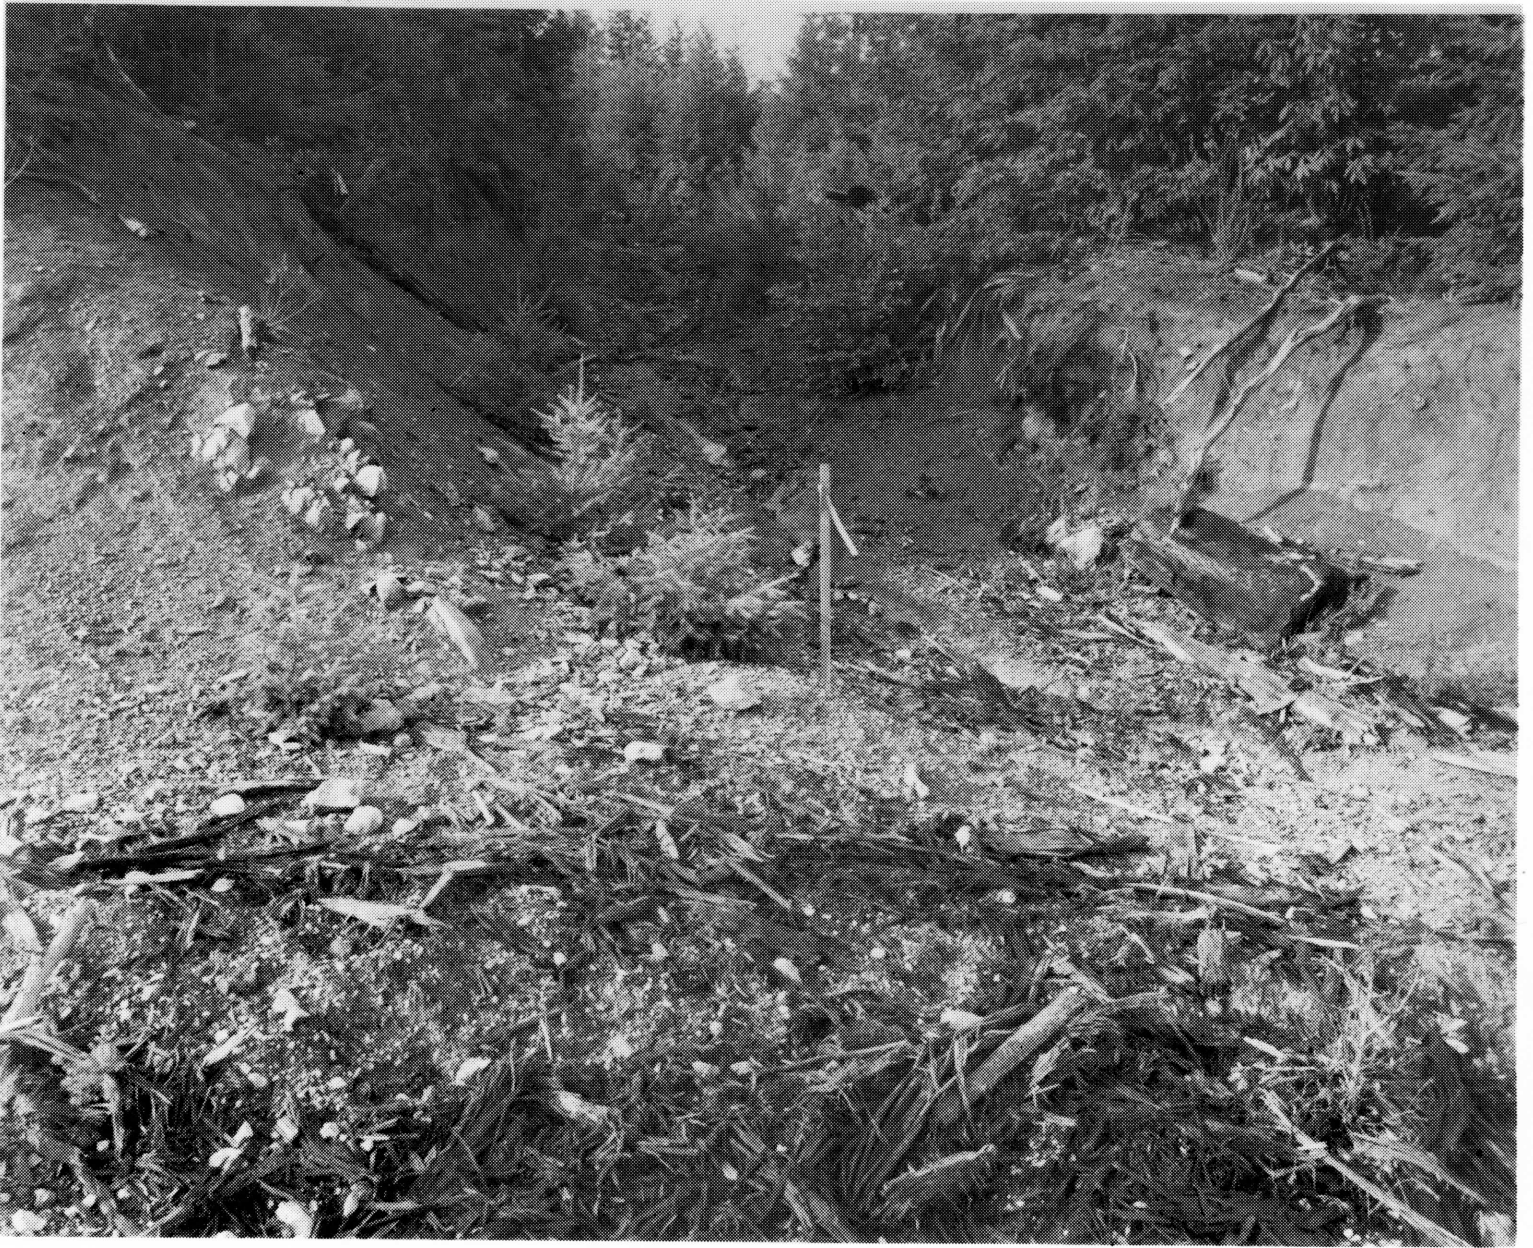
8. This is an old skid road tributary to the C-Line road. The area was logged in 1955 and relogged in 1965. Virtually no erosion. Note young trees.

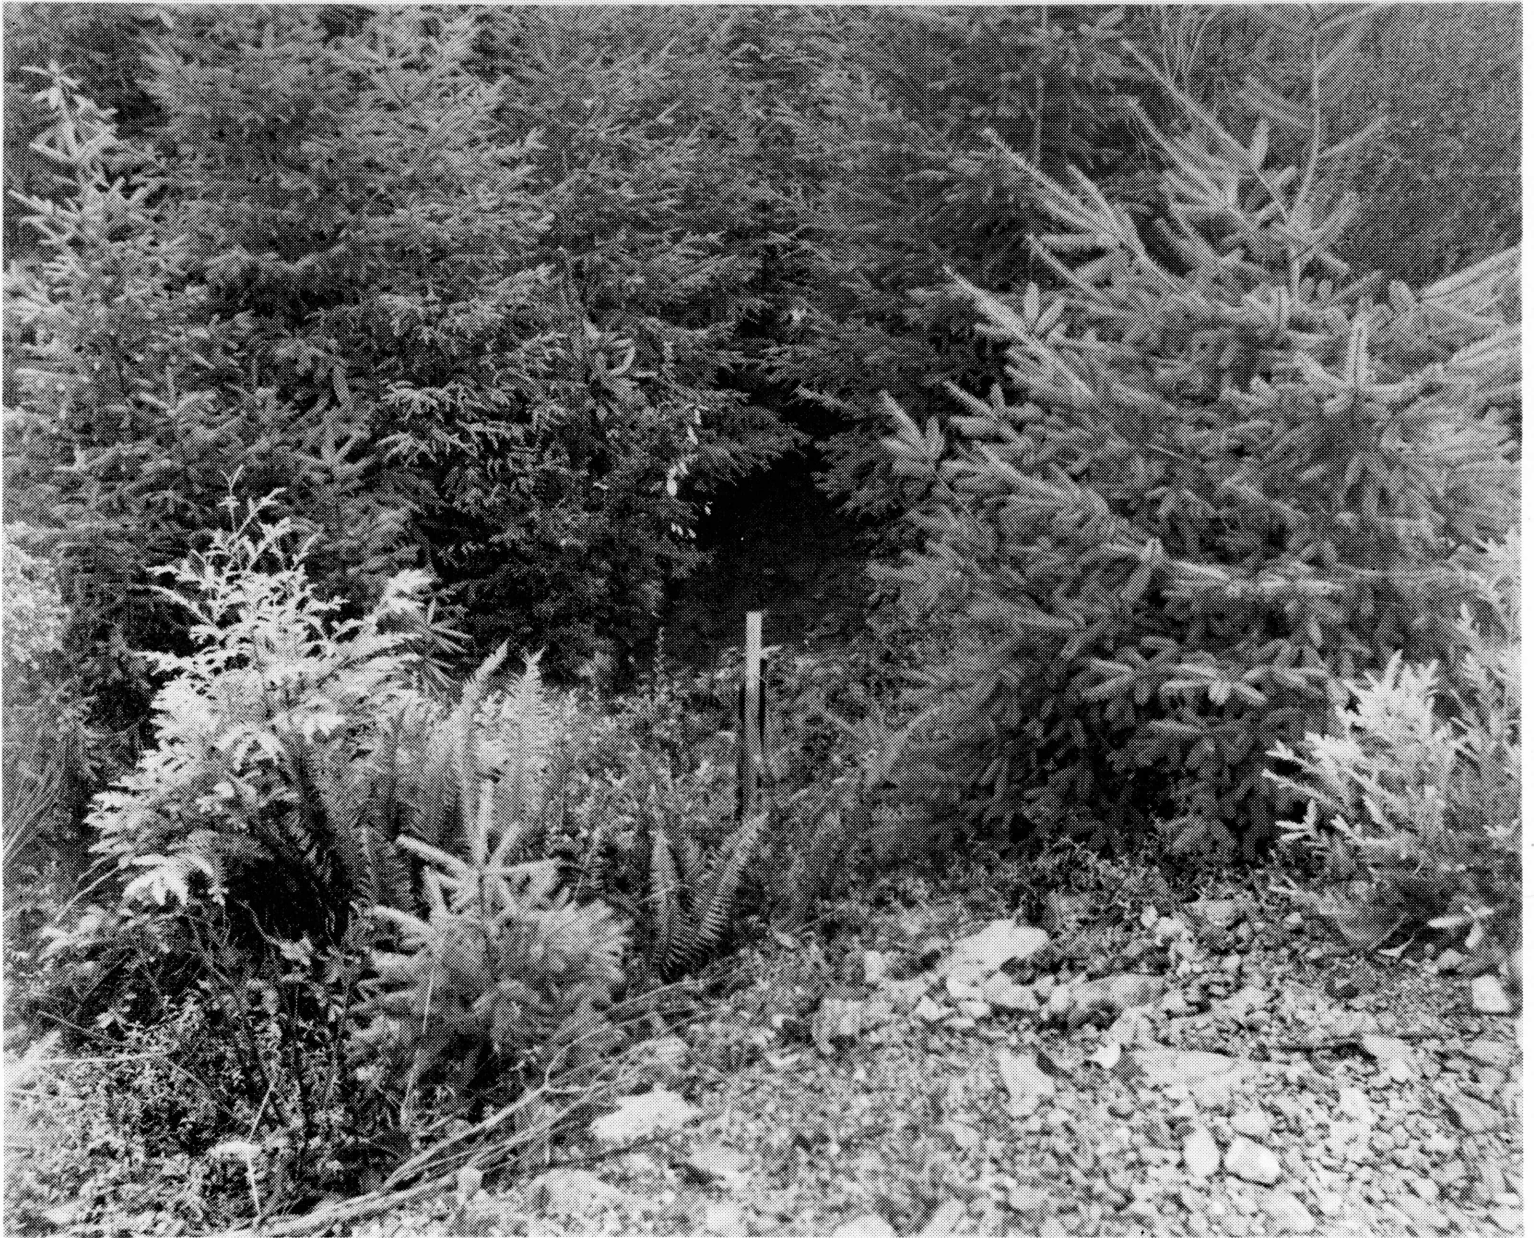
9-A. Culvert head on the C-Line logging road. This culvert was installed in 1949. The area was logged in 1958 and relogged in 1964. No erosion. Much vigorous young growth.
