DOES REDWOOD TIMBER HARVESTING

LEAD TO MASSIVE EROSION AND EARTH SLIDES?

PHOTOGRAPHIC LOCATIONS
Georgia-Pacific Big Lagoon
Area

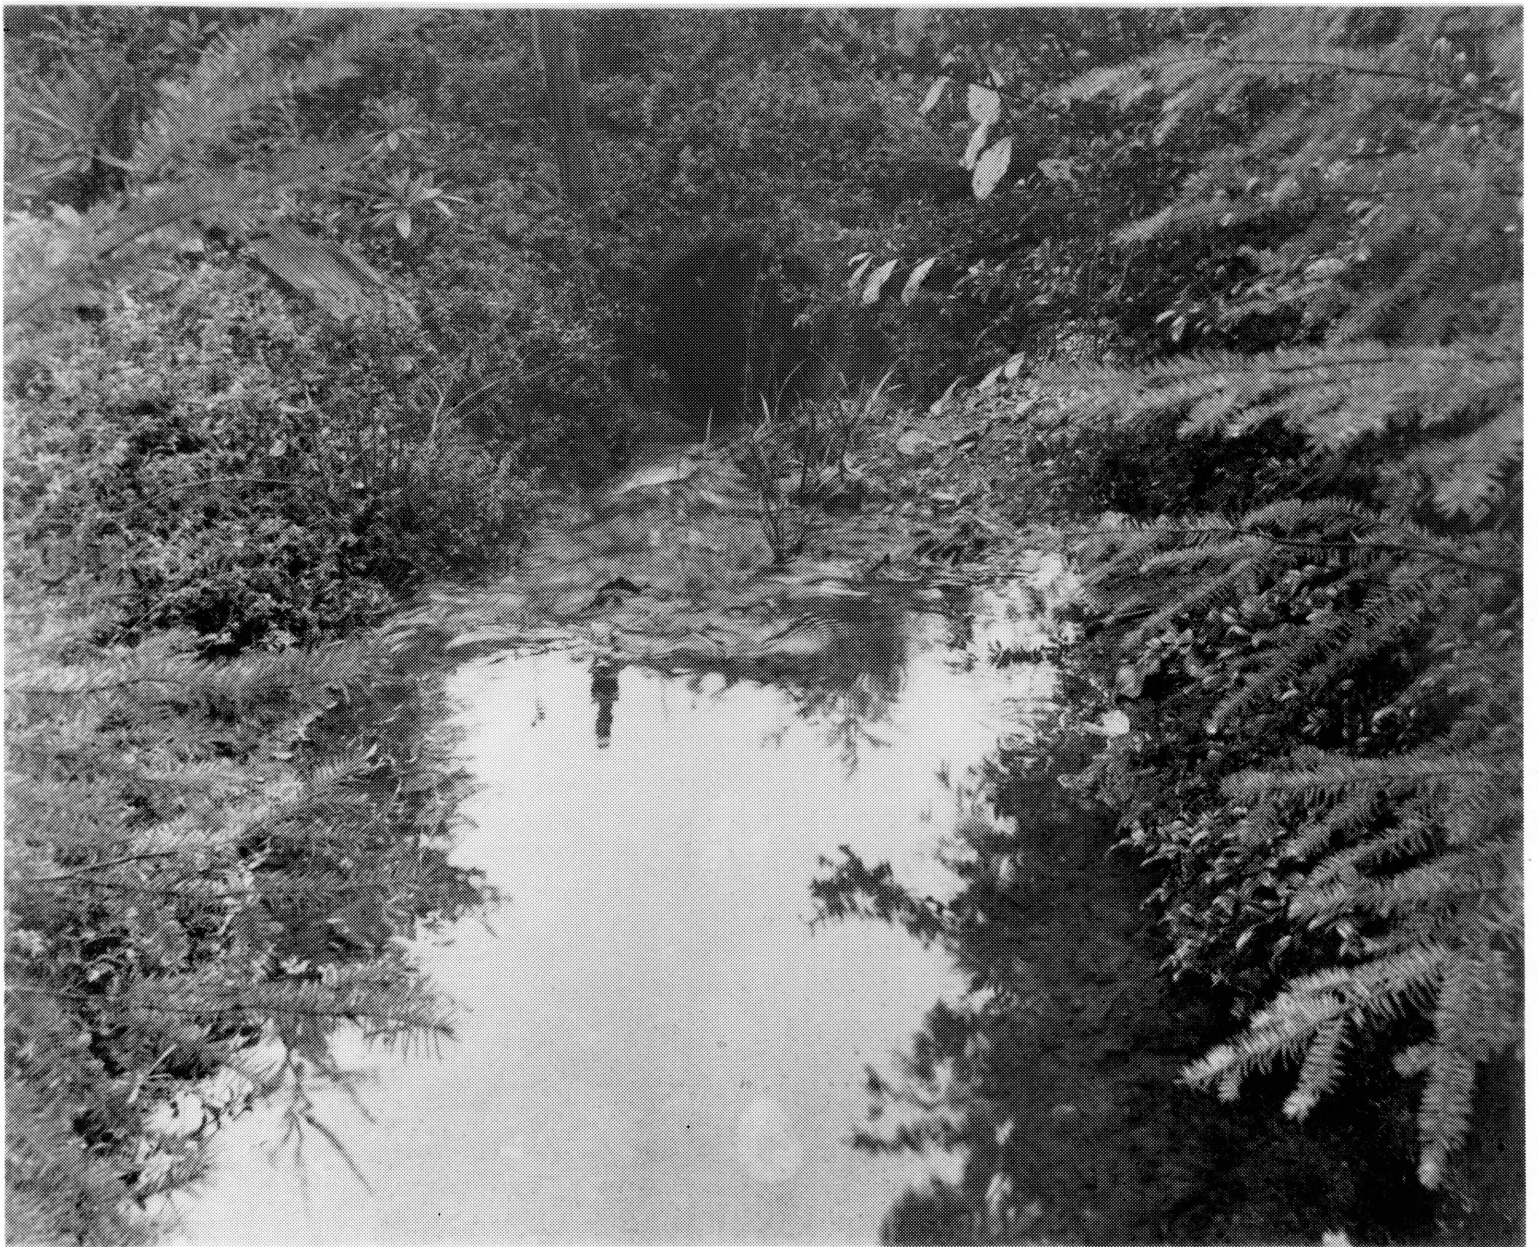
9-B. This view is looking into the culvert shown in Photo 9-A,
on the C-Line road. Very clean.

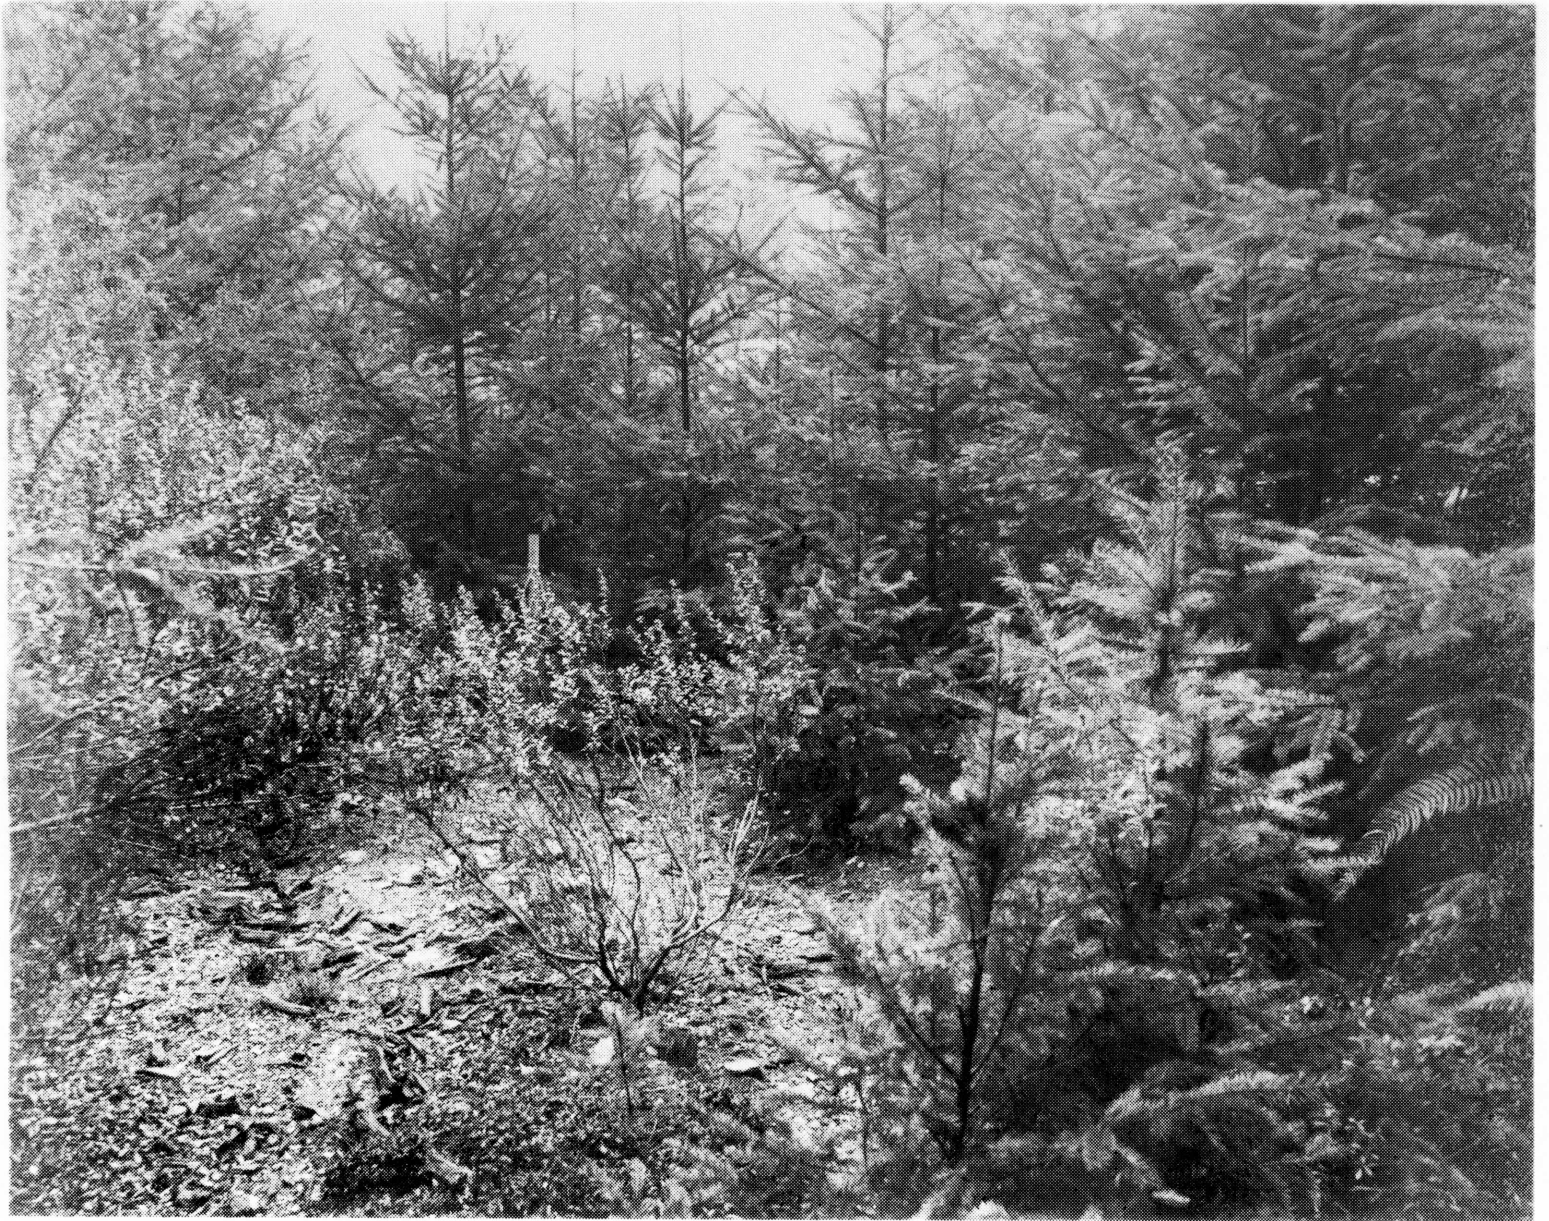
10. This is an old skid road, tributary to and below the C-Line logging road. It was used when the area was logged in 1953. This point is just a short distance above the Redwood National Park. No erosion. Young trees have overgrown access.

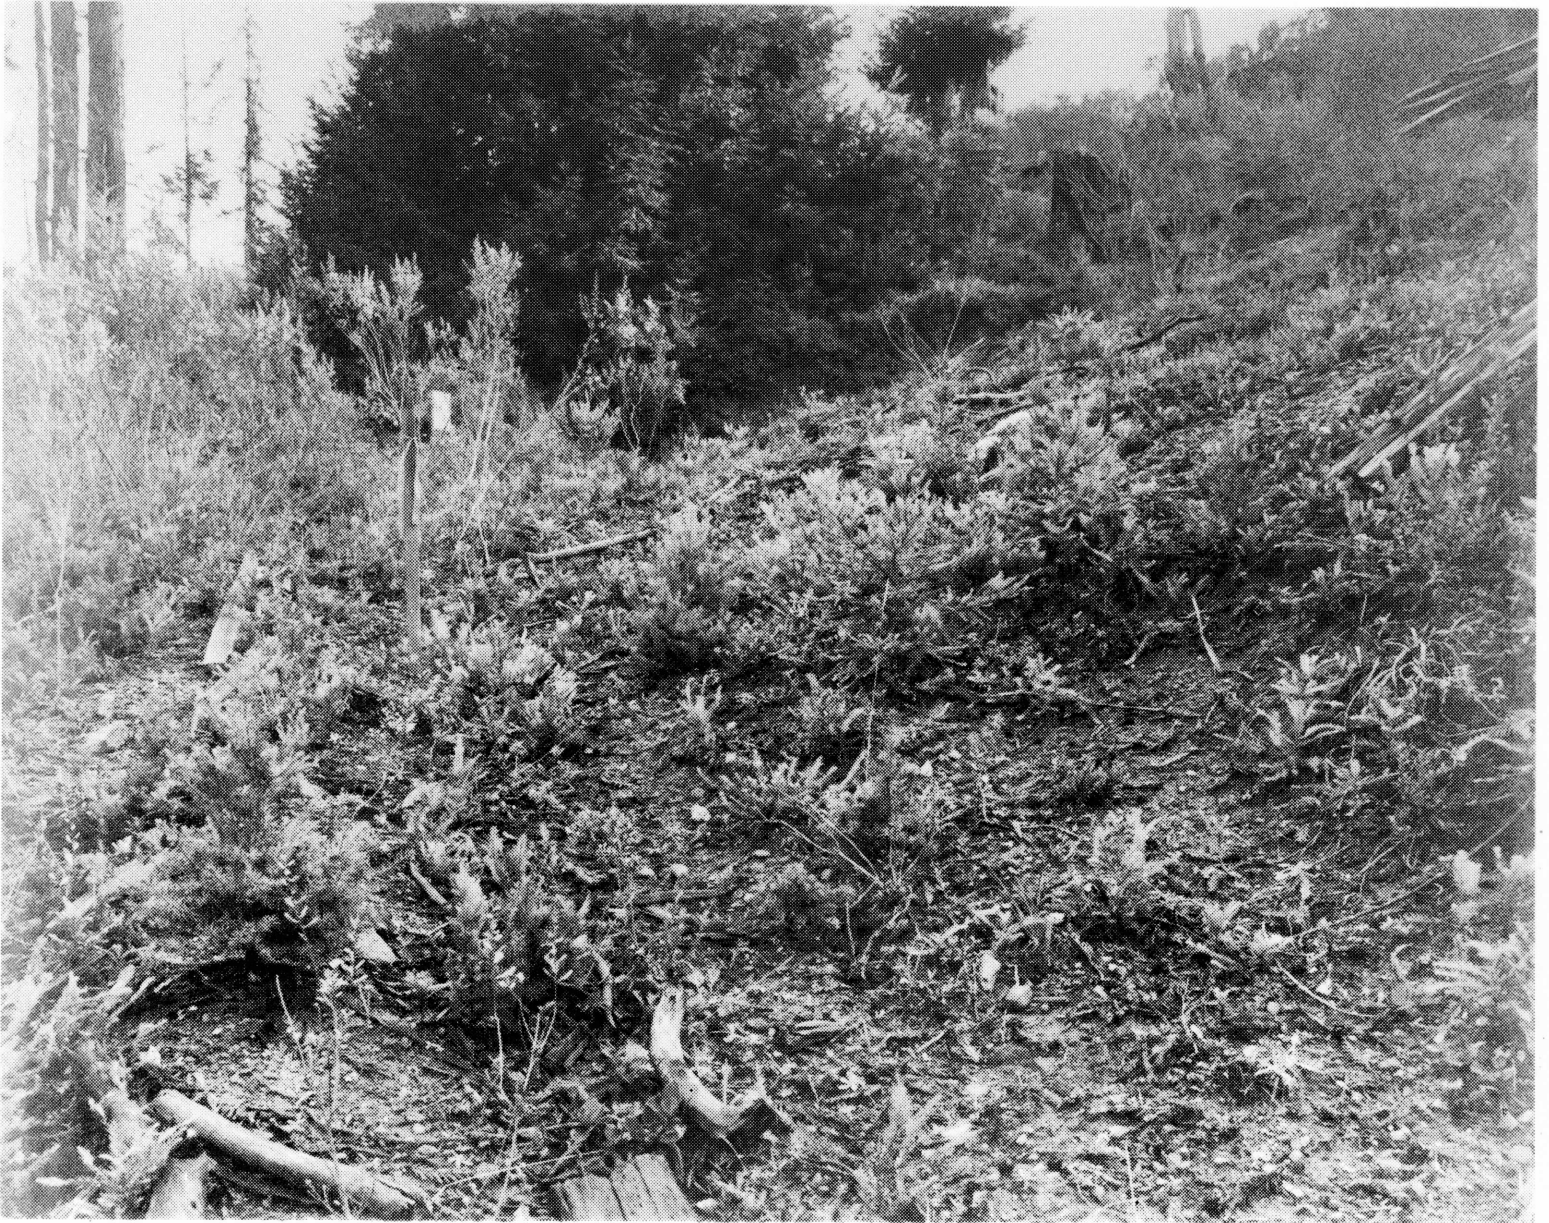
11. Skid road at the Redwood National Park boundary. This area was logged in 1960 and relogged in 1964. No erosion.

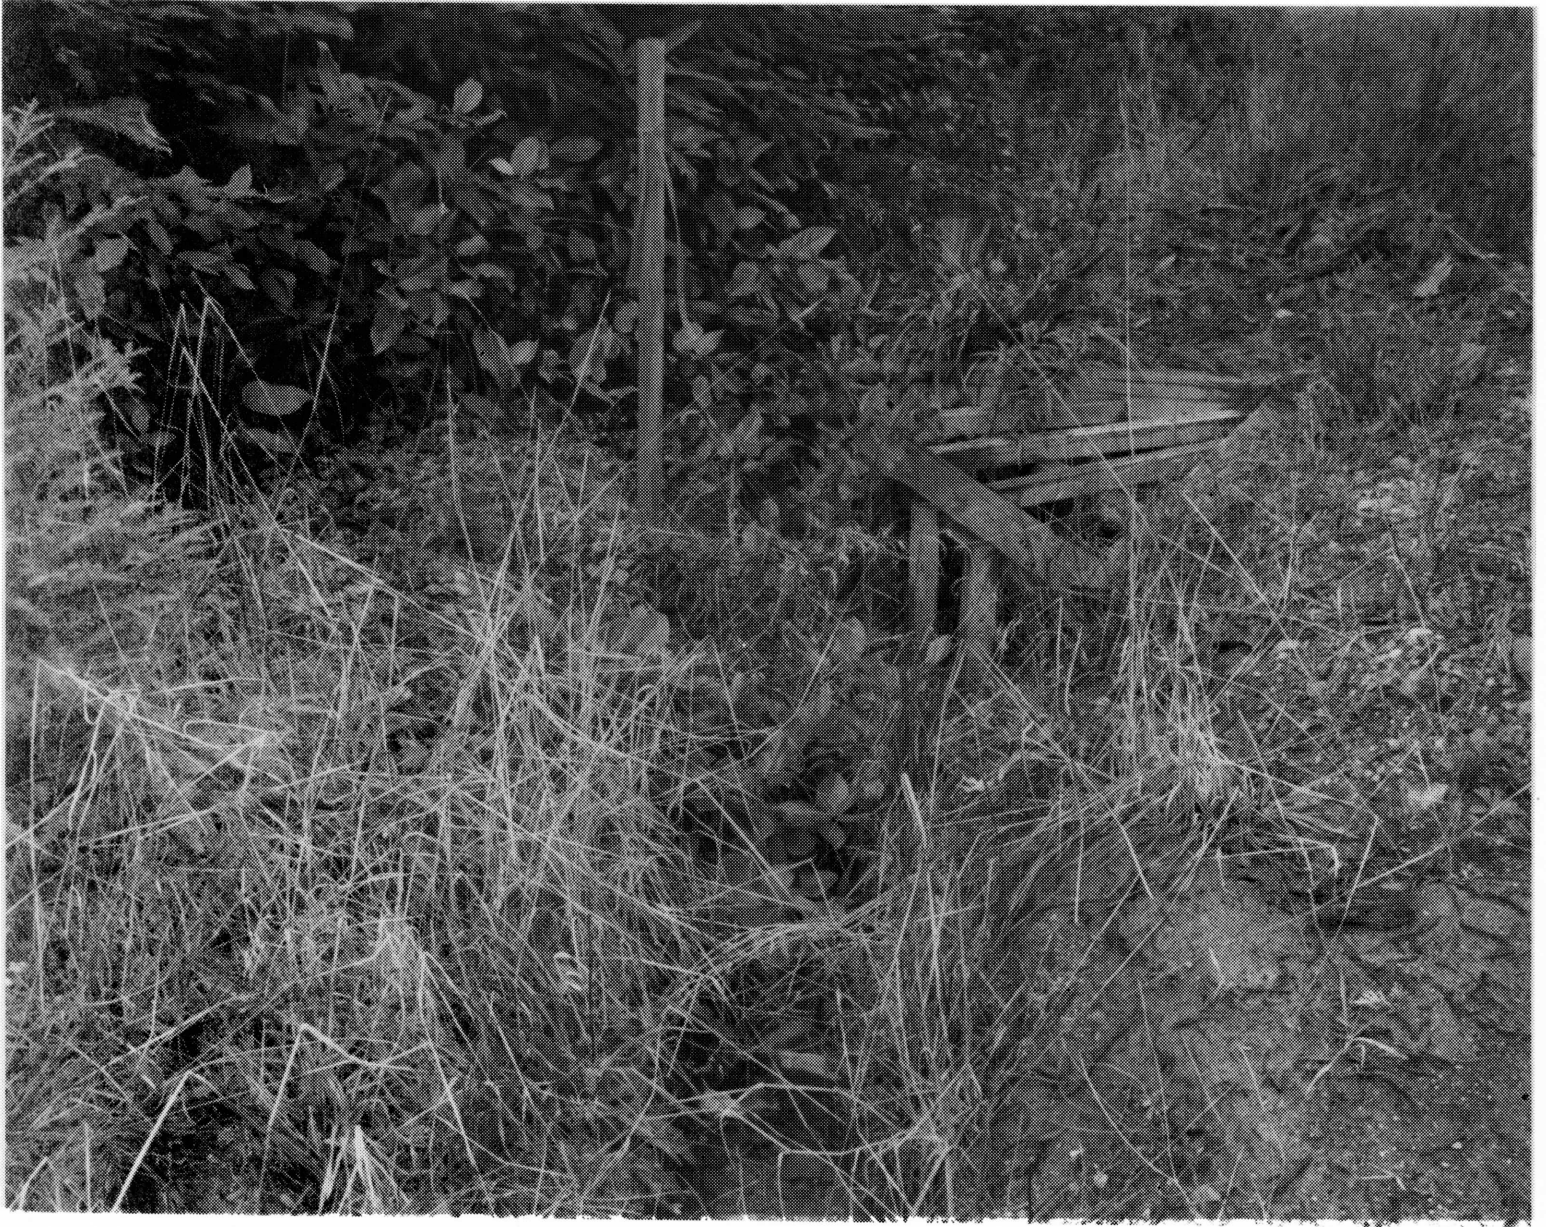
12. This culvert head installation is on the C-Line road and was made in 1953. The area above the road was logged in 1963. Clean; uneroded.

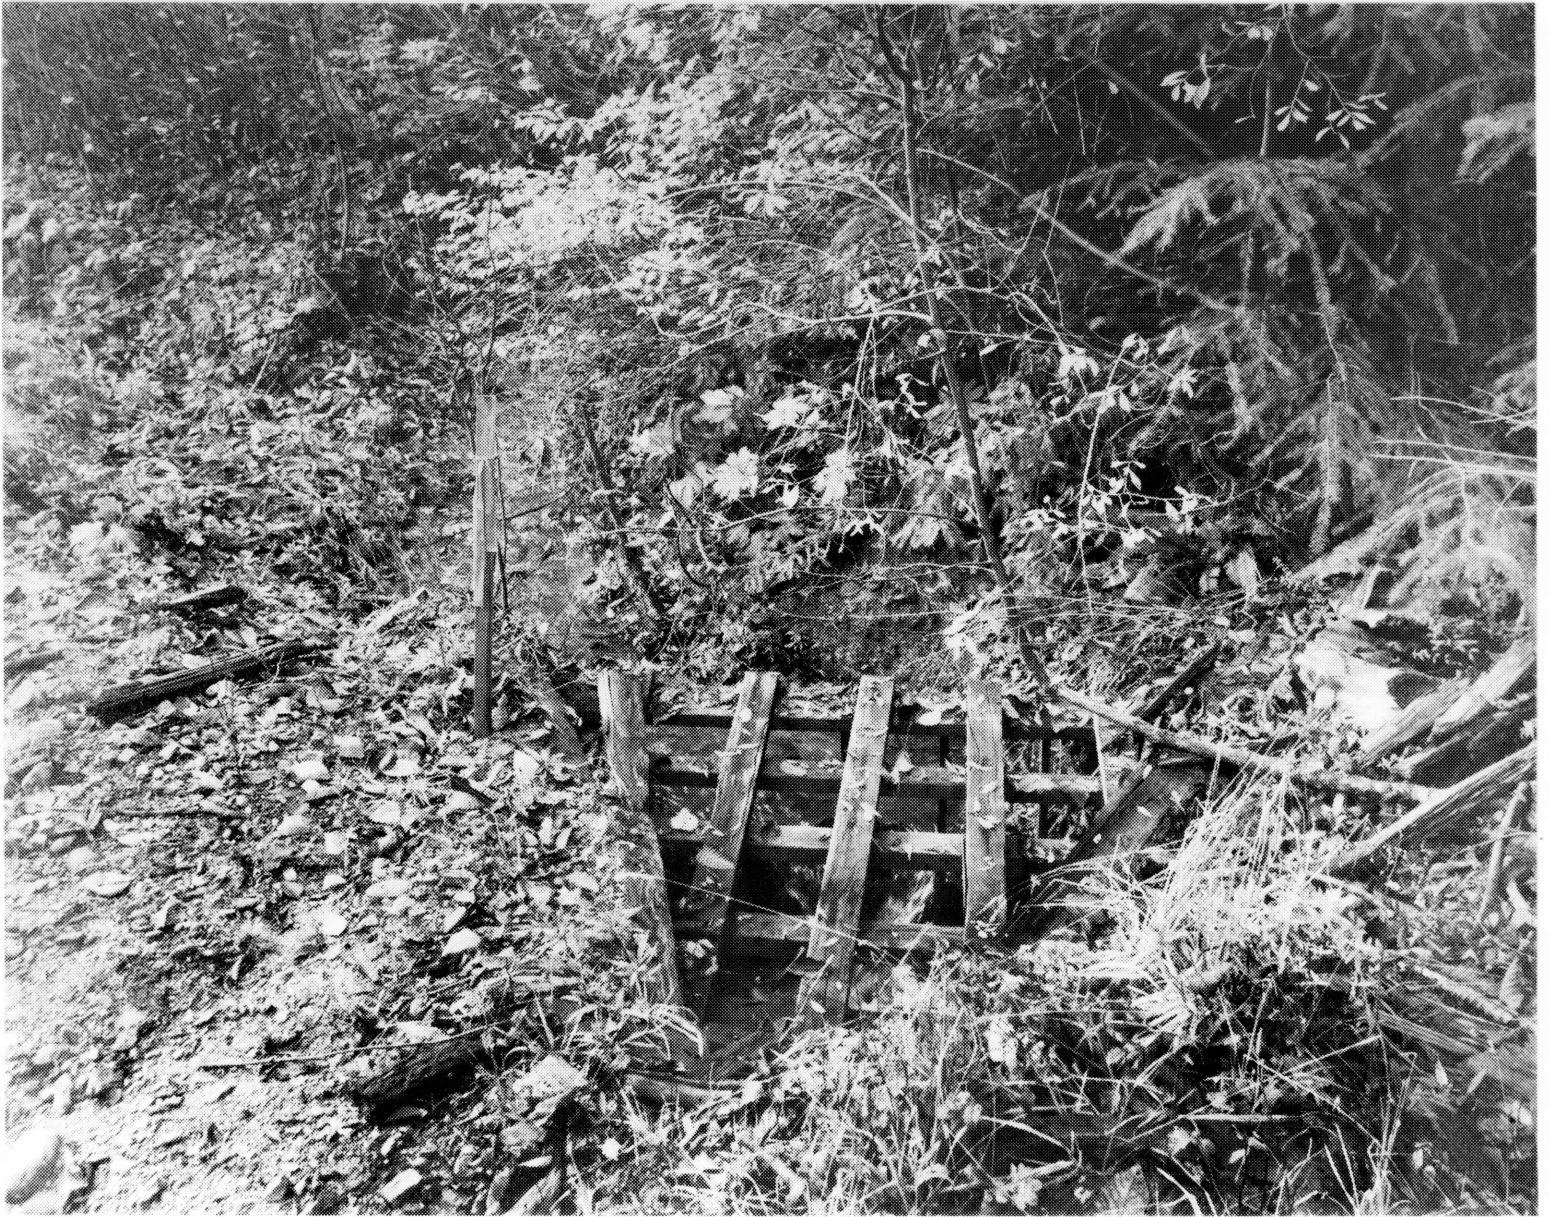
13. Another culvert head on C-Line logging road, installed in 1953. The area above the road was logged in 1962. Clean; uneroded.

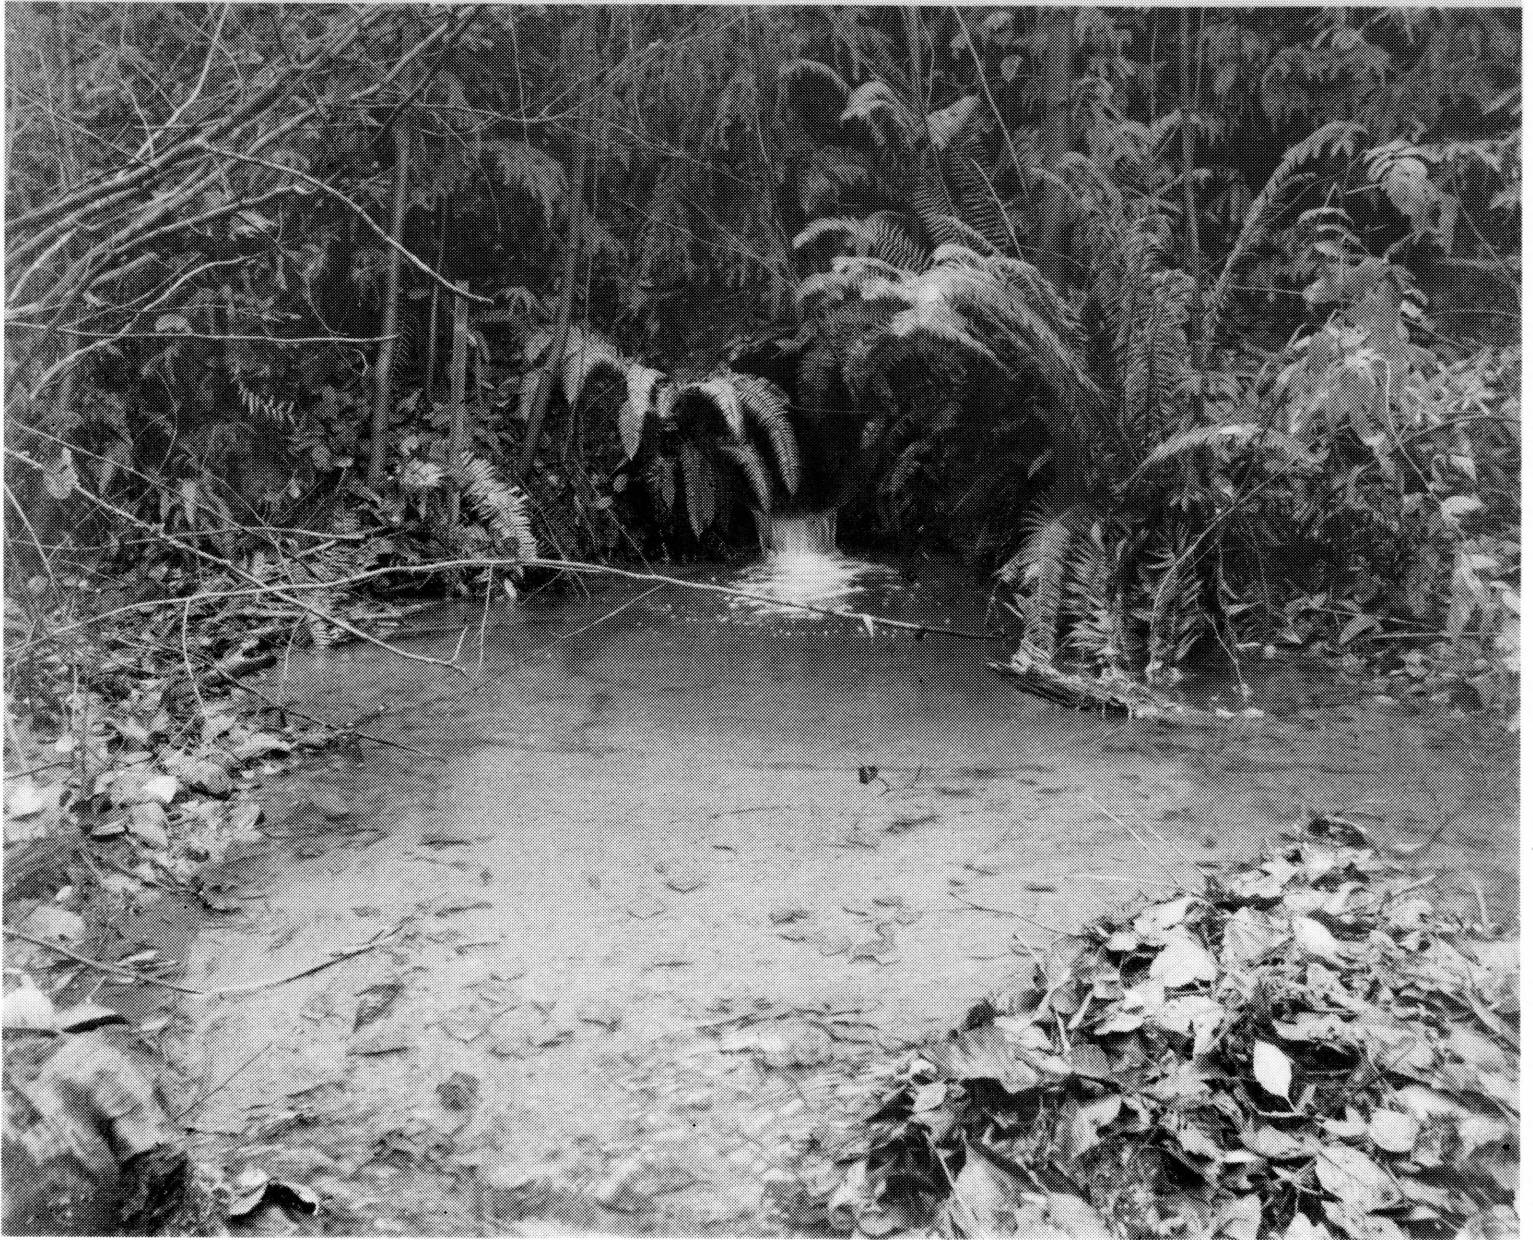
14. This culvert outlet, surrounded by lush vegetation, is on the C-Line logging road. The area above the road at this point was logged in 1953. Clean, clear and uneroded.

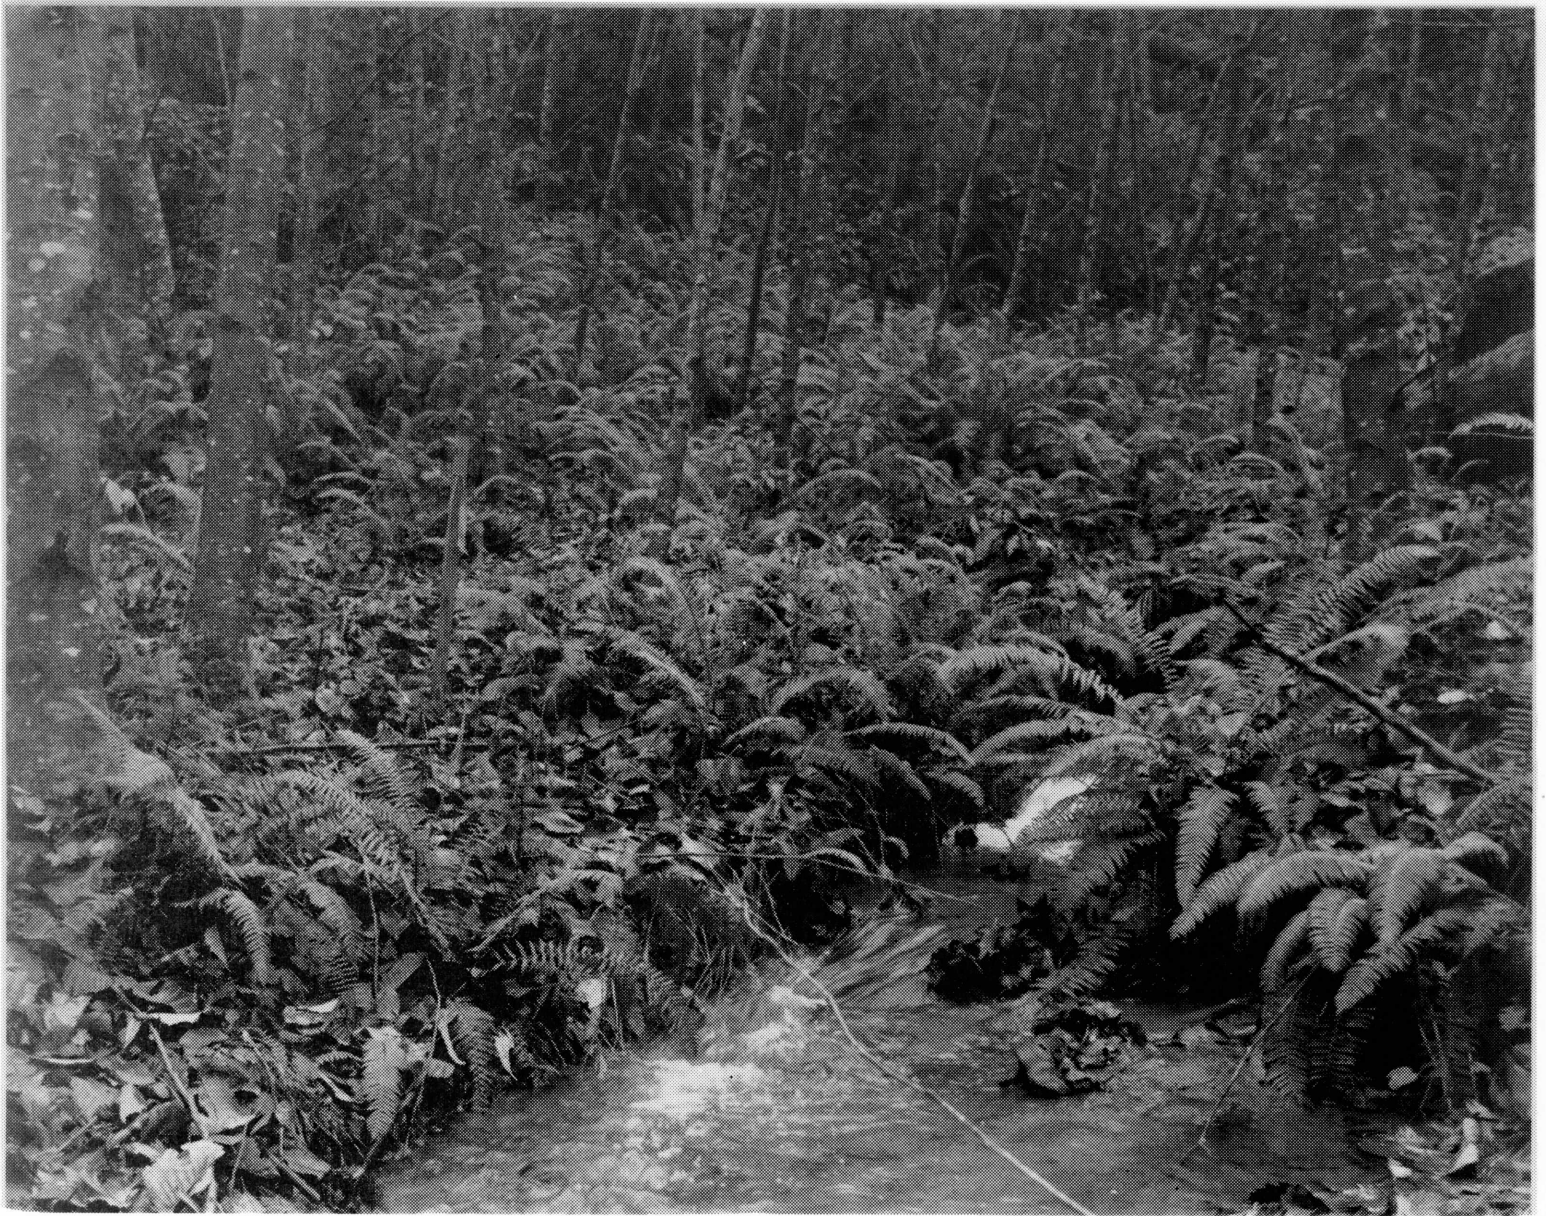
15. This creek is tributary to Forty-four Creek in an area logged in 1955. After 2 days hard rain. Note stream-side cover shading creek.

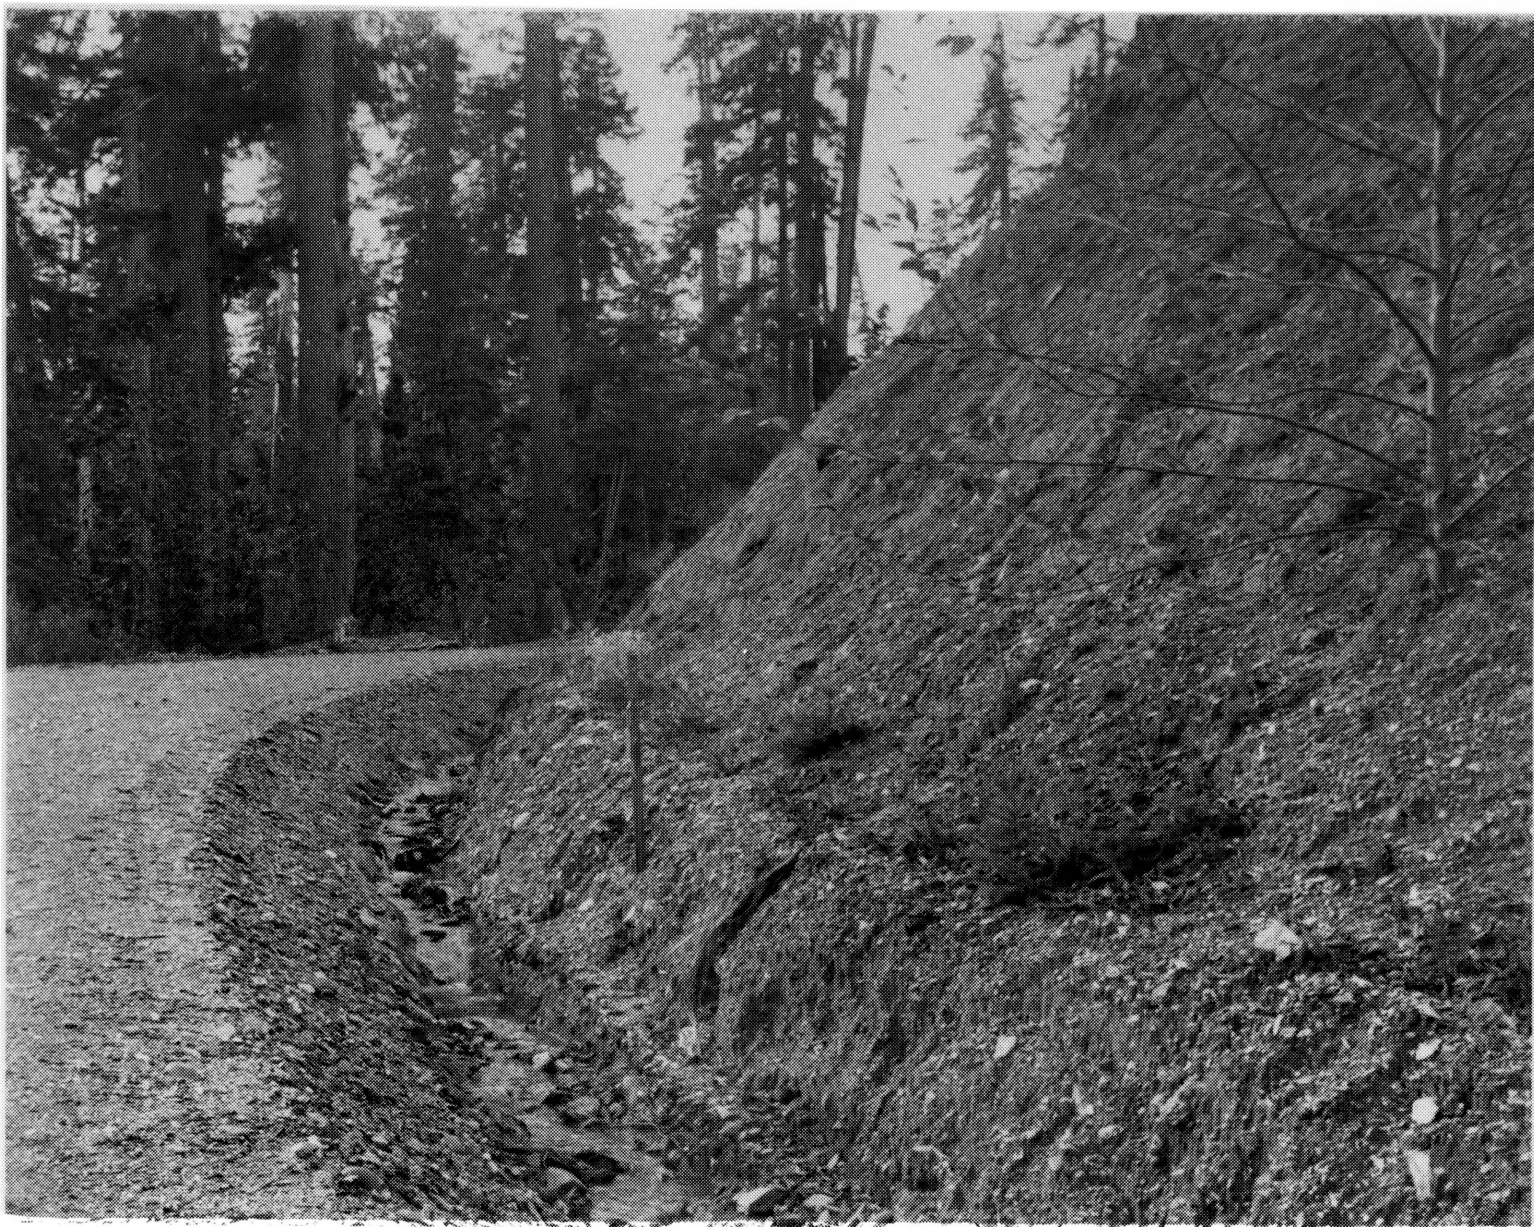
16. This is a section of the A-9 logging road, looking uphill to the west a little more than half a mile above the Redwood National Park. This road was constructed in 1965. The area above the road was logged in 1968, with relogging in 1969. Water in gutter is runoff after 2 days hard rain. Bank and road are in good shape.

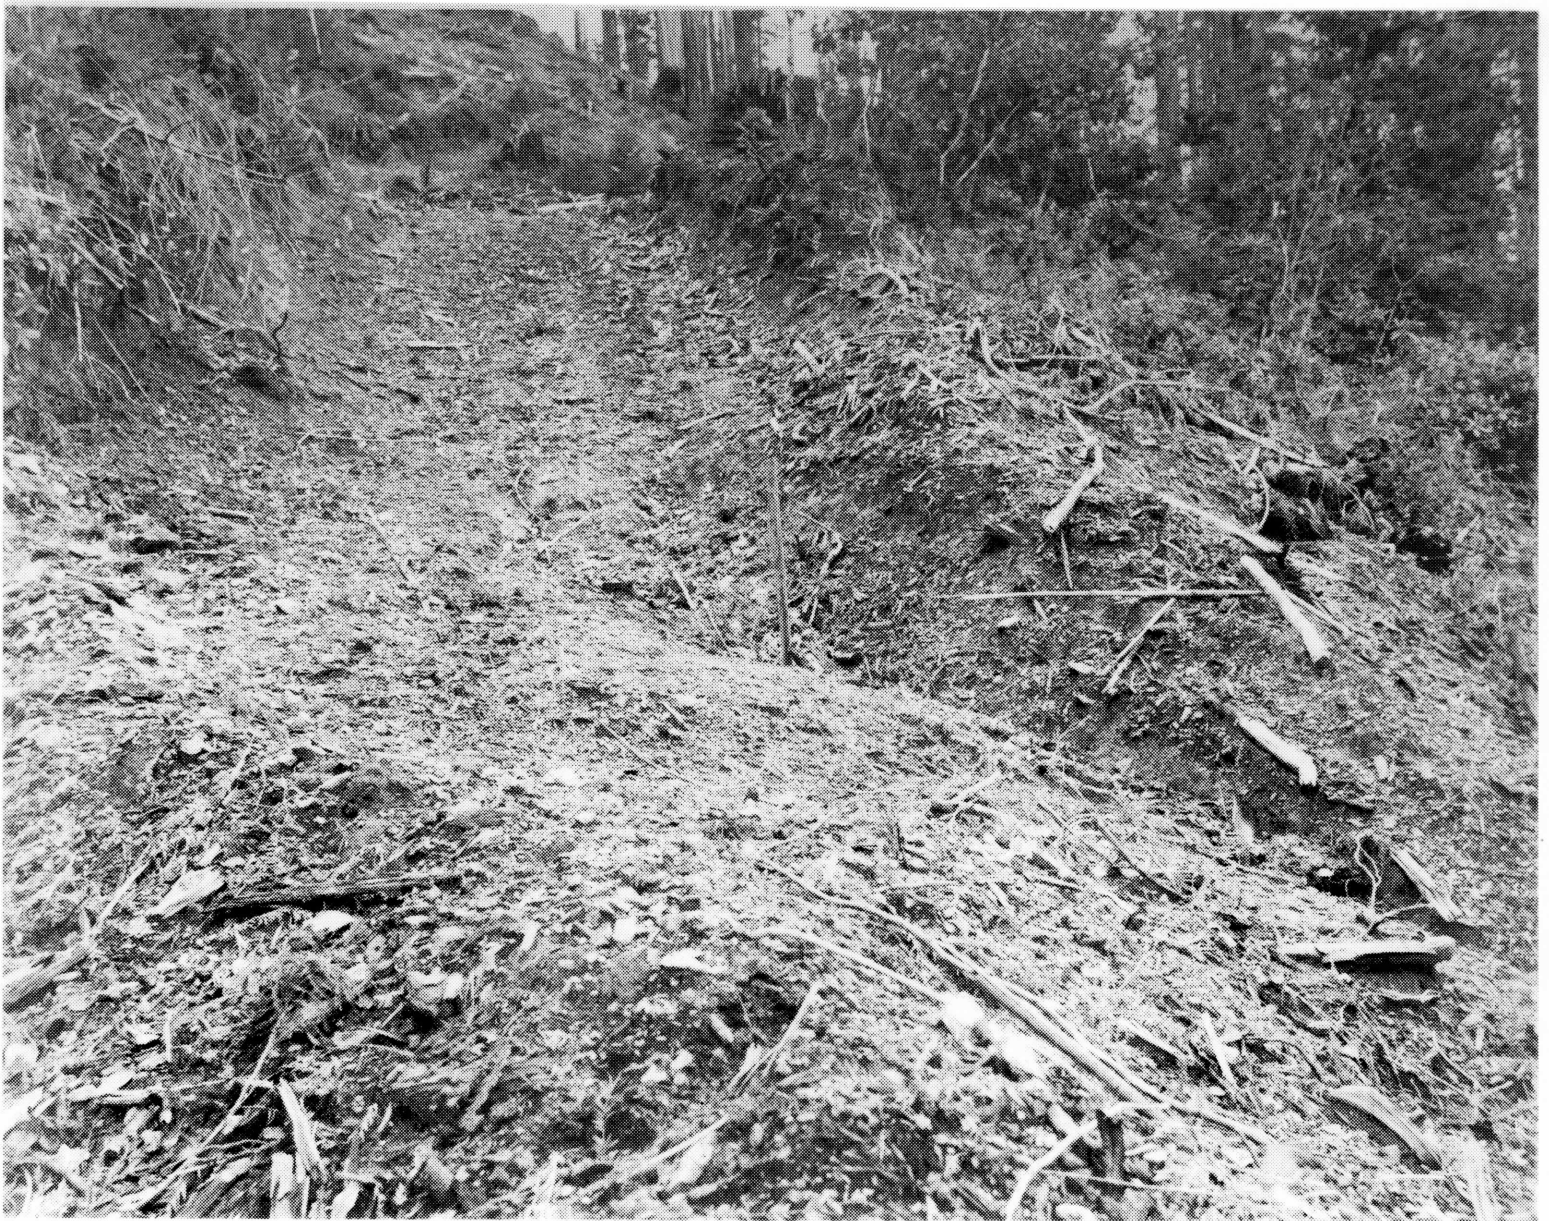
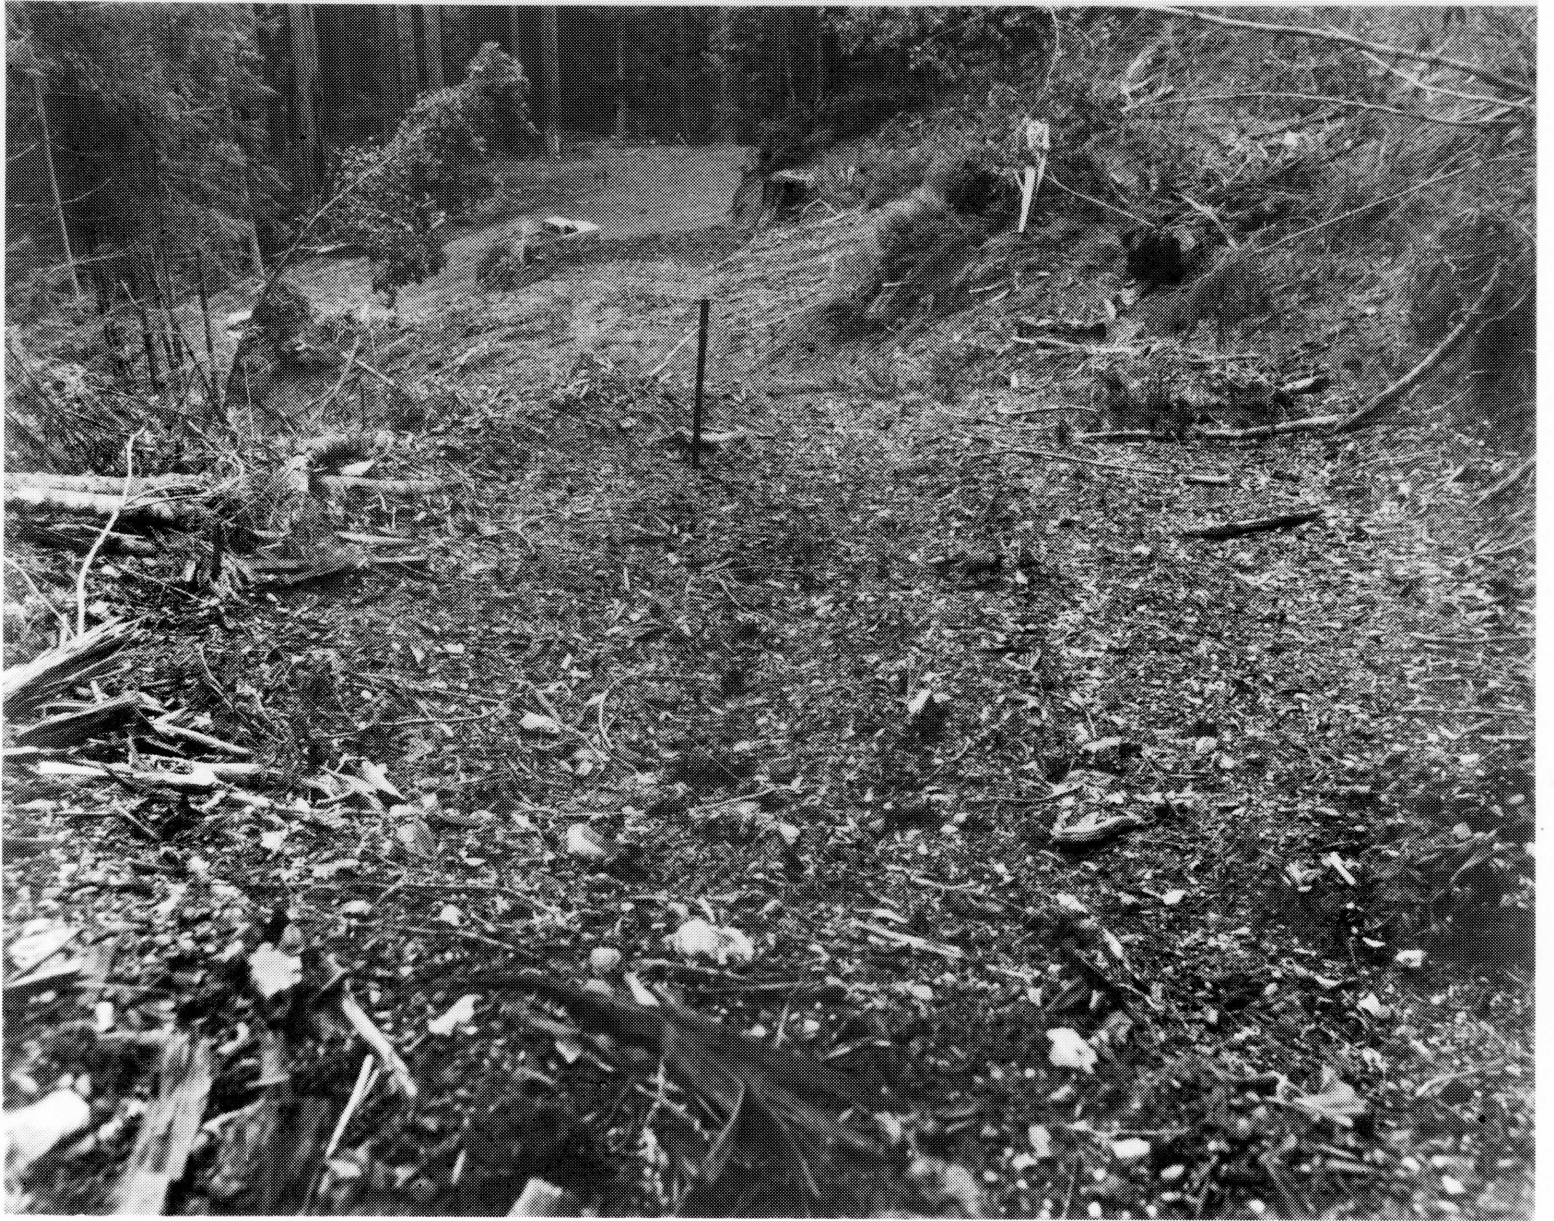
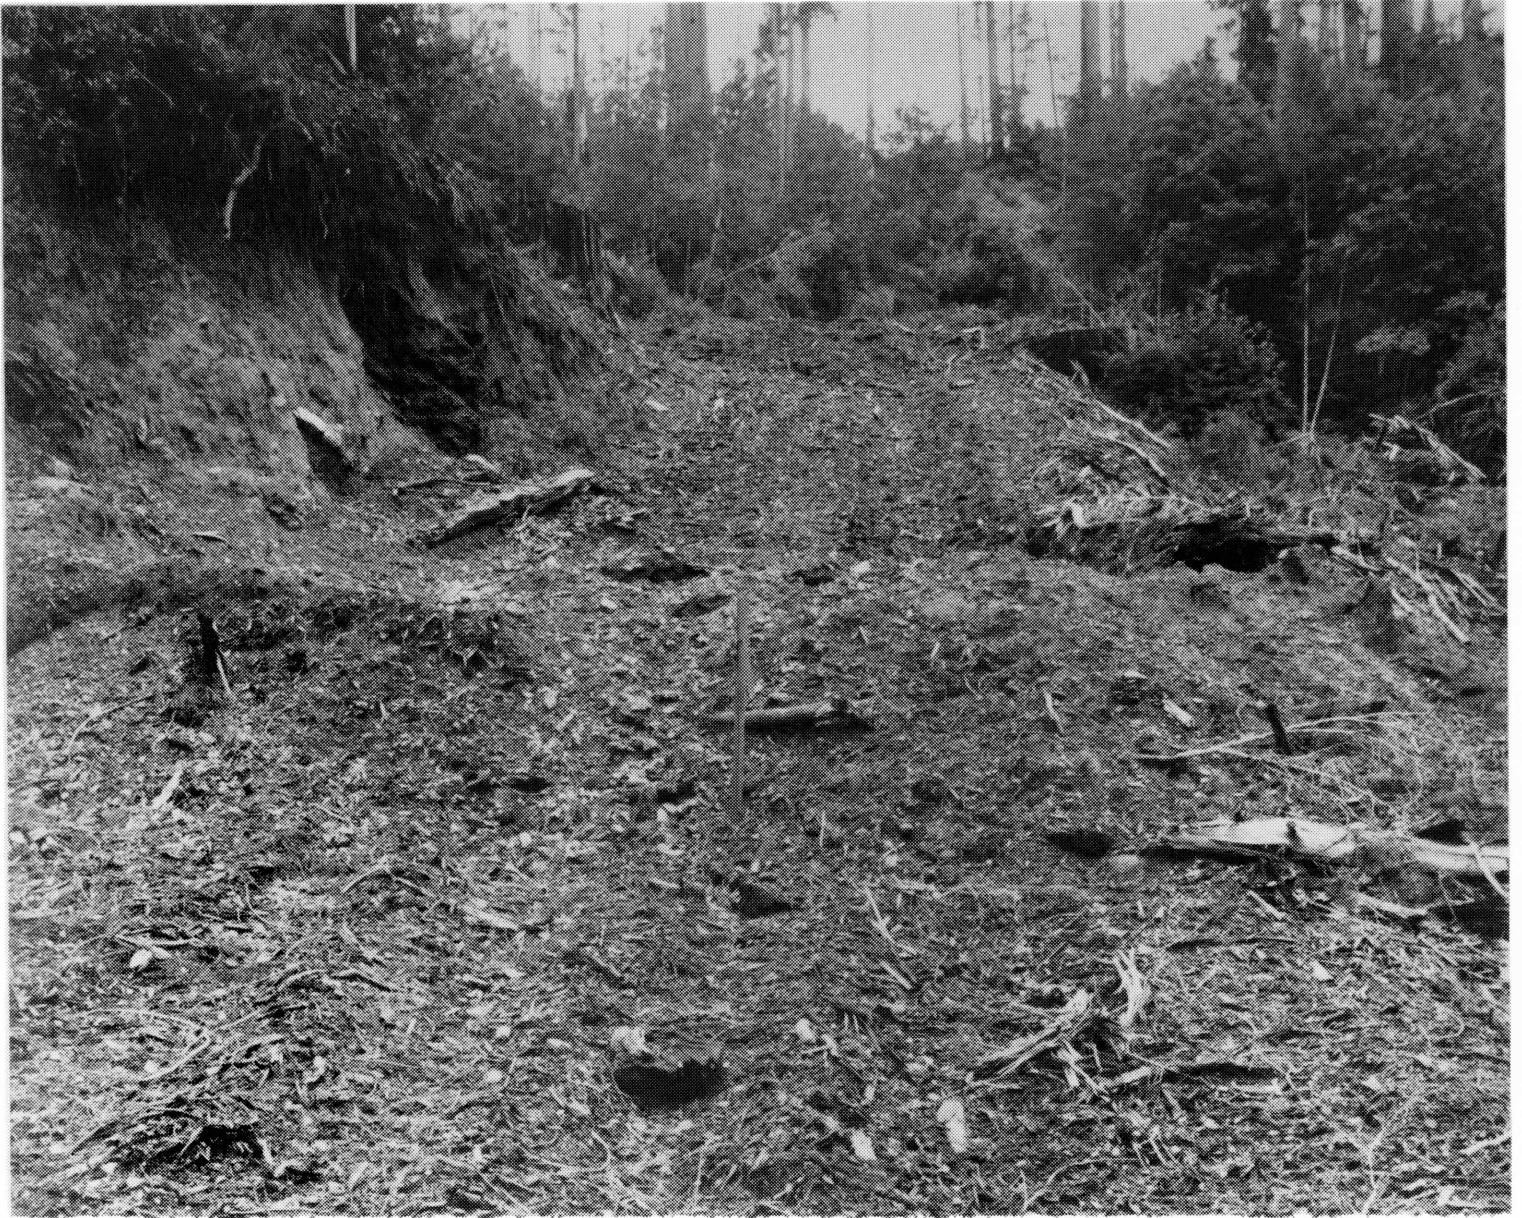
17-18-19. Three views of a skid road near the point it joins the A-9 logging road in an area logged in 1969. Note, water diversion bars show in all three photos. No erosion. Hundreds of small trees on this ground, too young to show up in photo.

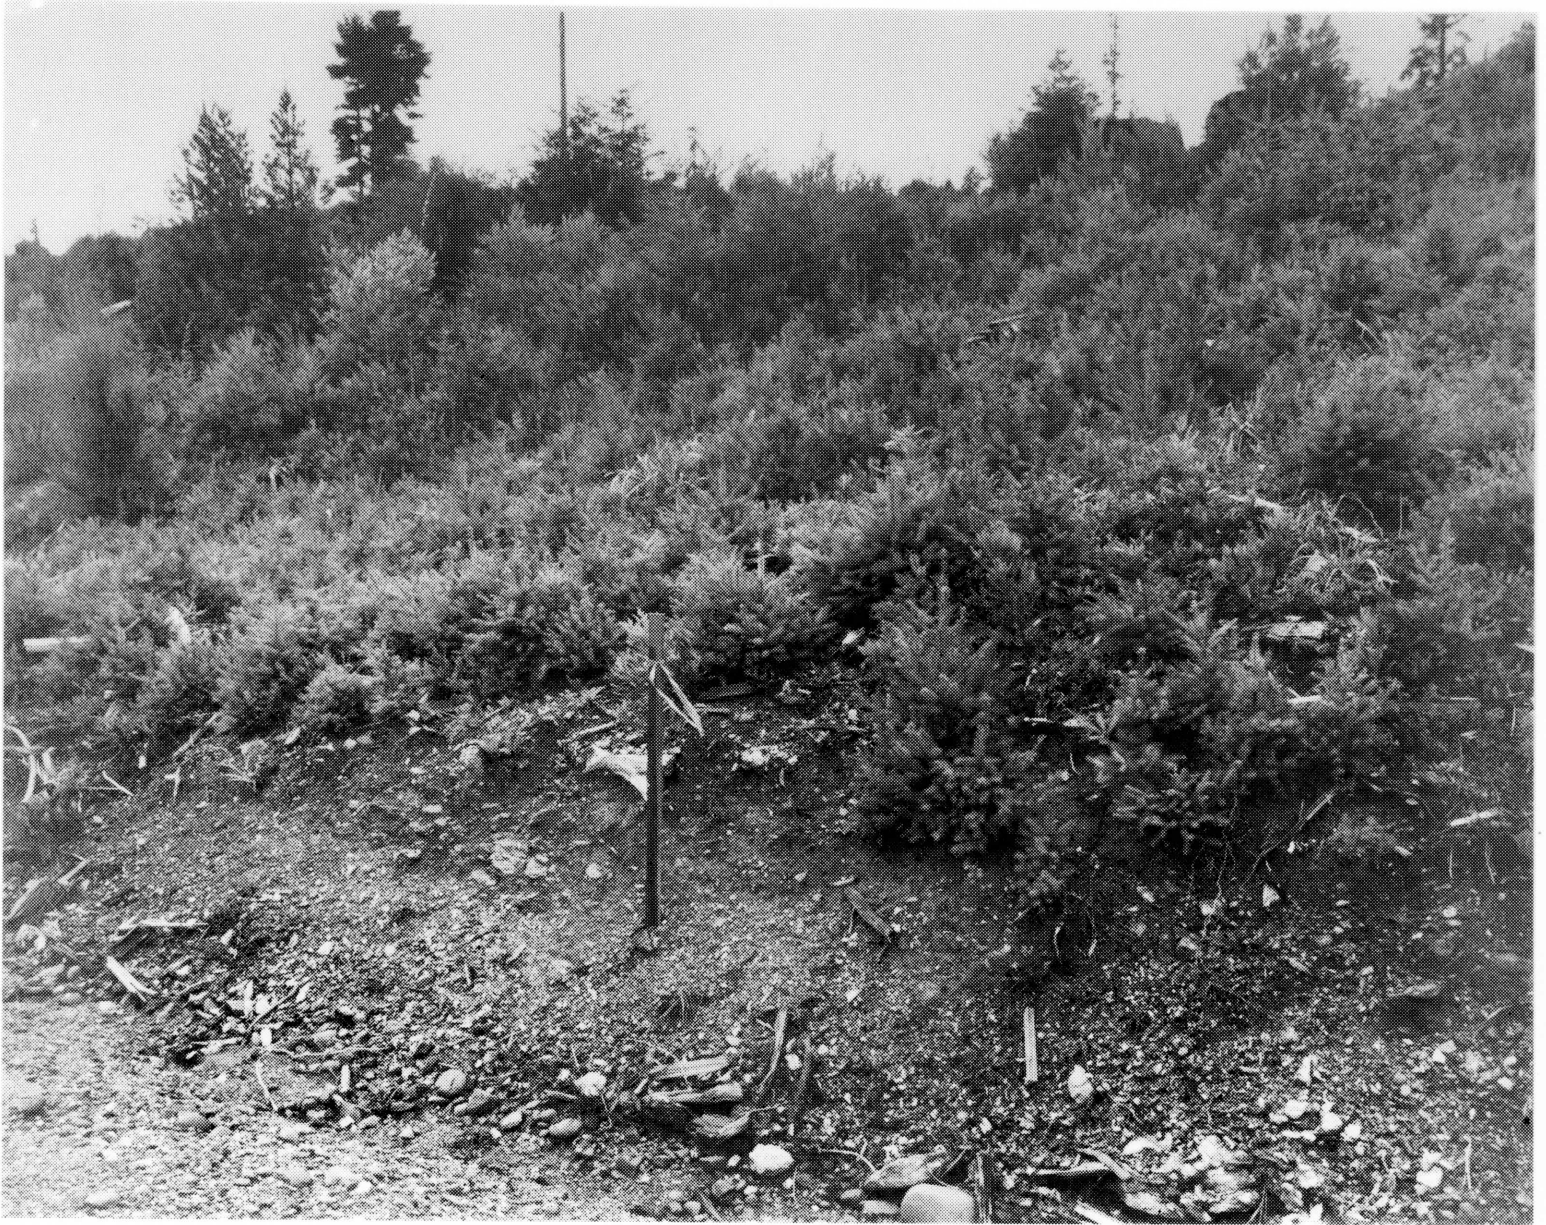
20. Road bank on L-1 logging road, a quarter of a mile above Redwood National Park. This area was logged in 1965 and relogged in 1971. No erosion. Too many young trees have sprung up and will need to be thinned later.
