DOES REDWOOD TIMBER HARVESTING

LEAD TO MASSIVE EROSION AND EARTH SLIDES?

PHOTOGRAPHIC LOCATIONS
Georgia-Pacific Big Lagoon
Area

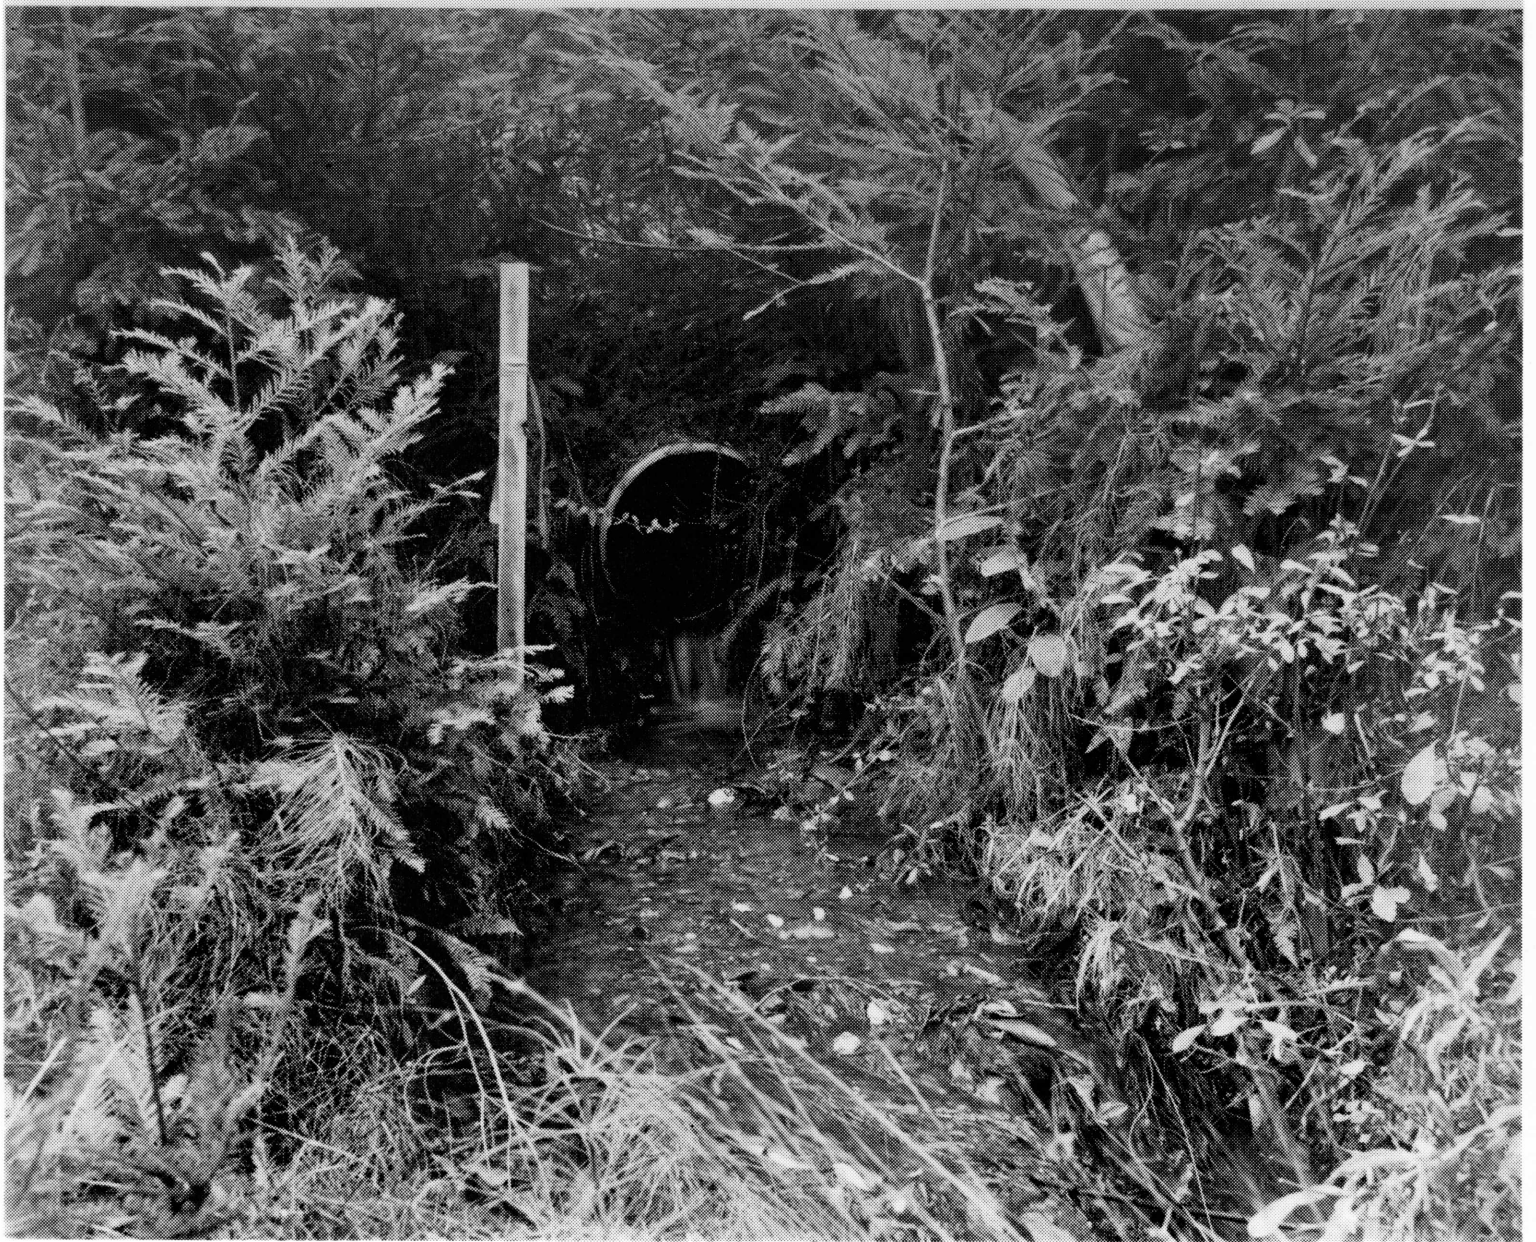
21. This culvert outlet is on L-1 logging road about one mile from the scene in Photo No. 20 and about an eighth of a mile above the Redwood National Park boundary. This area was logged in 1965 and relogged in 1971. Clean, uneroded and uncluttered.

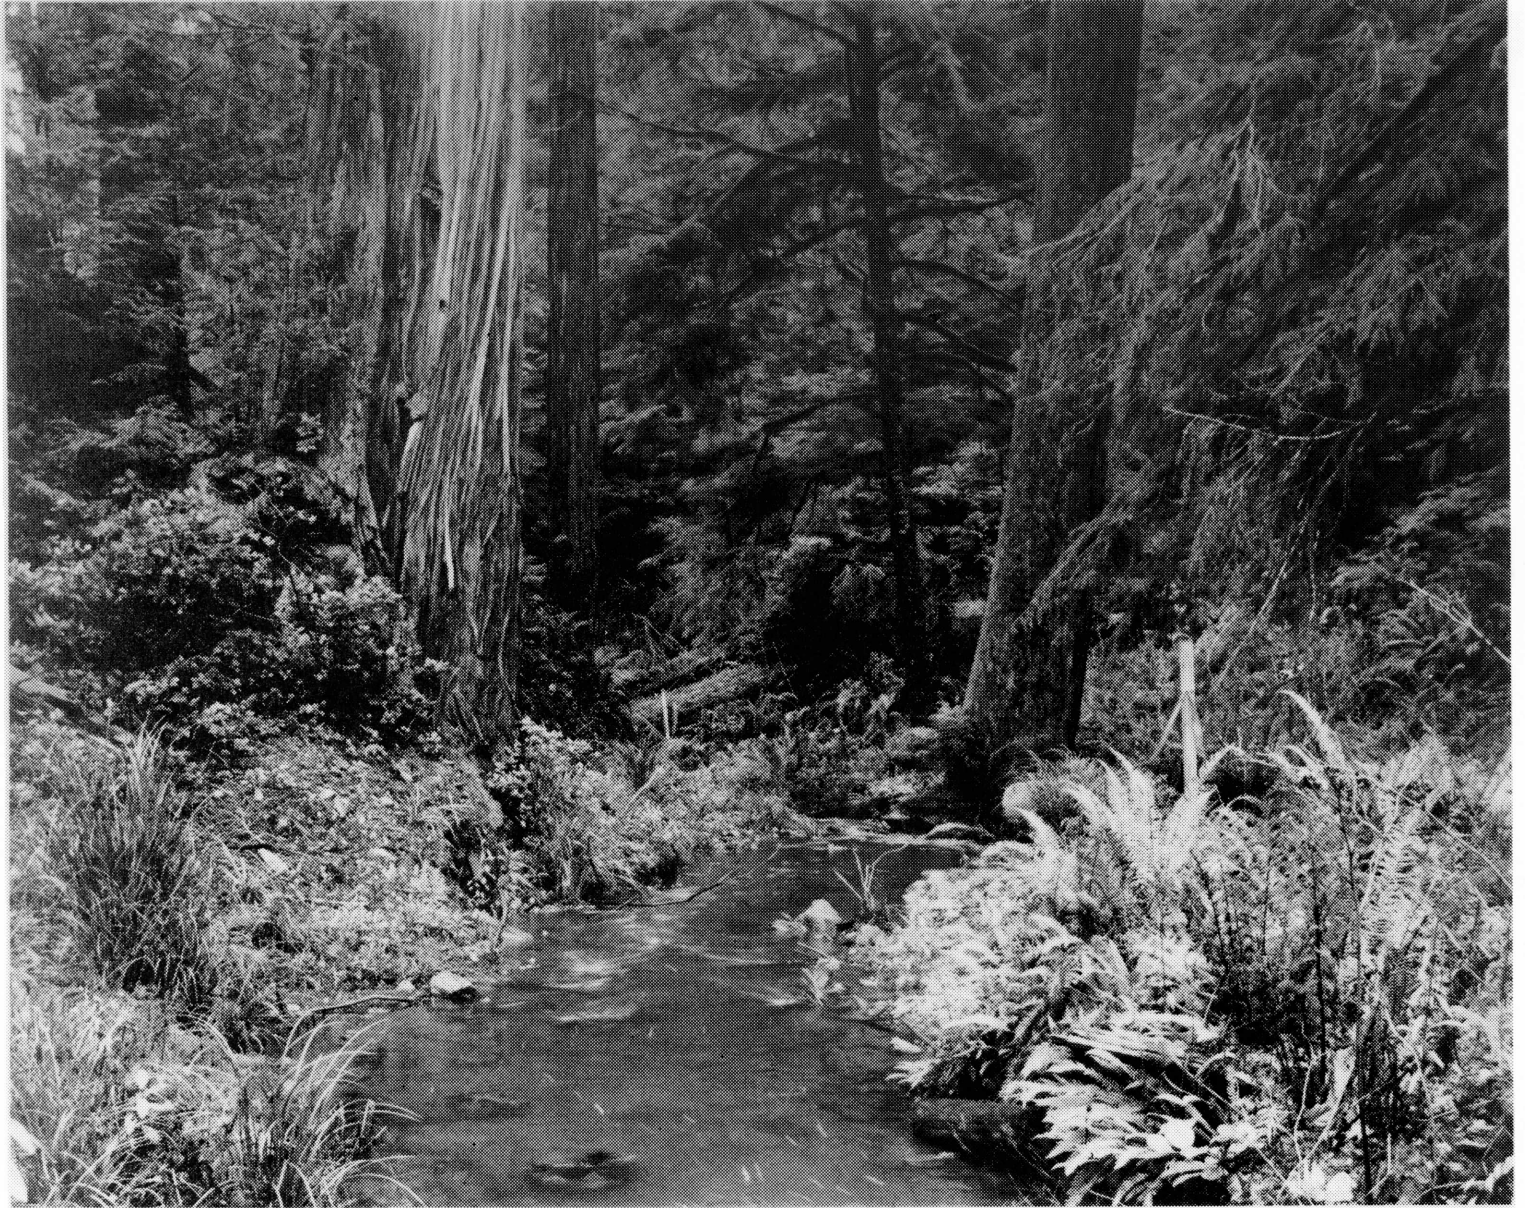
22. This view of Elam Creek is about three-fourths of a mile west of the Redwood National Park boundary. The upper watershed was logged and relogged in 1962, 1963, 1969, 1970 and 1971. In color photos you can perceive bottom of the creek even after 2 days hard rain.
