# **ANTARCTIC TREATY INSPECTIONS 2005**

**Report of Antarctic Treaty Inspections undertaken jointly by the United Kingdom, Australia and Perú in accordance with Article VII of the Antarctic Treaty and Article 14 of the Environmental Protocol.**

**Foreign and Commonwealth Office, London, UK  
Australian Antarctic Division, Kingston, Tasmania, Australia  
Instituto Antártico Peruano, Lima, Peru**

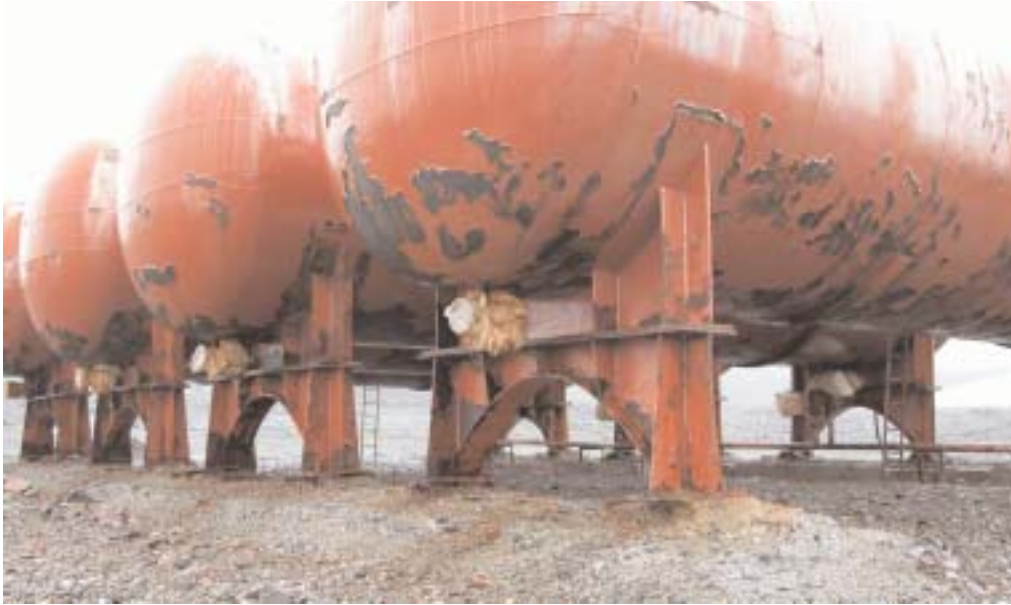
Poor maintenance of tanks and transfer equipment was also evident at some stations. Tanks and tank foundations were at times noted to be heavily corroded and in some cases actually leaking fuel. Only one of the stations inspected had formally audited its fuel storage and transfer procedures and equipment, and containment and response capability, against COMNAP's recommended checklists.

*An example of badly corroded and leaking bulk fuel tanks set on severely eroded foundations*

- That Parties should prepare, and make publicly available, Policy Statements on tourism in relation to their Antarctic stations;
- That bulk fuel facilities currently lacking secondary containment should be replaced either with double-skinned tanks, or provided with adequate bunding;

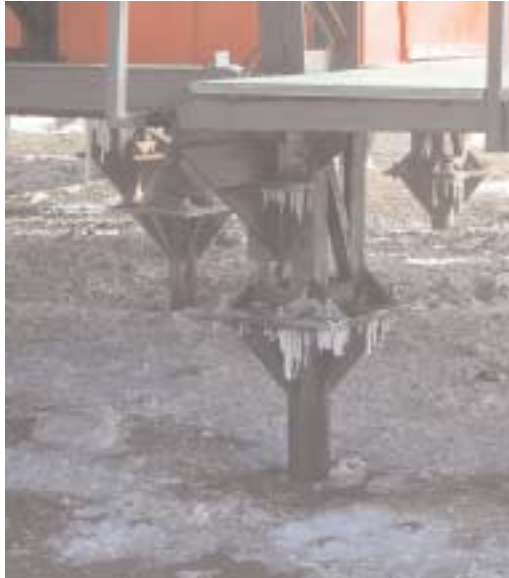
Because of its elevated position, the station experiences harsh conditions and is frequently cloud covered. The ground surface consists of some 45 centimetres of very fine clay-like wet soil overlying permafrost. There is active frost heave and most of the buildings are elevated on steel supporting piles driven into the permafrost, rather than on footings. The piles incorporate flanged baffles to minimise heat transfer from the buildings melting the permafrost, which could destabilise the buildings.

*Detail of the permafrost piles supporting the building.*

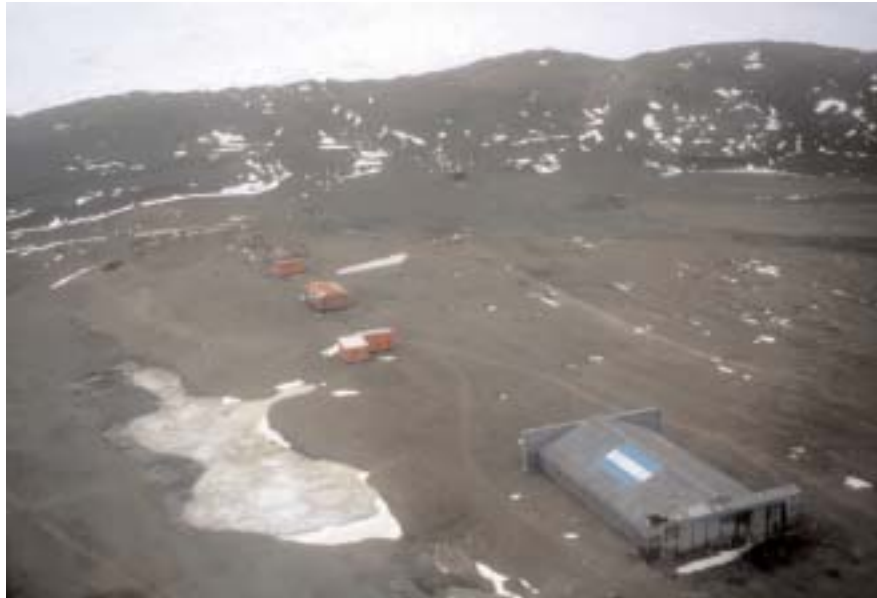
*Southern end of Petrel Station, looking south-east.*

The buildings are generally in very poor condition. It is unlikely that the generator building or main living quarters will remain stable or safely habitable in the near future. The roofs of most buildings were leaking. Some attempts were underway to stabilise some of the buildings. In particular, the emergency accommodation building was being repainted, with a view to refurnishing it and establishing this as the main accommodation building.

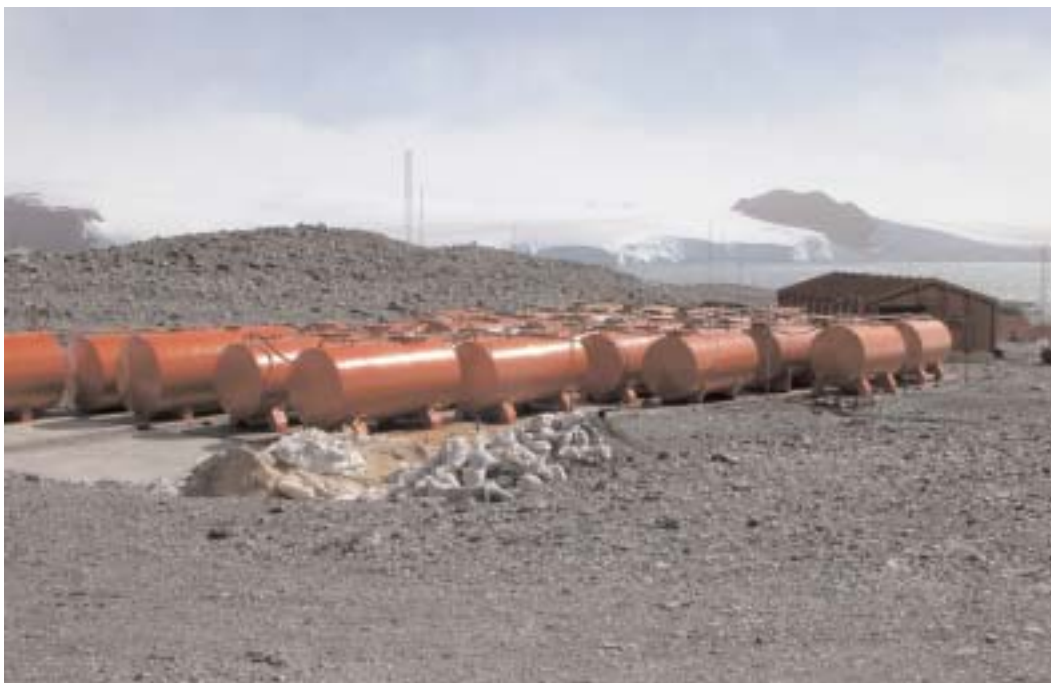
*The bulk fuel-farm at Esperanza. The building materials in the foreground are for constructing an overall bund around the tanks.*

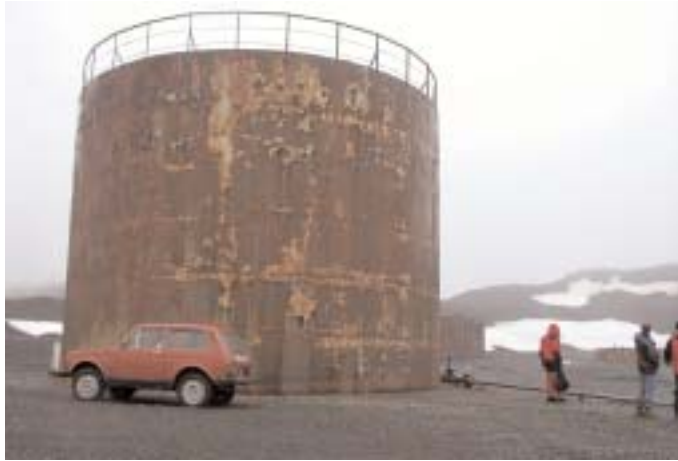
Fuel is delivered from the bulk tanks to the station by a tanker-truck, over a rough 3.5km track. This truck was out of service at the time of the Inspection. A tank of around 2,500 litres capacity has been fabricated on station to be fitted to a six-wheeled all-terrain truck as a replacement.

*One of the large (250,000 litre) bulk fuel tanks at Rocky Cove, North of Bellingshausen.*

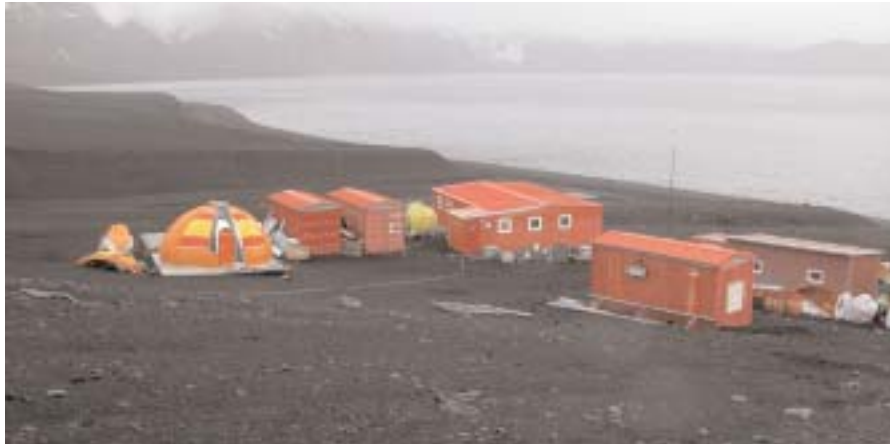
*A view of part of Gabriel de Castilla showing the new laboratory building (centre) and the storm-damaged fibreglass igloo.*

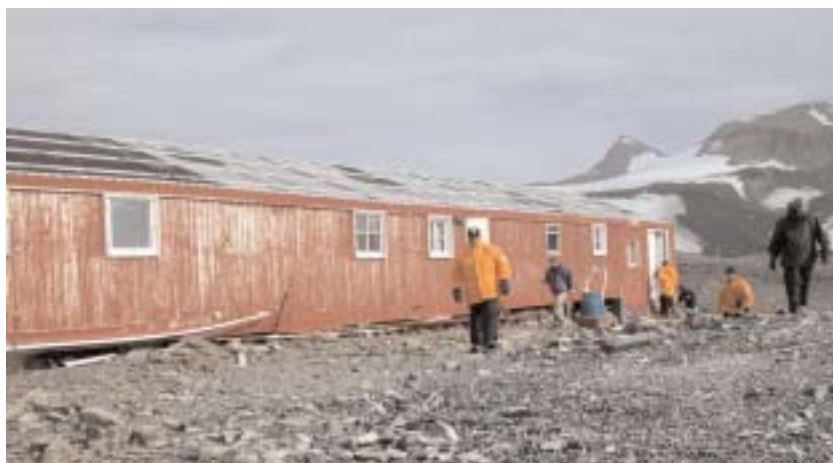
*The single building comprising T/N Ruperto Elichiribehety. The lack of roofing membrane can be seen.*

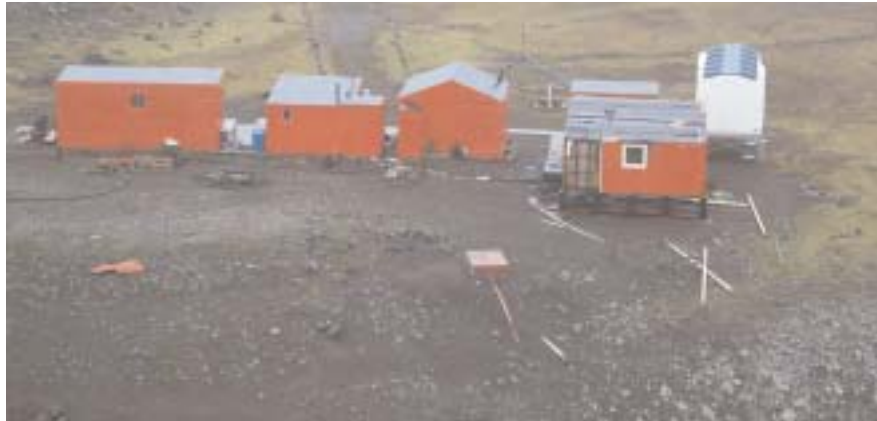
*The rear view of Risopatron. Note the storm-damage to the right hand red building.*
