# LOWELL CULTURAL RESOURCES INVENTORY

IDENTIFICATION 237 MERRIMACK STREET MAP SHEET # 7  
 1) CURRENT OWNER The Rector, Wardens, and Vestry of St. Anne's Church, Lowell OWNER OCCUPIED yes  
 2) HISTORIC NAME St. Anne's Church  
 3) CURRENT NAME same  
 4) PROPERTY TYPE church 5) ZONING CLASSIFICATION B3  
 6) TAXES: PAYMENTS exempt STATUS clear  
 7) WITHIN BOUNDARIES OF LNHP, City Hall HD, LHPD

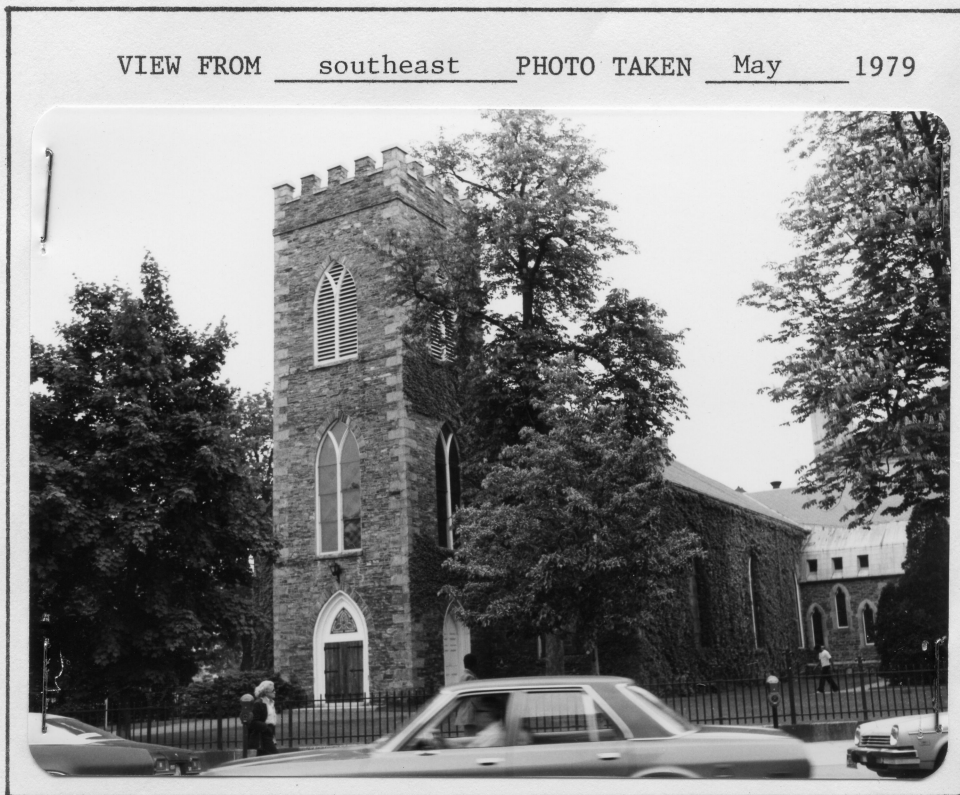
VIEW FROM southeast PHOTO TAKEN May 1979

- 1) CONDITION OF BUILDING FABRIC. excellent
- 2) IF DETERIORATED, CAUSES not applicable
- 3) INTEGRITY OF HISTORIC BLDG FABRIC: GF intact with evolutionary alterations  
UF intact with evolutionary alterations
- 4) SURROUNDING LAND USES commercial, canal frontage, institutional
- 5) INTEGRITY OF PROP'S HIST SETTING intact with minor intrusions and/or losses
- 6) IMPORTANCE OF PROP TO HIST SETTING focal point in area
