# National Register of Historic Places Registration Form

Historic name: John and Ruth Rose House  
Other names/site number: \_\_\_\_\_  
Name of related multiple property listing:  
N/A  
(Enter "N/A" if property is not part of a multiple property listing)

Street & number: 944 Main Road  
City or town: Granville State: MA County: Hampden  
Not For Publication:  Vicinity:

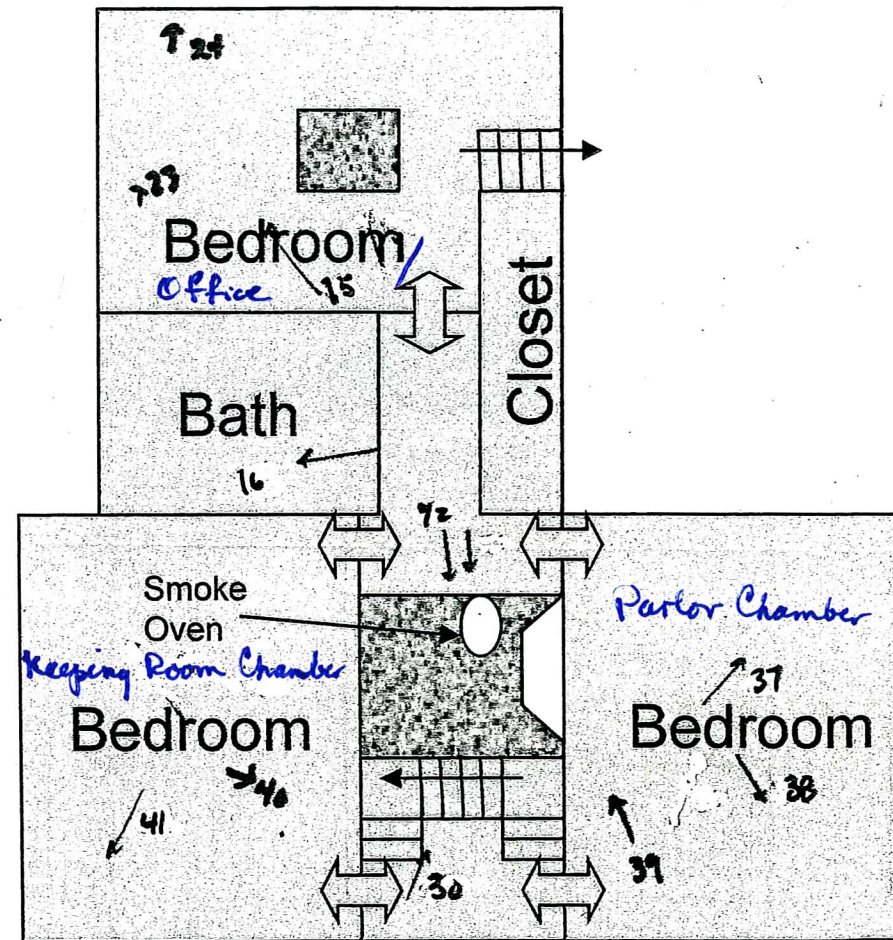
John Rose House  
Second and Third Floors  
(approx. scale)

Second Floor  
(Overlays First Floor)

Third Floor  
(Overlays Second Floor)

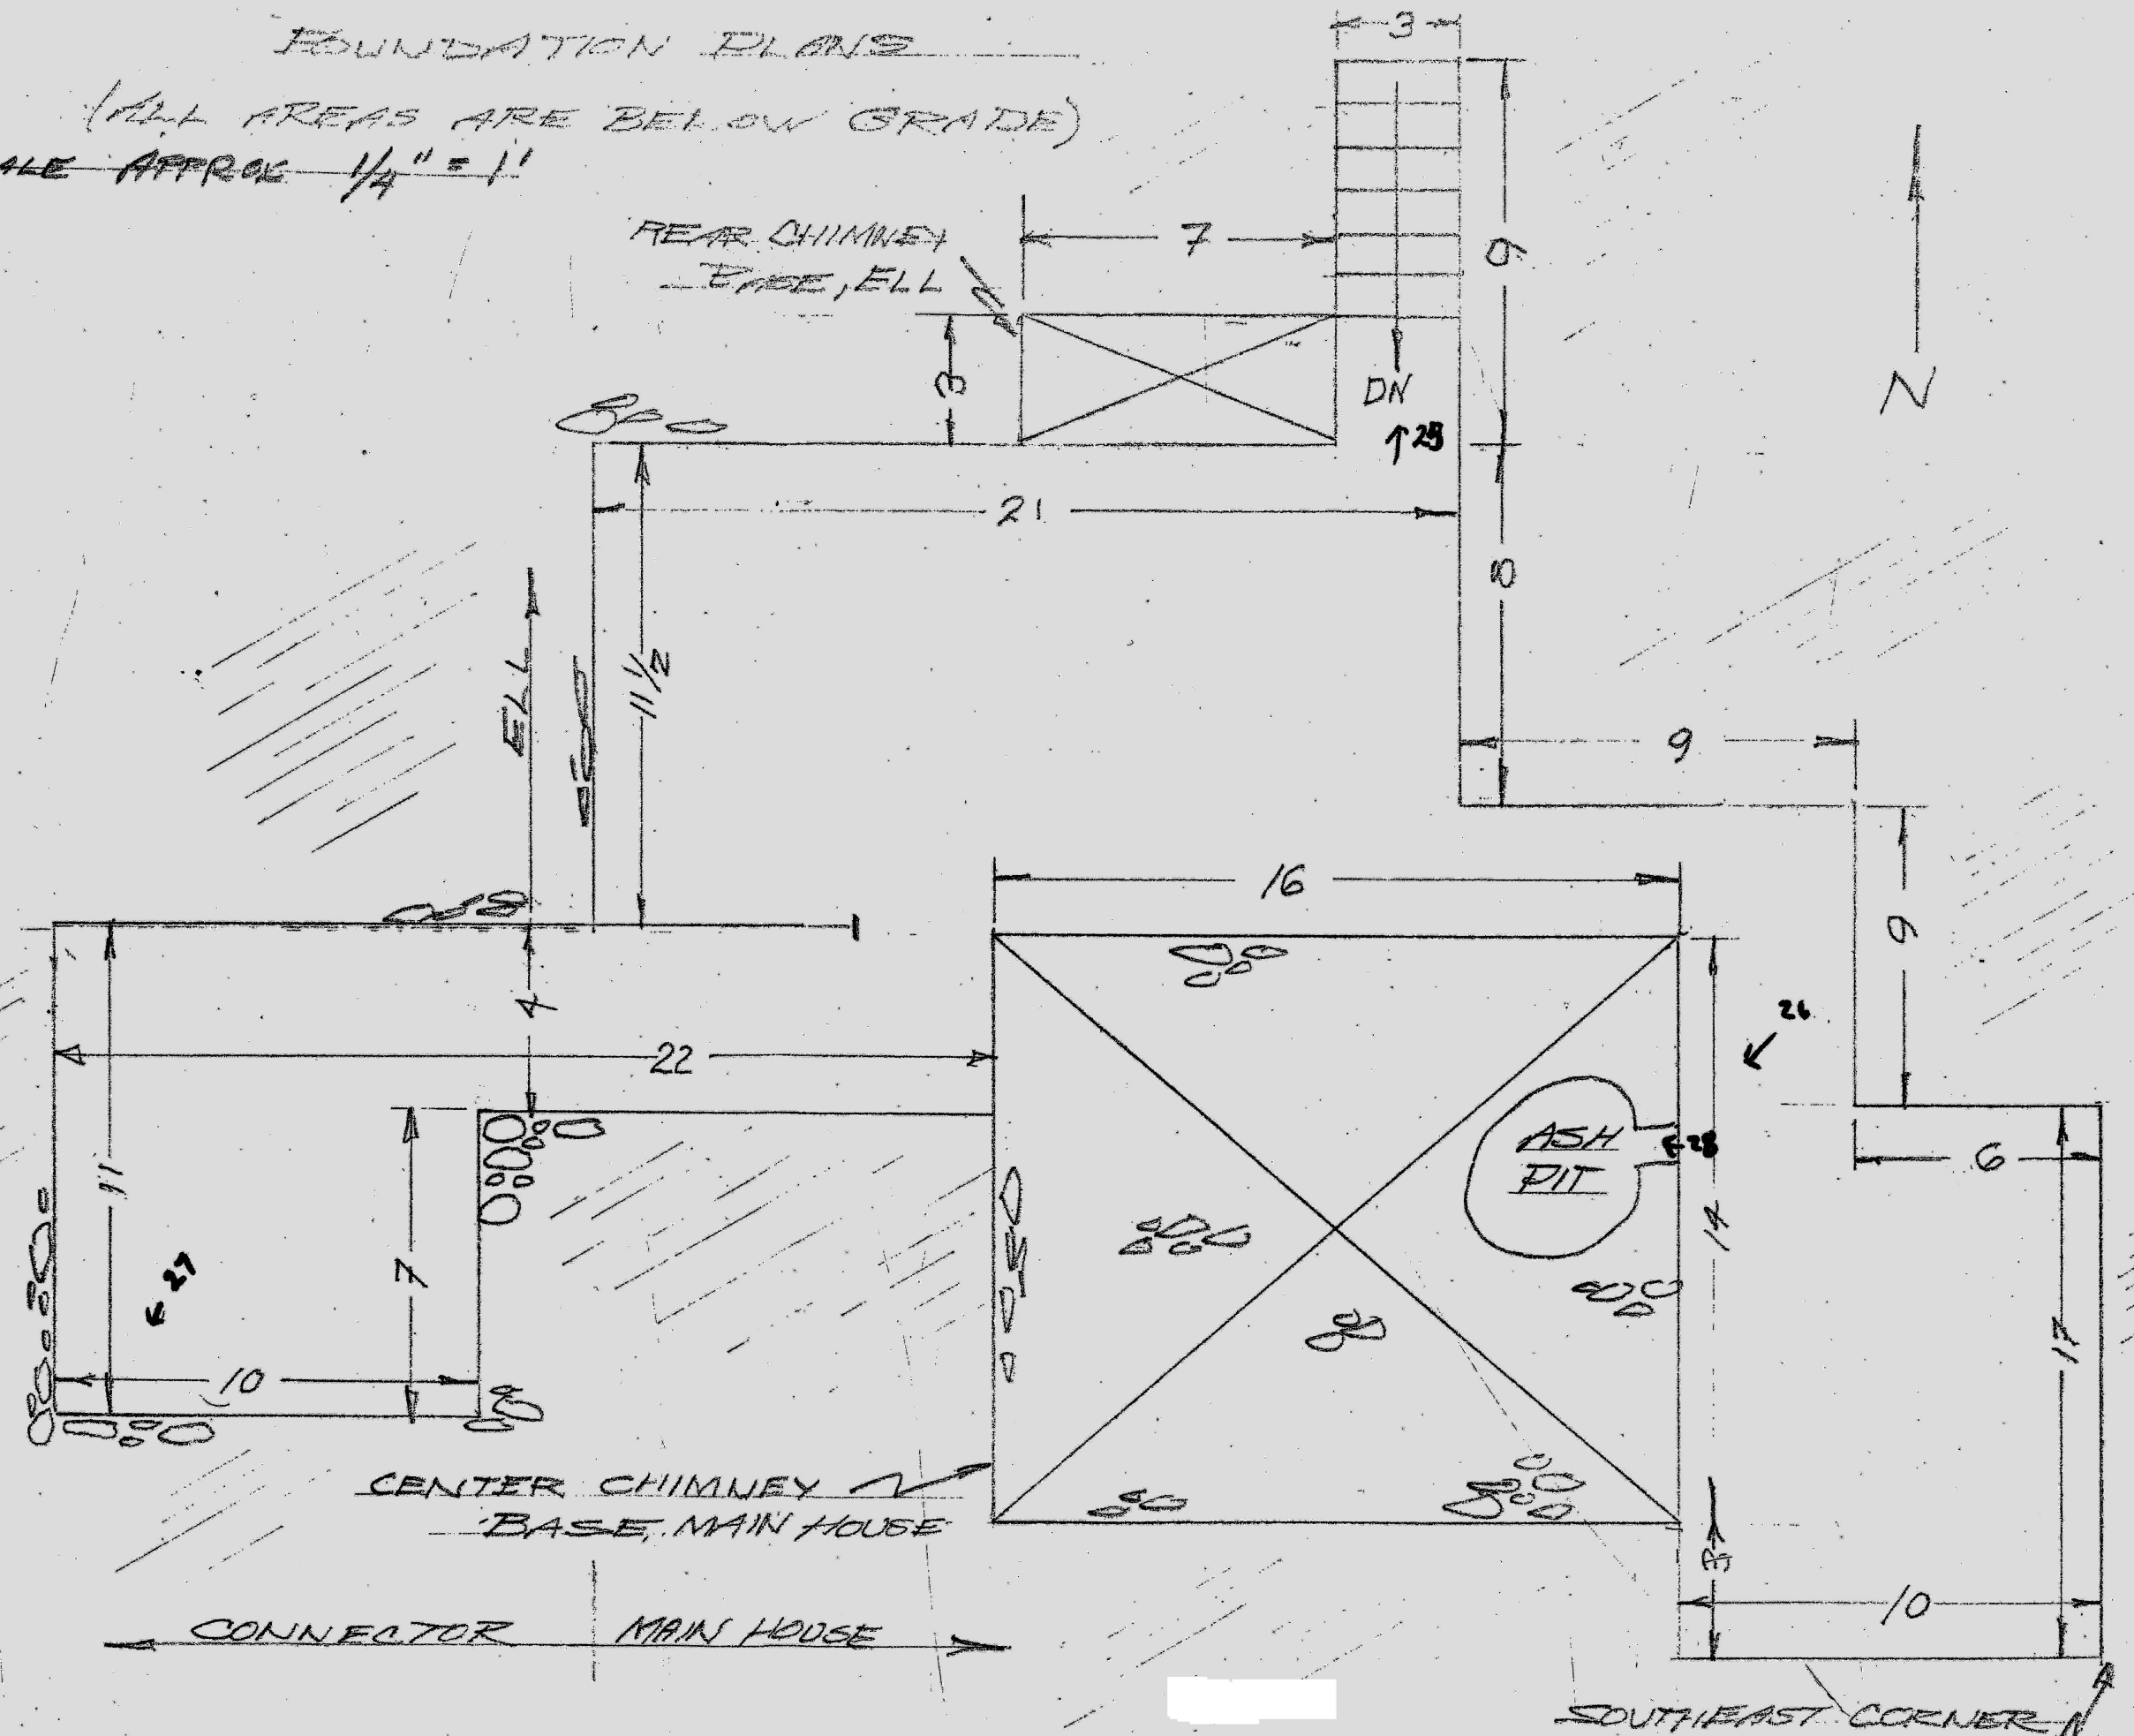
Figure 4

FOUNDATION PLANS

(ALL AREAS ARE BELOW GRADE)

SCALE APPROX 1/4" = 1'

The fully excavated portion of the cellar is reached from the northeast corner of the ell, and is now the laundry room (**figure 4**). A trapdoor opens to a straight run of quarried stone steps, the risers of which retain traces of red paint (**photograph 25**). The walls beside the steps are made of fieldstone that has been parged. At the foot of the stairs, on west side, is the stone chimney foundation of the ell. Exposed on its east and south sides, the ell chimney foundation measures seven by three feet. The chimney foundation of the main block of the house on the south side of the cellar measures sixteen by fourteen feet on its exposed north and east sides (**photograph 26**). The two chimney foundations are about twelve feet apart. The cellar is fully excavated beneath the ell's bath and dining rooms, and fully excavated beneath the parlor of the main block. The southern quarter of the keeping room has only a crawl space. An eleven-by-seven-foot room has been fully excavated beneath the west wing's study as well. The resulting fully excavated space of the cellar is roughly C-shaped in plan. The stone chimney foundations rest in part on the fully excavated cellar floor and on the crawl space floor. In other words, there are no completely free-standing foundations. The mortar for the stonework is clay, patched in places by cement (**photograph 27**).

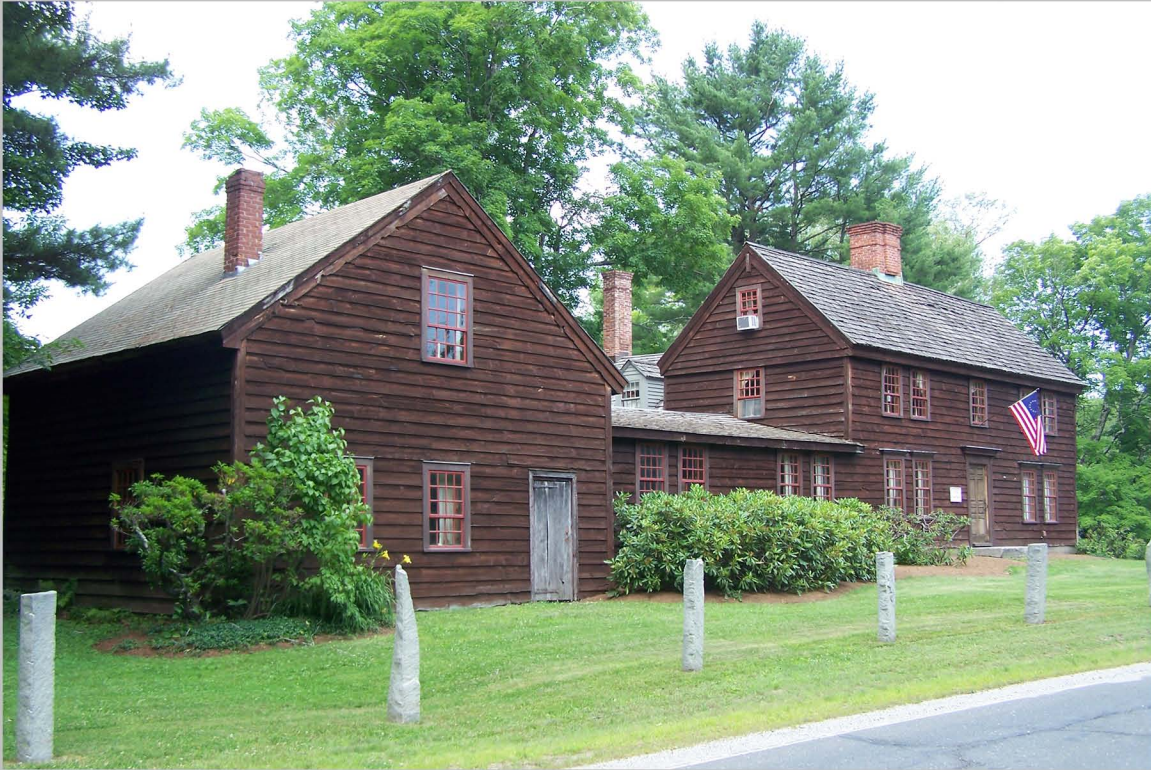
1. South façade view to northeast.

On the east elevation, the windows are centered, one per story, and have 12/12 sash at the first story, 12/8 at the second story, and 6/6 at the attic level. Above the first story, the west elevation has the same fenestration and windows as the east elevation (**photograph 1**). The visible portion of the north (rear)

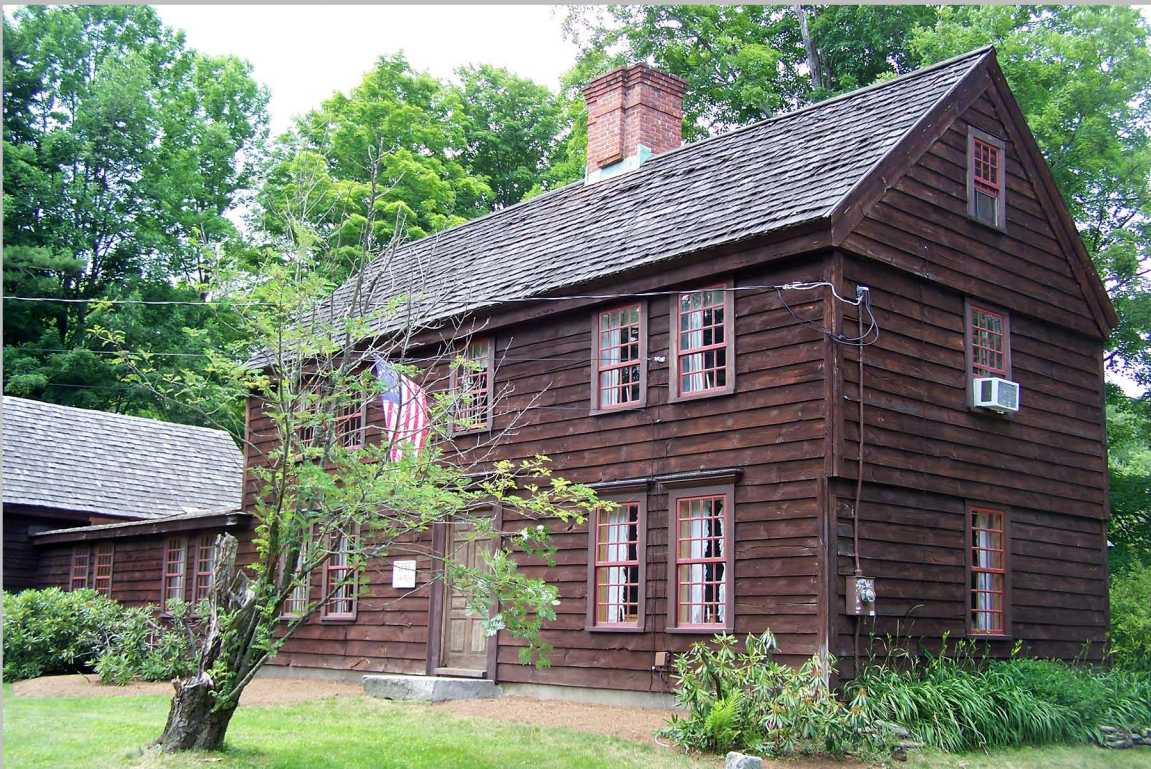
2. Main block of house view to northwest

The Rose House (ca. 1743), clad in clapboard of varying exposure, is roughly L-shaped in plan. It consists of a main block, an ell, a wing, and a carriage barn. The south-facing main block is two-and-a-half stories in height beneath a wood-shingled, side-gabled roof of 12/12 pitch. It measures 38 feet wide and 16 feet deep. Roof eaves are clipped in early Georgian fashion (**photograph 1**). The main block is five bays wide and one bay (or pile) deep and has a center, pilastered, brick chimney that rises behind the ridge of the roof. The south (primary) façade of the main block has a center entry with a trabeated surround whose entablature consists of a flared frieze beneath a widely projecting cornice. The entry has a replacement eight-paneled door above a single granite-block step (**photograph 2**).

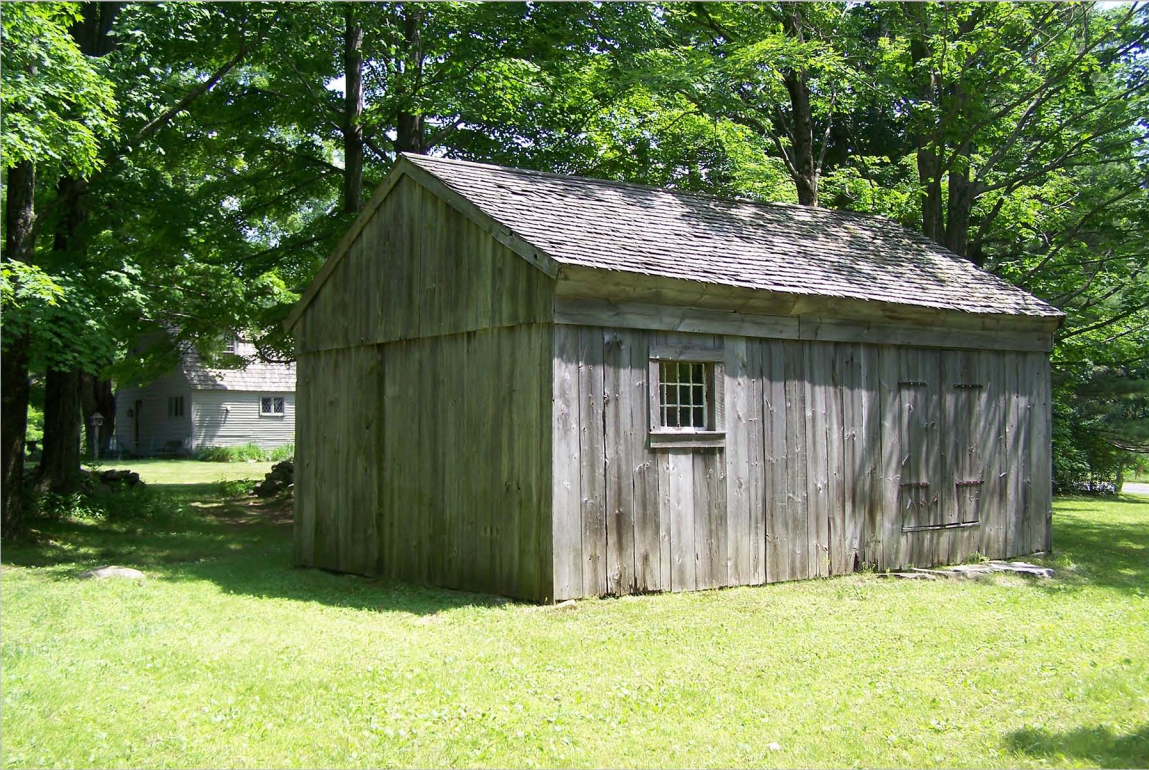
9. Cottage, view to east.

West of the house is a one-story cottage (ca. 1941). It is two bays wide and one room deep. It is clad with vertical boards and has a wood-shingle roof. The building faces east and its façade consists of an entry at one side adjacent to a fixed, twelve-light wood sash window. The building rests on fieldstone foundations, and the entrance, on the east side, is preceded by a granite stepping stone. The west elevation of the building has a twelve-light fixed window with a wood surround, and a set of double doors that are raised but have no entry steps **(photograph 9)**.

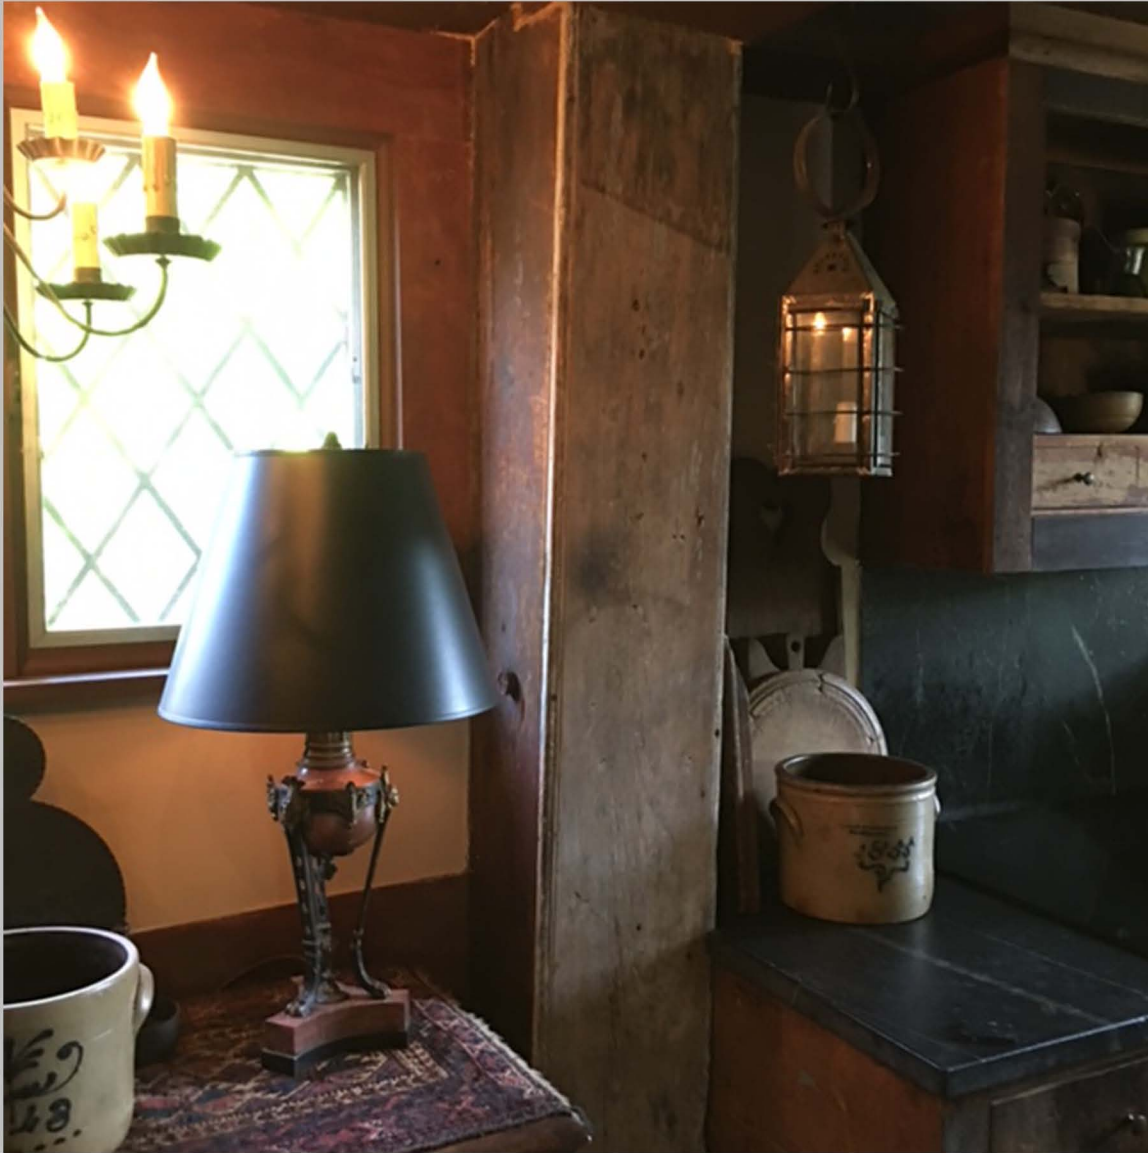
17. Cased post, ell kitchen, view to west.

The main block and ell are both scribe-ruled, post-and-beam construction. The scribe-rule method of framing a post-and-beam building was one in which each joint in the structure was individually made to accommodate the dimensions of the framing members. In the late 18<sup>th</sup> century, scribe rule began to be replaced by square rule, in which framing members were measured in advance to create uniform dimensions and not requiring each joint to have a unique fit. The square-rule form of construction was made possible by sawmills set up with long carriages between 1770 (when one was established in Franklin County, MA) and 1800. Though cased, the first-floor posts of the main block are flared to accommodate the individually scribed tying joints between first and second floors. For instance, a cased corner-post in the ell kitchen measures eleven inches in width at the ceiling and six inches in width at the floor (**photograph 17**).

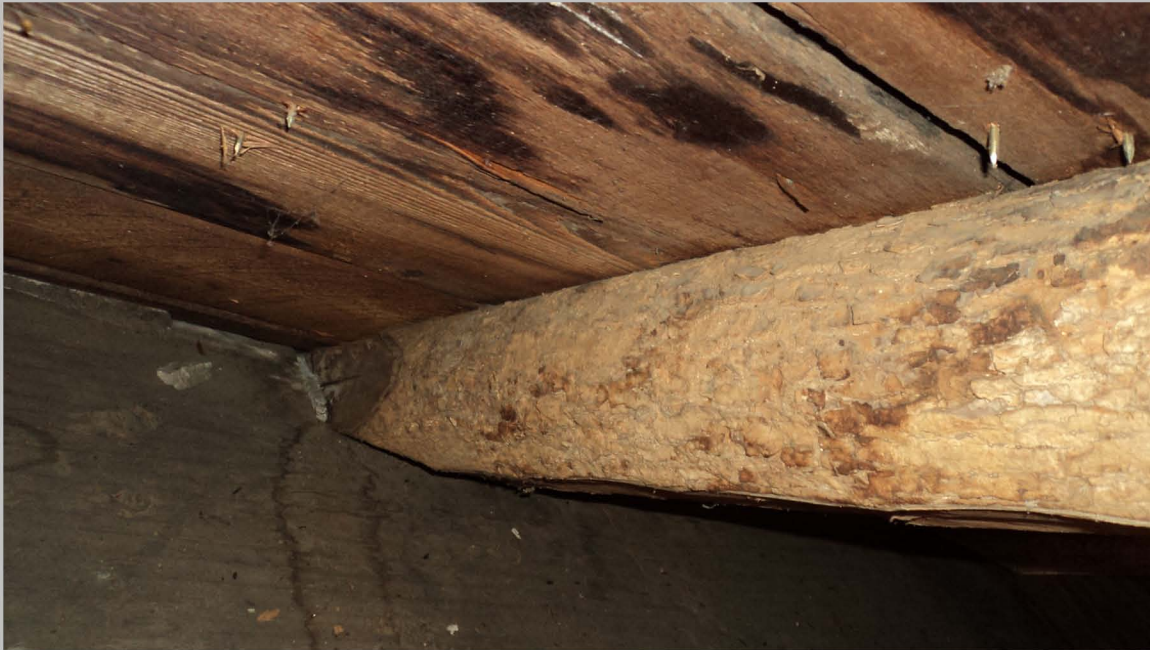
19. Attic rafter, main block, joint into plate.t

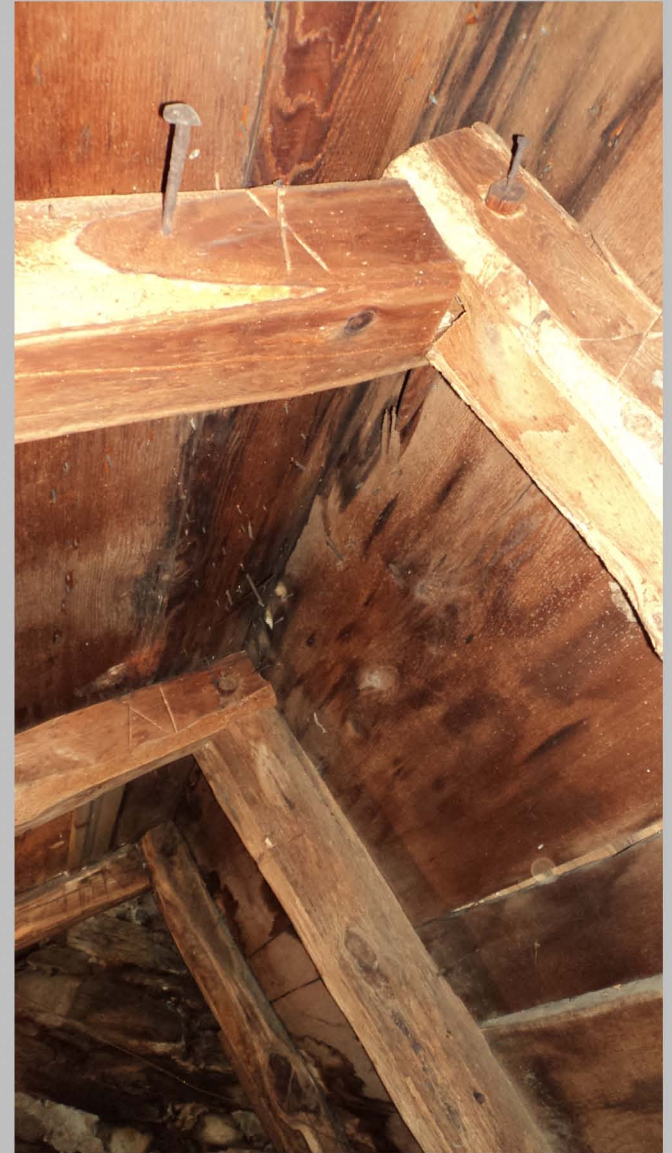
20. Scribe rule markings, attic main block, view to west.

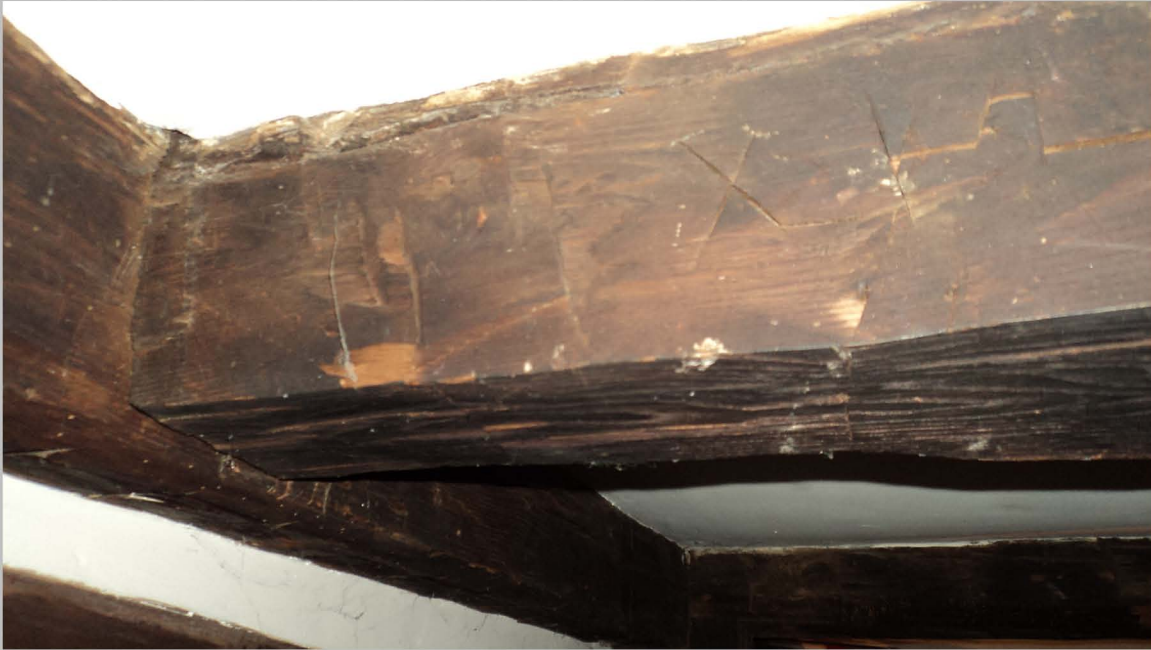
23. EII, second floor, scribe rule markings on collar tie, view to north.

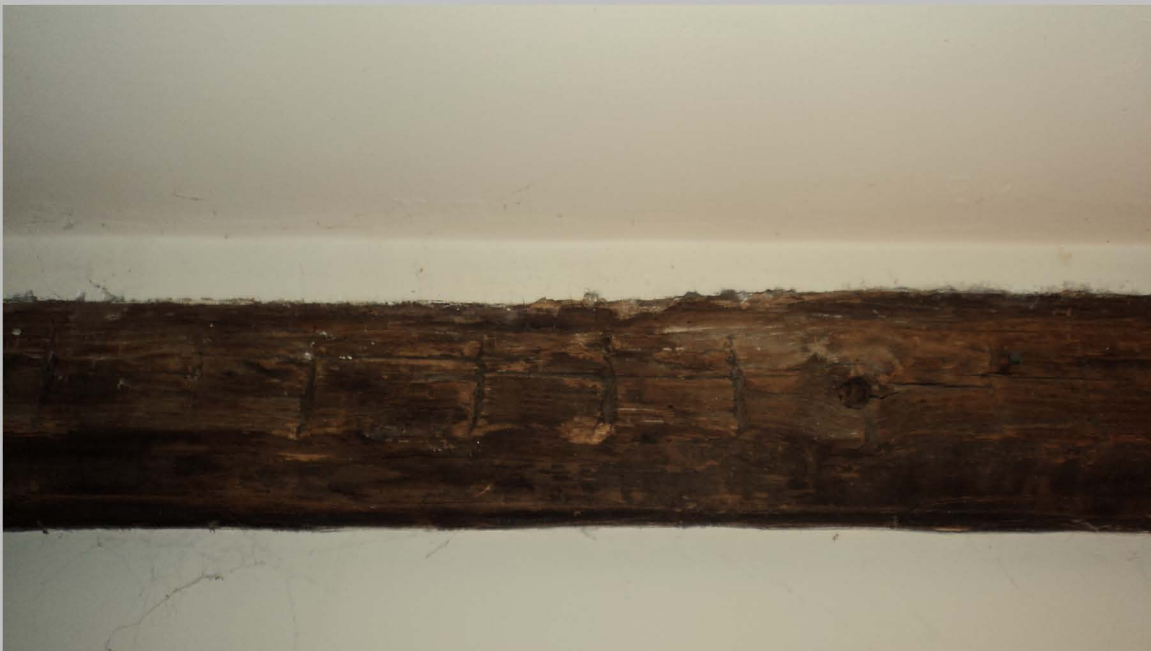
24. EII, second floor, scribe rule markings on plate, view to west.

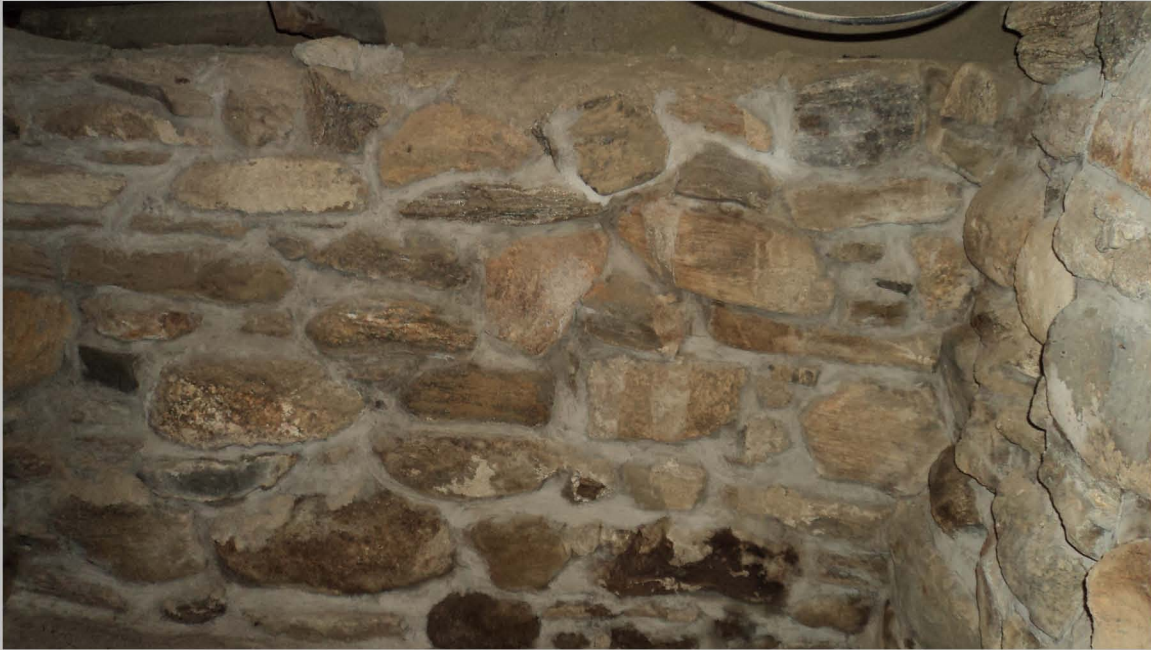
27. Wing, cellar foundation, view to north.

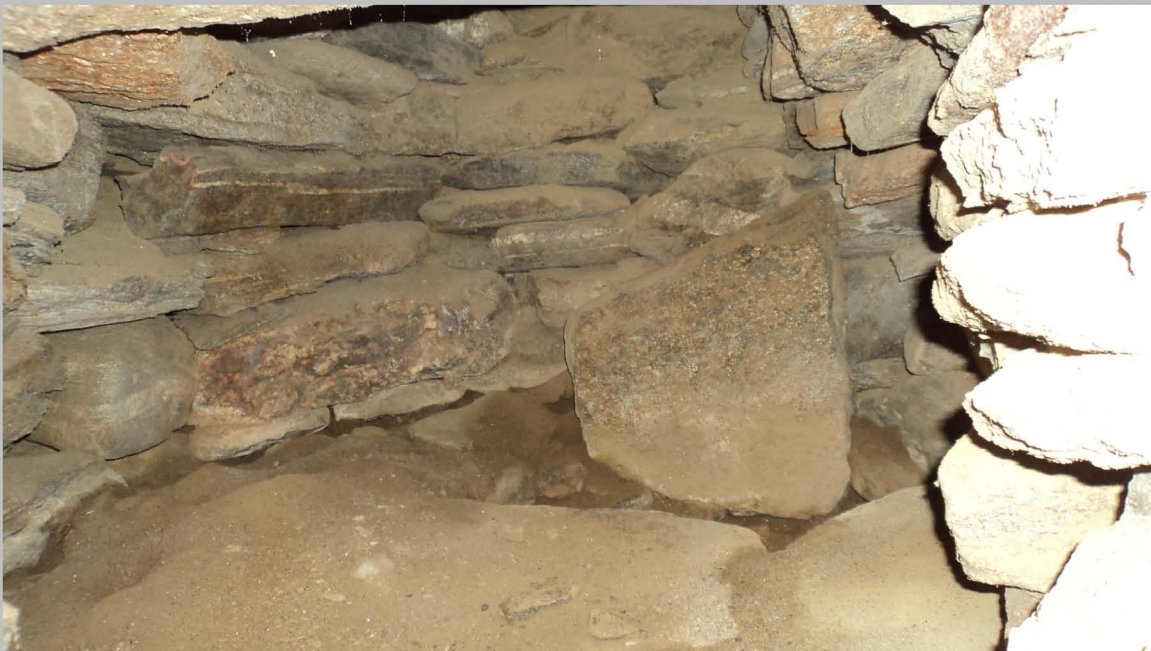
28. Main block, chimney foundation, ash pit interior, view to southwest.

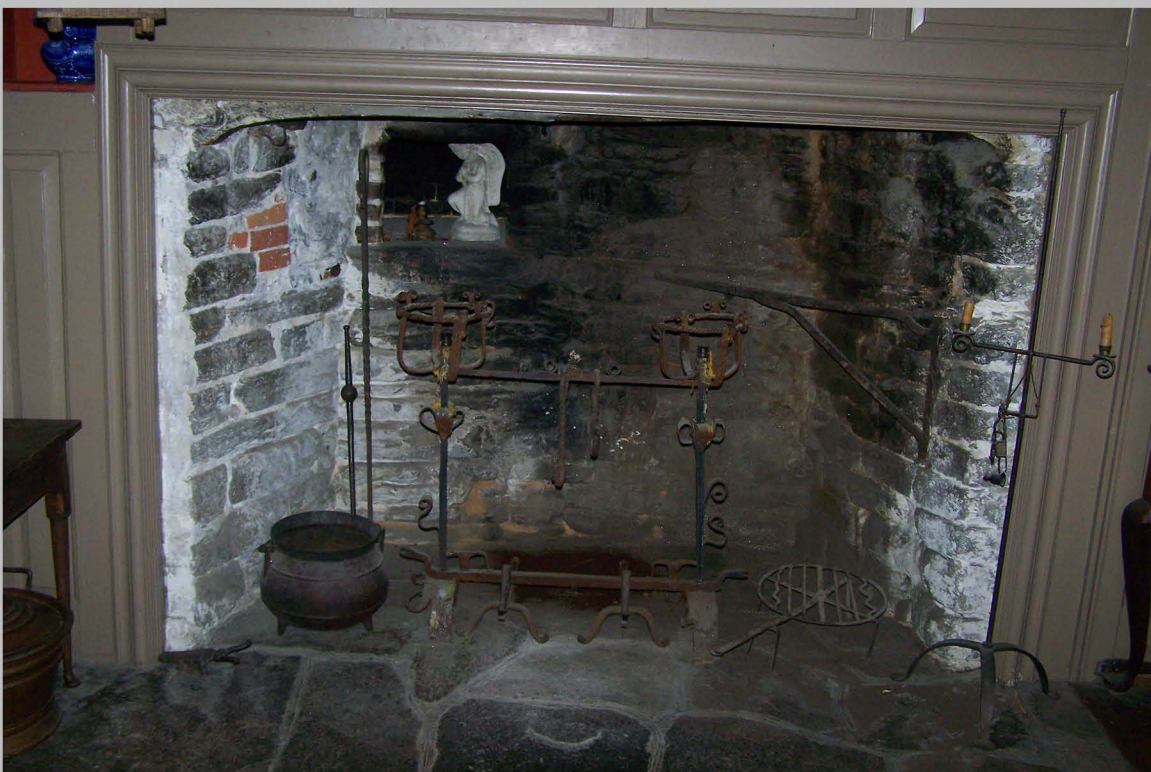
36. Main block, keeping room fireplace with oven in rear wall, view to east.

Location of a beehive oven at the rear of the keeping room fireplace follows the practice of the late 17<sup>th</sup> and first half of the 18<sup>th</sup> centuries in the region. The Rose House chimney also features a second-floor smoke oven. As for framing members, reduction of the depth of summer beams from the eighteen to twenty inches commonly used during the 17<sup>th</sup> century to thirteen-, ten-, and nine-inch-deep summer beams found in the ell kitchen and dining room and the main block parlor, place the main block of the house and its ell in the middle of the 18<sup>th</sup> century.<sup>31</sup>

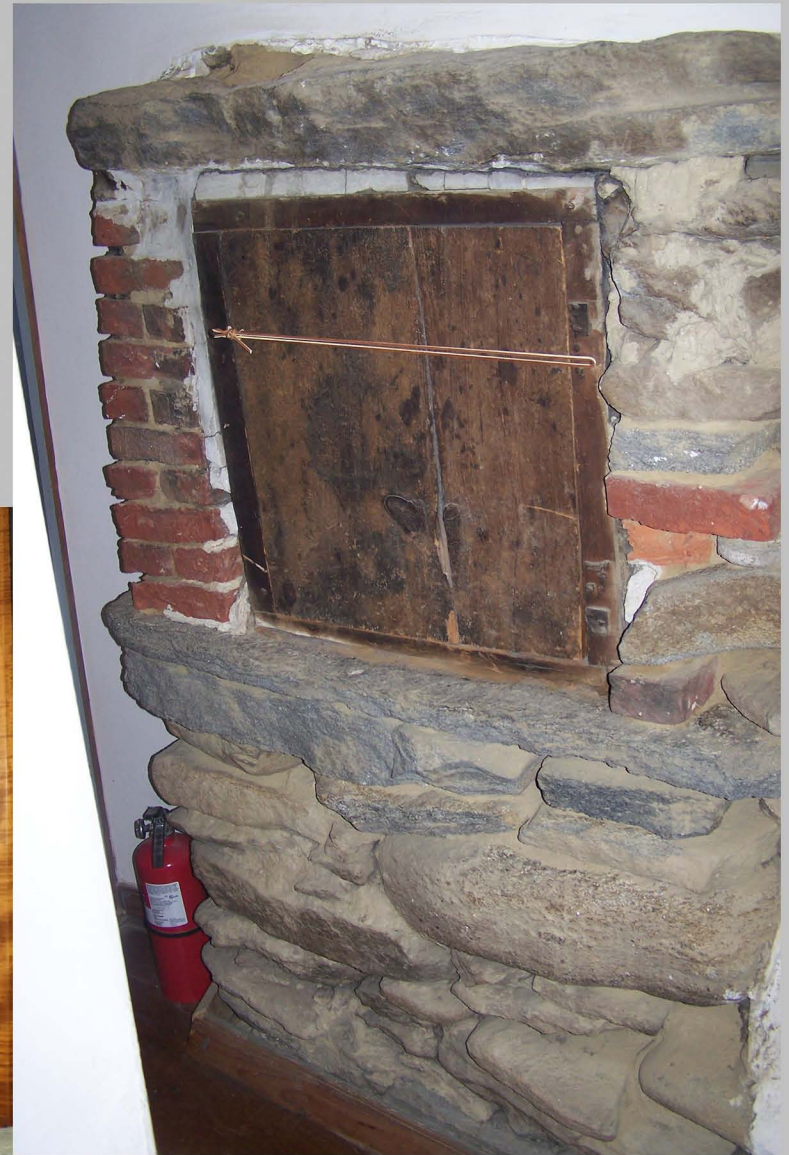
42. Main block, second floor, north side of chimney, detail of smoke oven door, view to south. (Photo: Elizabeth Rairigh, July 2014)

The north side of the chimney at the second story reveals its stone construction and two brick repairs. It has a smoke oven closed by a wood door beneath a large stone lintel. The wood frame around the door has rose-head nails remaining in remnants of leather strap hinges (**photographs 42, 42A**).
