The Daniel Rose House, 'Fort Rose', 1741

Before and After Restoration

By William Brian "Bill" Phelon

The Daniel Rose-Jacob Baldwin-Francis G. Baker-Phelon House

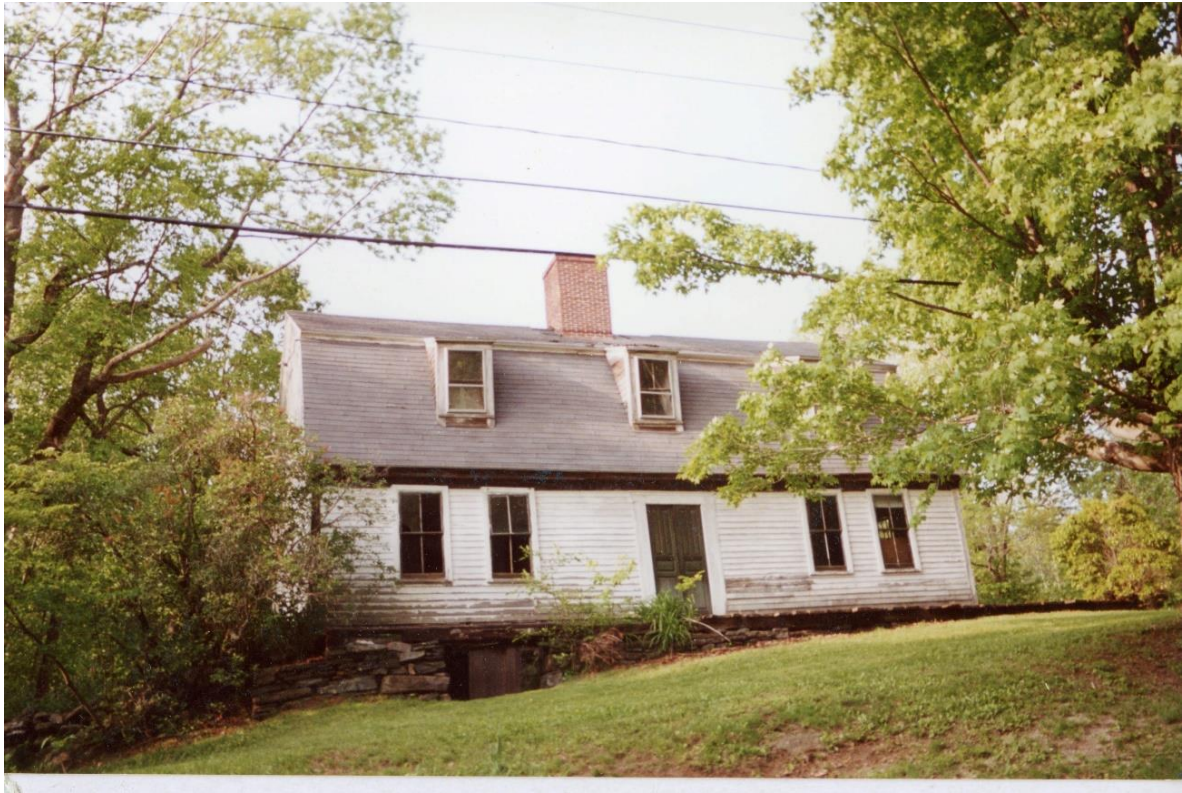
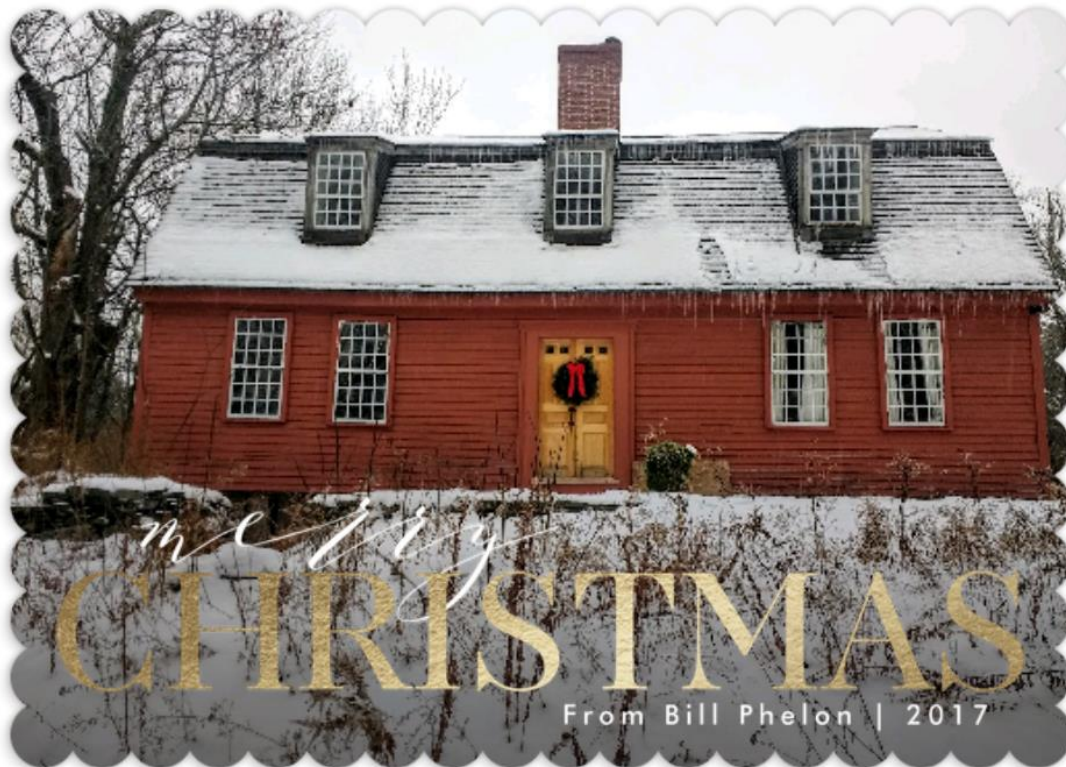
Figure 3.1. The Daniel Rose House, 1741. (Upper) Camera facing northeast. Photo by Bill Phelon, June 2001. (Lower) After Restoration by Bill. Camera facing north, photograph and Christmas Card Design by Bobbie-Jo Day, December 2017. The Rose-Baldwin-Baker-Phelon House is in the West Granville National Register Historic District.

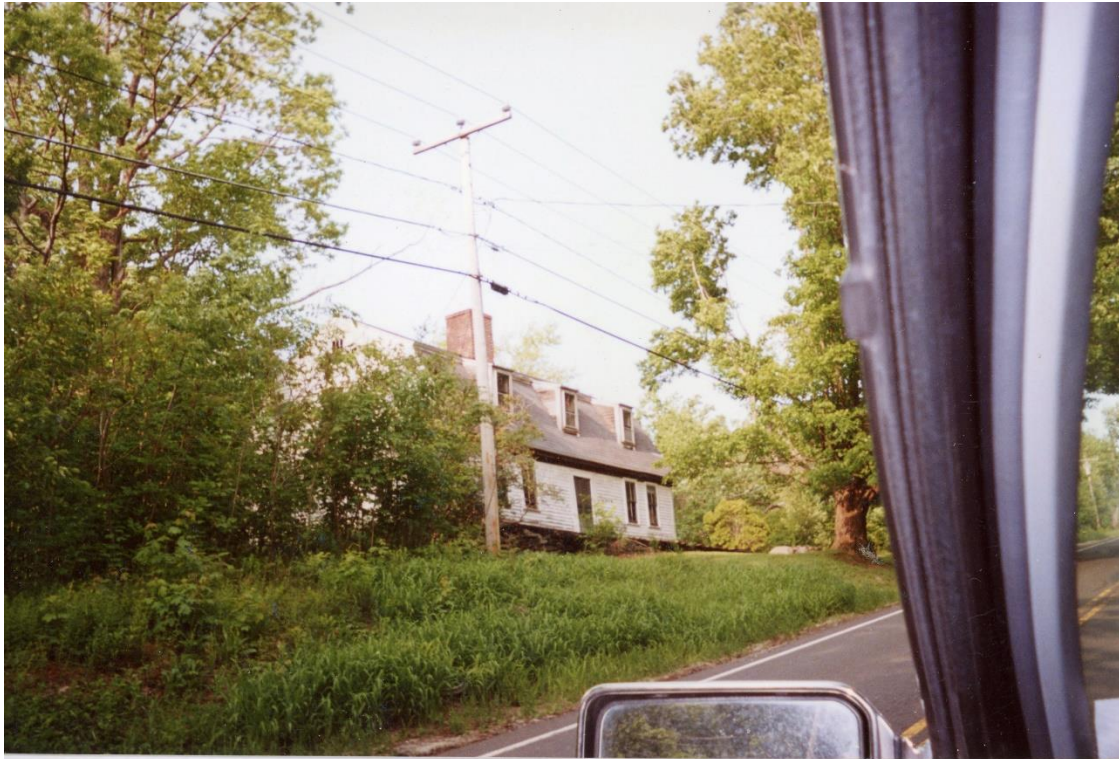
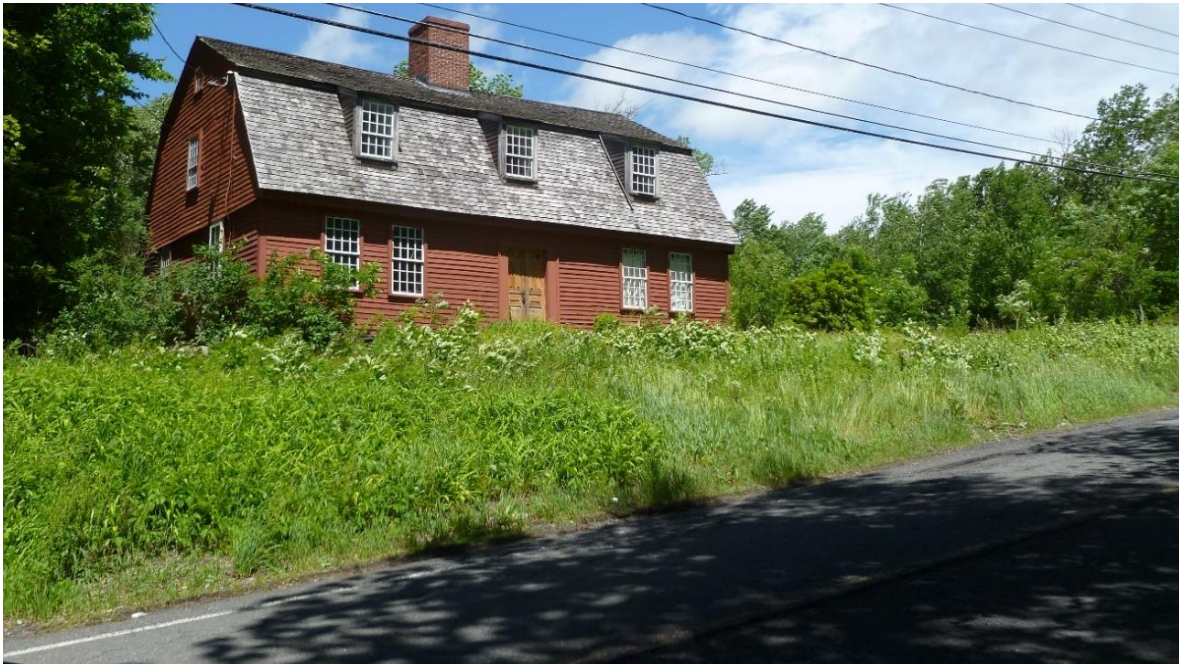
Figure 3.2. Daniel Rose House, 1741, of the original Bedford settlement, adjacent to homestead lot of Daniel's brother, Deacon David Rose. Home to six soldiers of the American Revolution; childhood home of two U.S. Navy Midshipmen in the War of 1812; and home to Olive Curtiss Baker's quilt (c. 1798) that was the Nation's first quilt exhibited (1886) in a period room installation in an American Museum, inspiring the Deerfield Arts and Crafts Movement in 1897. Original clapboarding; 12/12 windows; cedar shingle roof restored by Bill Phelon, who selected red paint for exterior; red paint was documented in the front southeast parlor. (Upper) Camera facing northeast, June 2001. (Lower) Photo, June 2019.

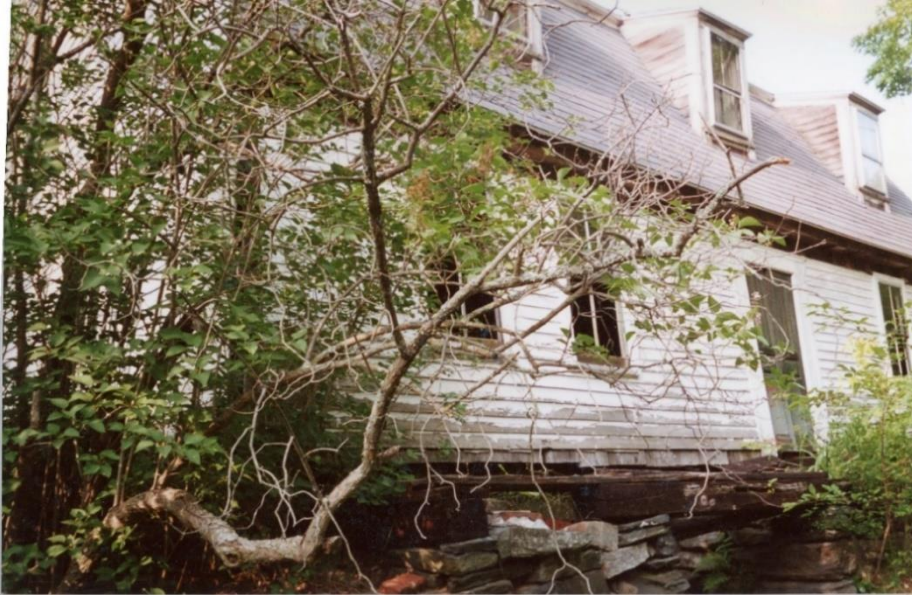
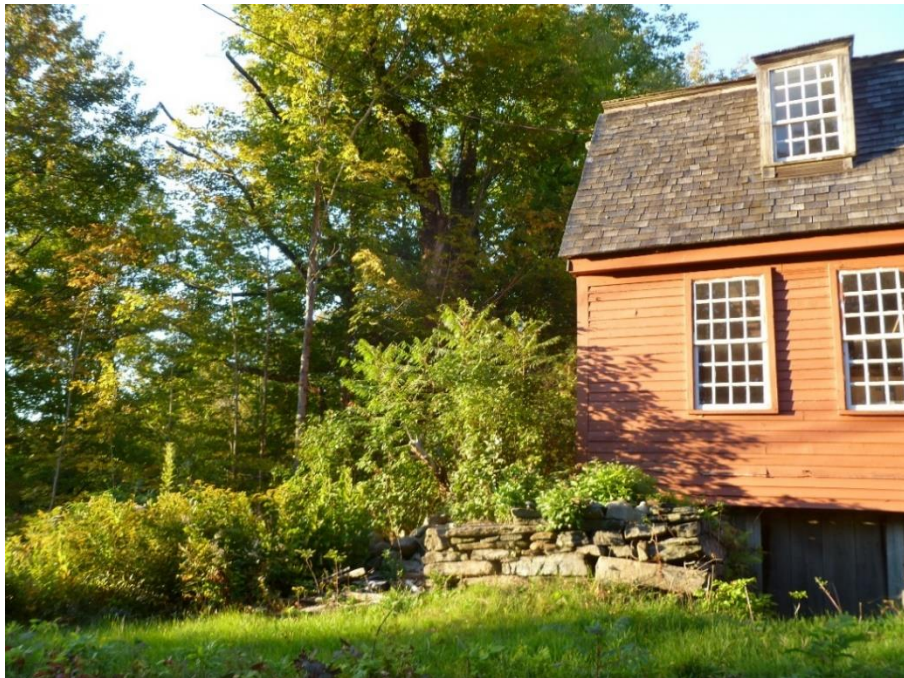
Figure 3.3. Daniel Rose House location is marked on 1738 survey of Granville by military surveyor, Capt. Nathaniel Dwight. Re: ‘Fort Rose’ theory of Bill Phelon (2013), “In the westward facing foundation wall there are what appear to be two cannon ports each 15” wide and 10” high with a bottom sill 30” off the ground. Other evidence like a gun port over the front door, a level foundation wall across the front of the house to support a palisade, mortices in the front surface of the front posts (with pieces of broken off tenons and trunnels) and framing modifications to enclose a well support the theory this was a fort.” The ports “could fire on parties approaching from the west. Located about 200 yards west of the crest of Prospect Mountain, the line of fire would have been optimal. Cannon facing west make strategic sense as the western branch of the Farmington River, flowing down from the north, is only about three or four miles to the west and for the spring months would be navigable by canoe or raft.” (Upper) Camera facing northeast, June 2001. (Lower) Camera facing northwest. Photo, Sept. 2019.

According to John O. Curtis (2003), former Director of the Curatorial Department at Old Sturbridge Village, “Two architectural features are particularly noteworthy. . . The other architectural feature, although now missing, is readily defined by the explicit physical evidence that does survive in the form of mortises in posts across the front frame of the house and the survival of a stone foundation which defines the footprint of the porch. Porches on 18th century houses are as rare as the proverbial hen’s teeth, and for the Baldwin House to have had a porch across the front, with a wrap-around to shelter the coffin door in the end, is, in my experience, unique. I know of no Massachusetts example.”

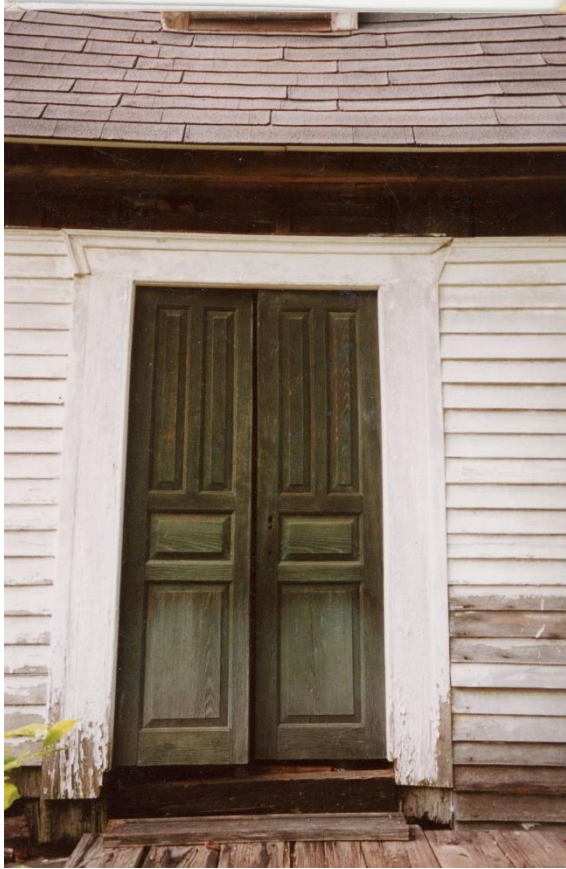
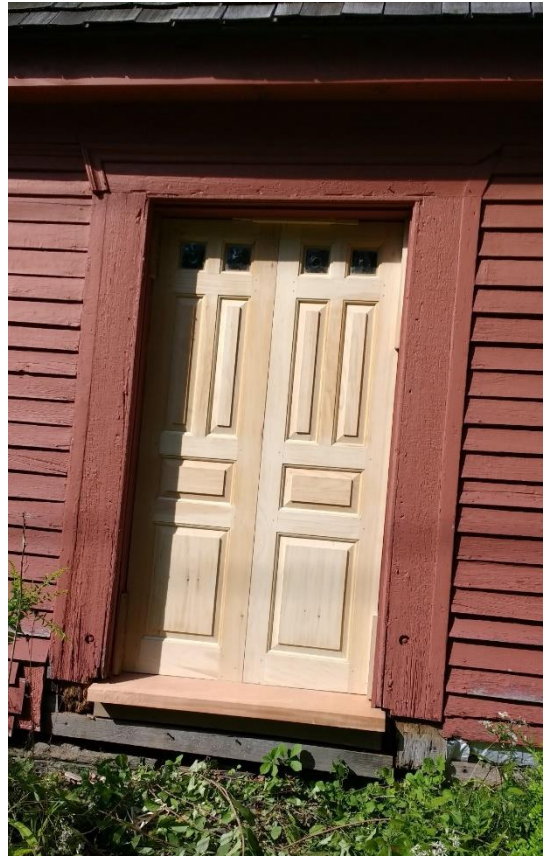
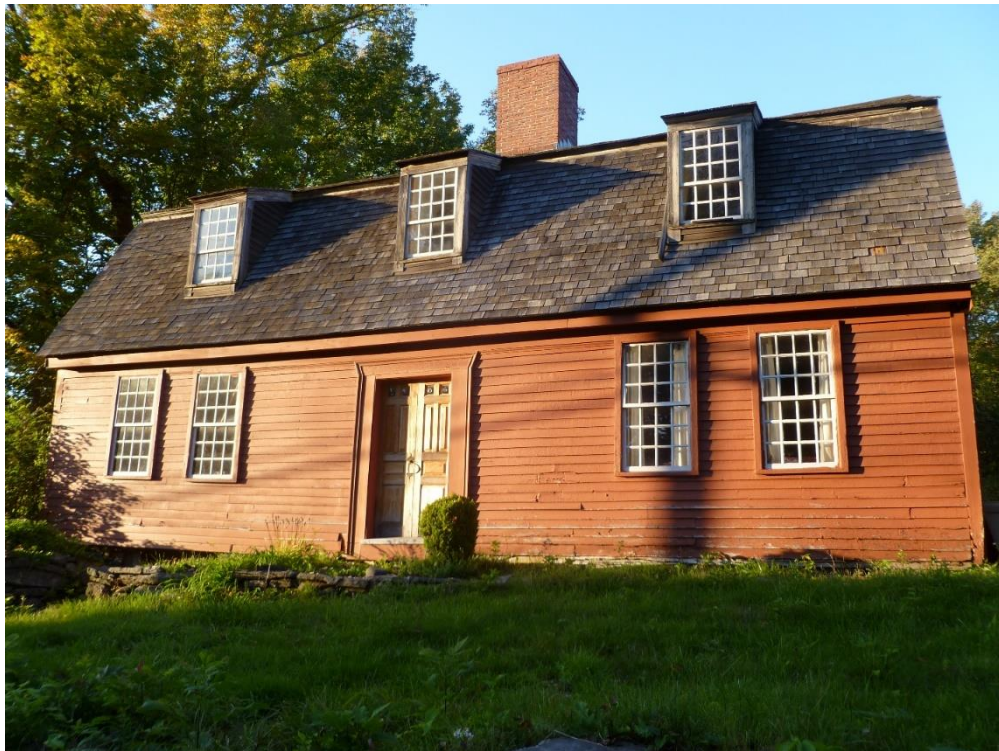
Figure 3.4. (Left) Original architrave, herein named the ‘Bedford Settlement Door Surround’, with pilasters and angled lintel at the Daniel Rose House, 1741, of the original Bedford settlement. Camera facing north, June 2001. (Upper Right, Lower) Right corner of angled lintel restored, 2017; eight-panel double-leaf door, with ‘bull’s eye’ glass added for interior light, and threshold reconstructed based upon the original. Photos, Sept. 2019.

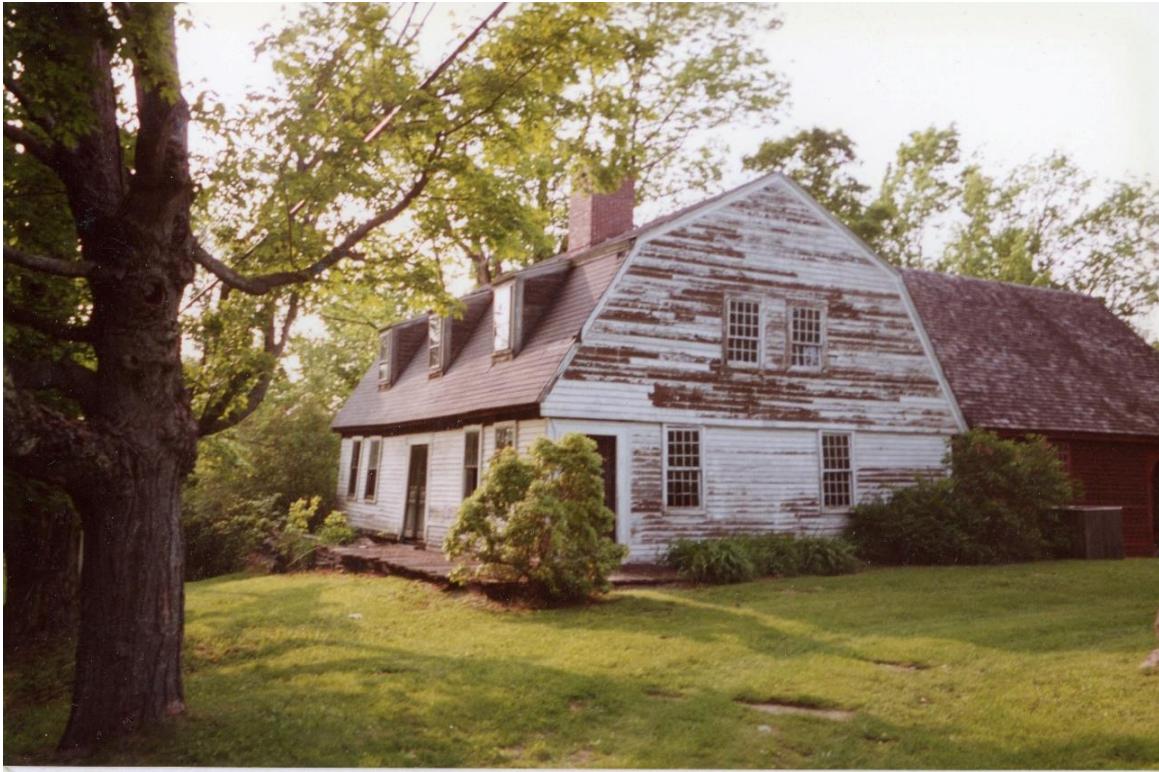
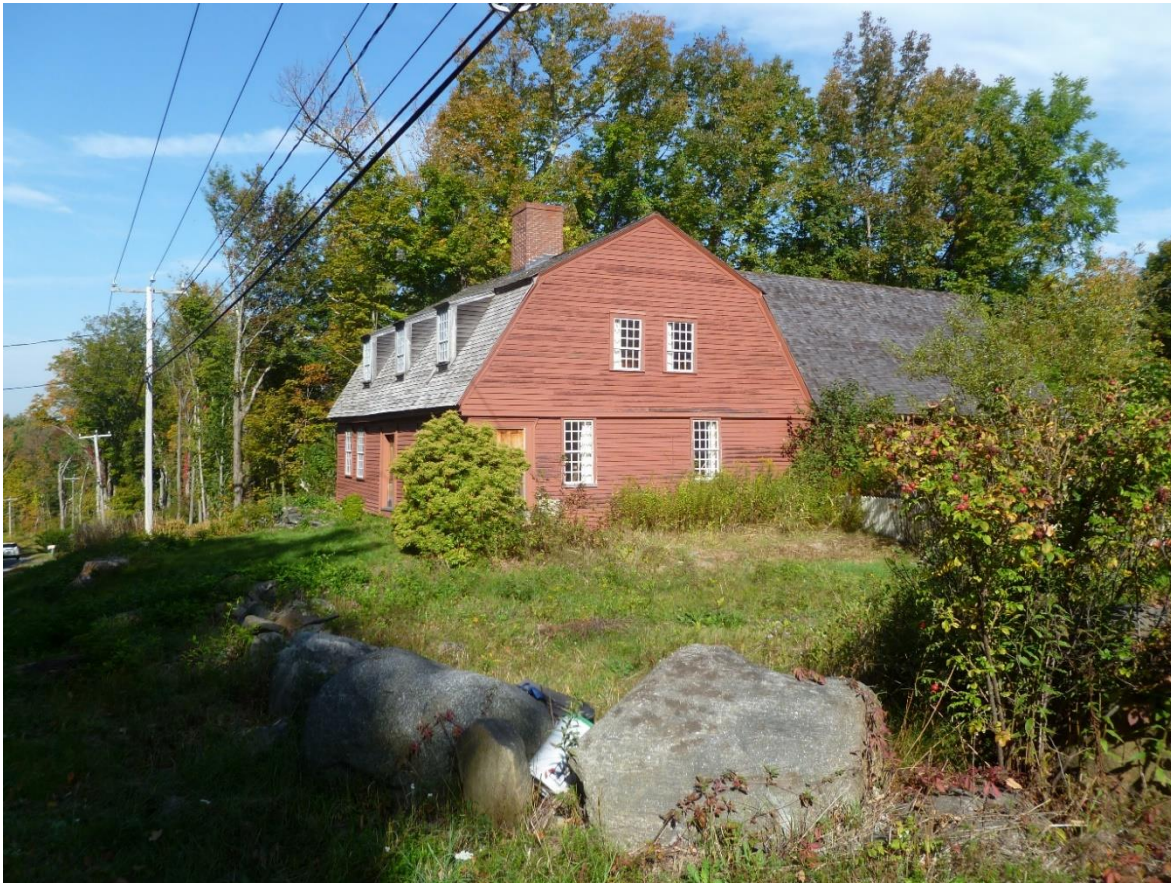
Figure 3.5. Daniel Rose House, 1741. Camera facing northwest, June 2001. (Lower) Bill Phelon restored the cedar shingle roof on main house and twentieth-century potential ‘Docent Wing’ (living quarters for a Museum caretaker’s family) to the north. Photo, September 2019. The Rose-Baldwin-Baker-Phelon House is in the West Granville National Register Historic District (sign just east of house near eastern line of Daniel Rose’s original settlement lot intact in 1985).

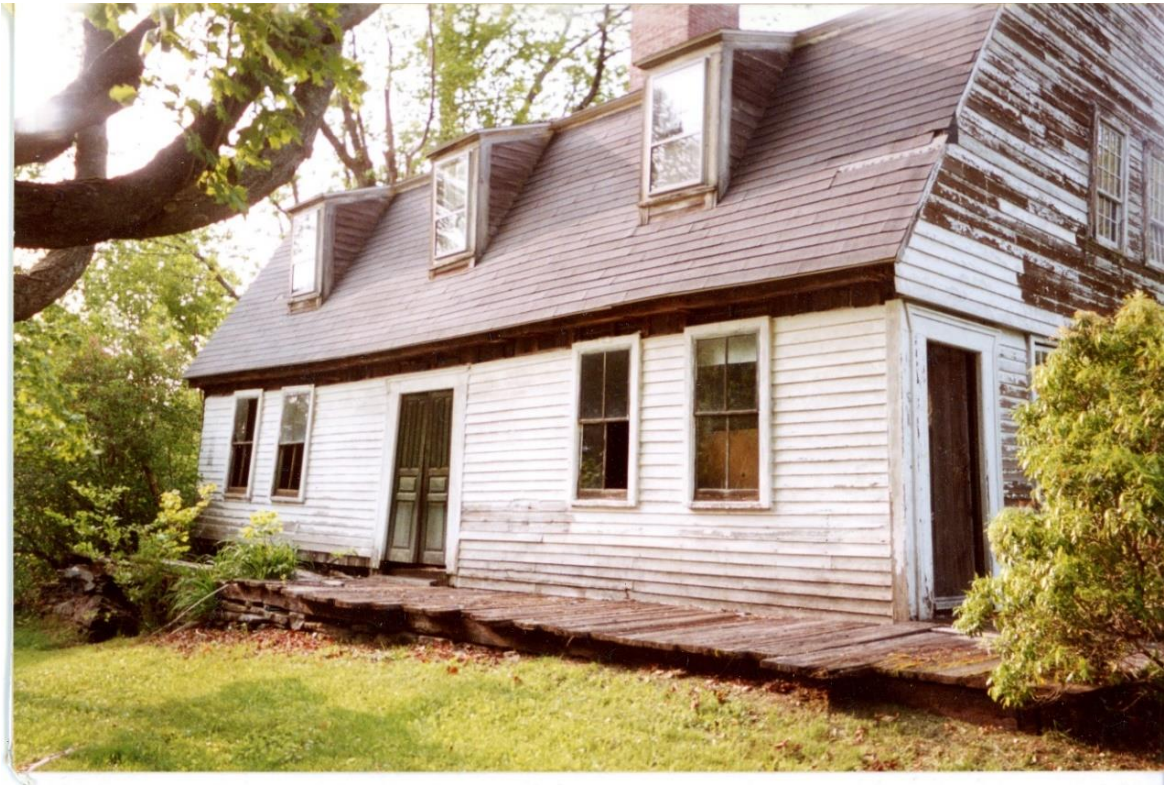
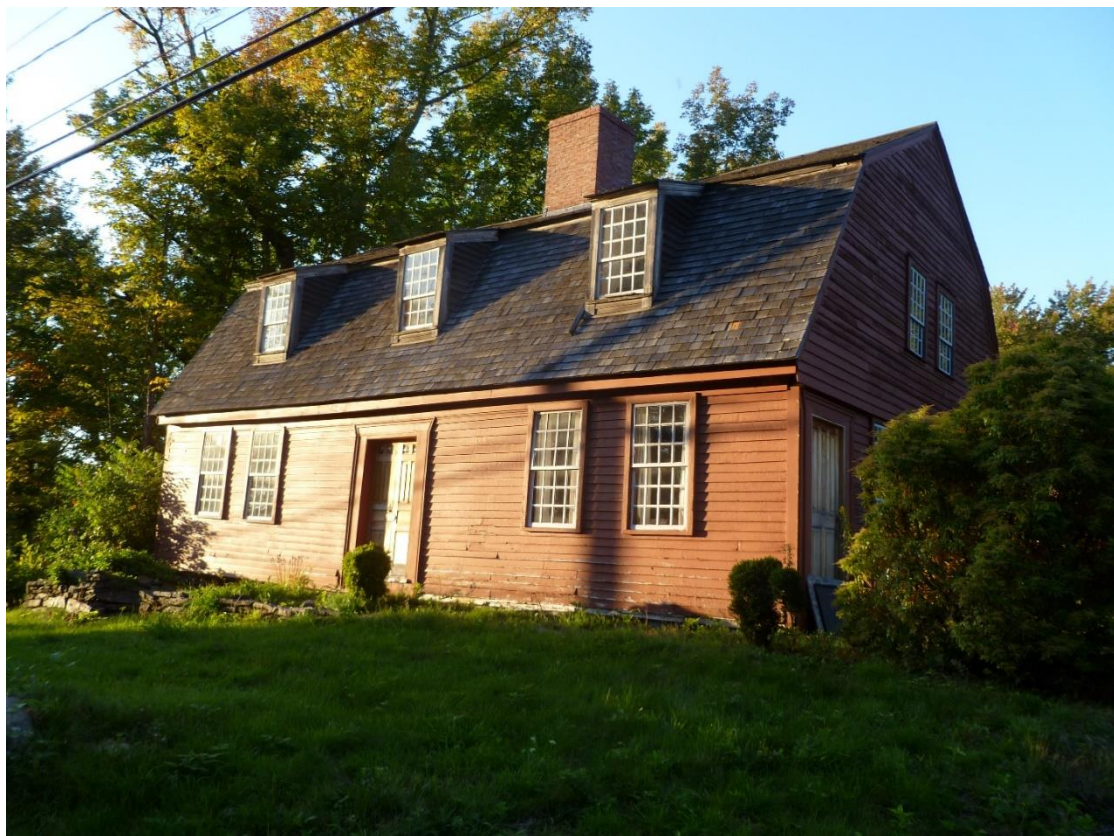
Figure 3.6. Daniel Rose House, 1741. (Upper) Camera facing northwest, June 2001. (Lower) After restoration by Bill Phelon, September 2019.

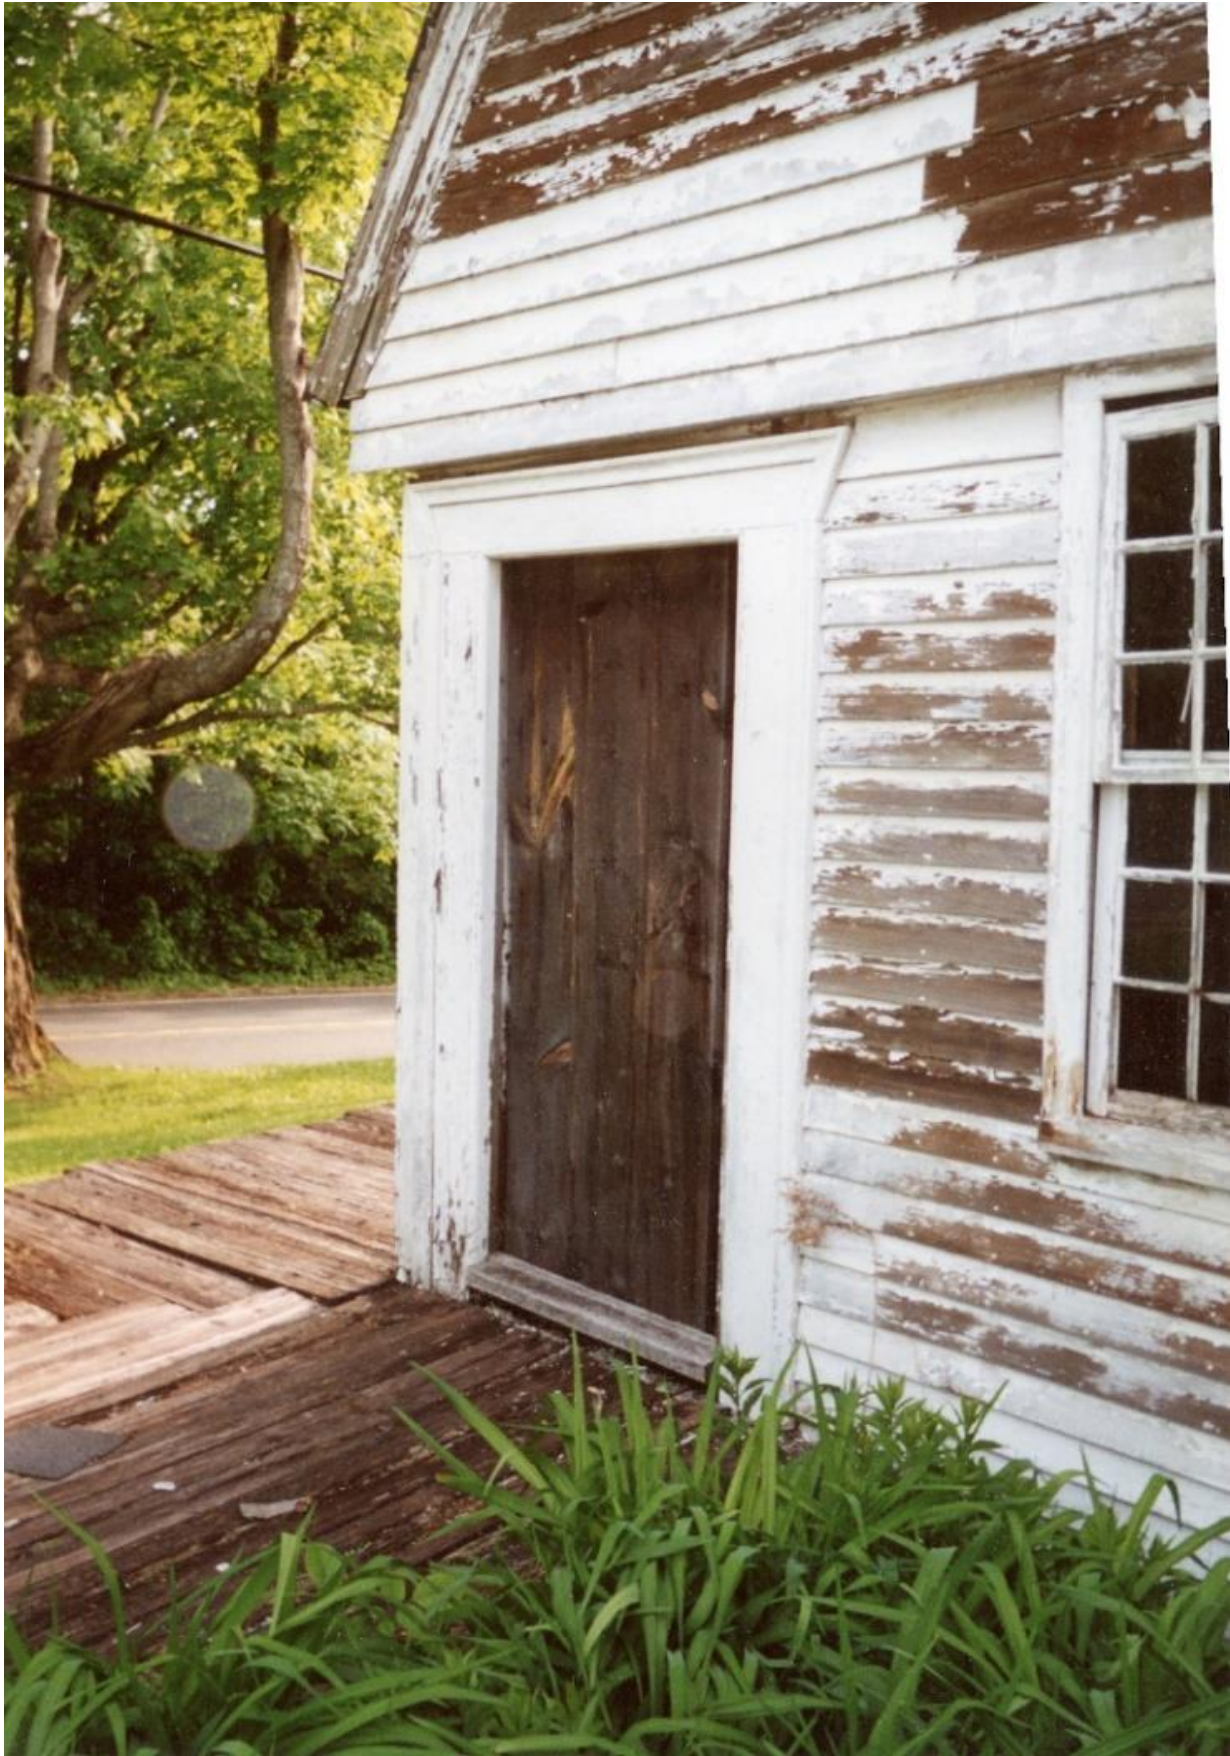
Figure 3.7. The Daniel Rose House, 1741, 'Bedford Settlement Door Surround' with the pilasters and angled lintel of the front entry, repeated for this east facing 'coffin door'. Camera facing southwest, June 2001.

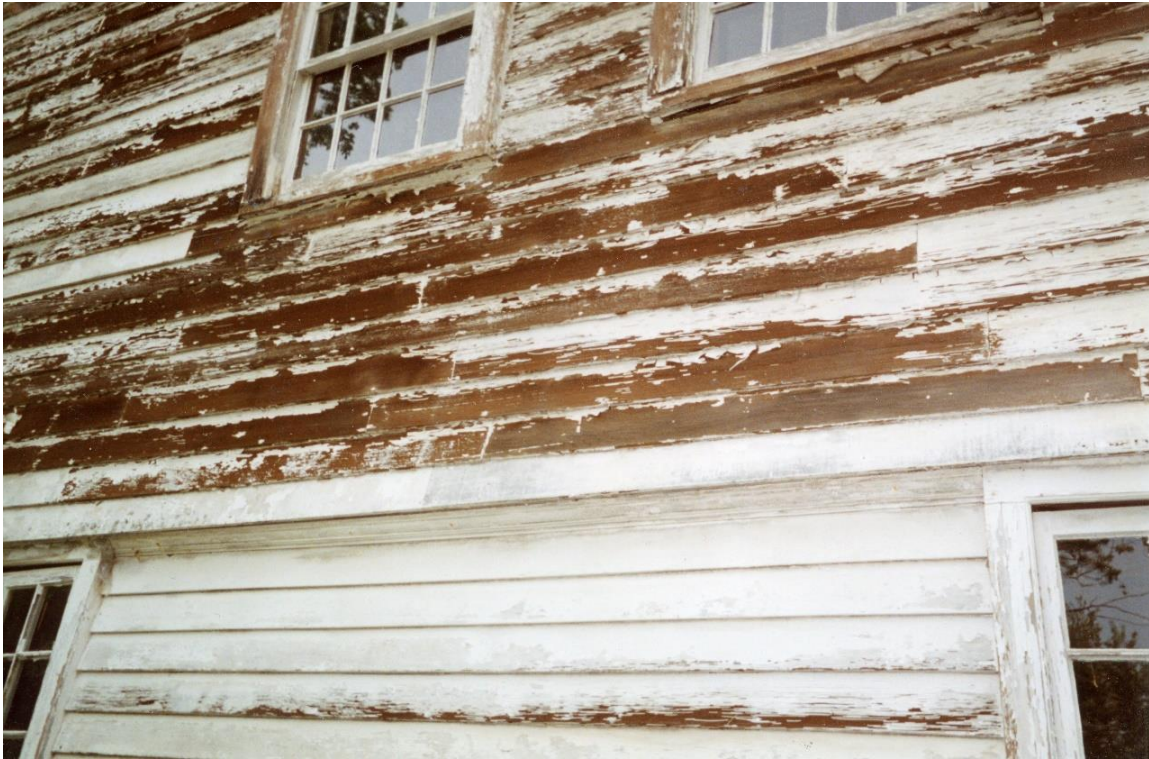
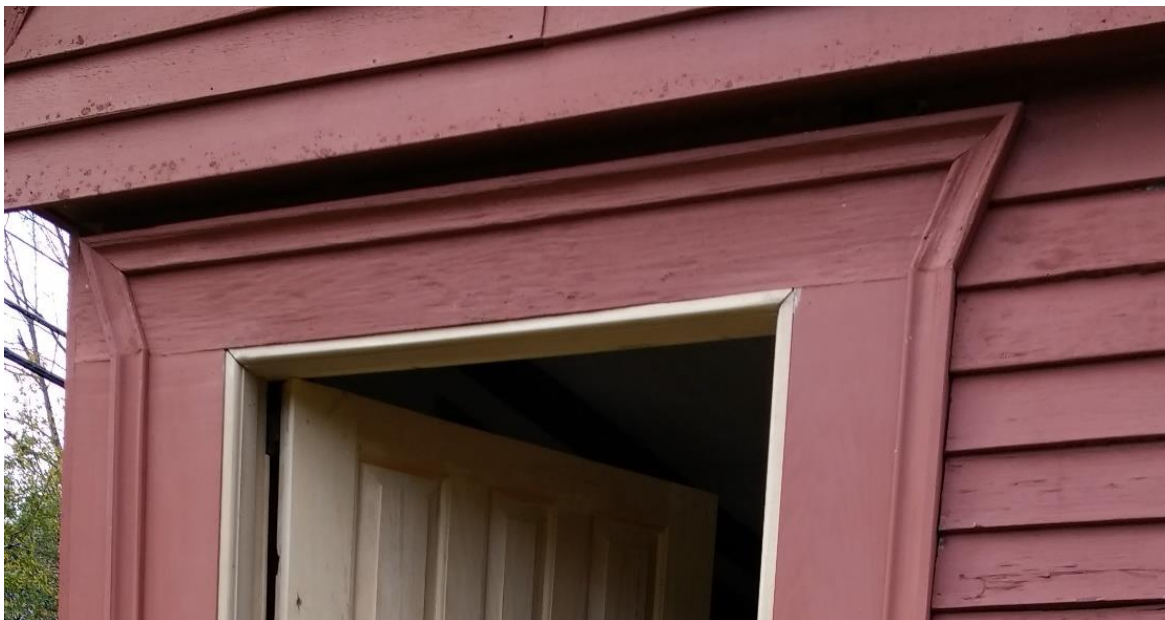
Figure 3.8. Daniel Rose House, 1741. Upstairs Ballroom windows of ‘12 over 8’ panes repeat number ‘8’ of the eight-paneled double-leaf front entry door, suggesting eight blessings of the Sermon on the Mount as found in western church architecture. East façade, camera facing west, June 2001. (Lower) Original architrave, herein called the ‘Bedford Settlement Door Surround’ for east facing door, is of the same detail as the front architrave with pilasters and angled lintel. Reconstructed coffin door reproduces the door seen in Fig. 3.10, the Kitchen Garden photo of 2017 (not the vertical plank door in Fig. 3.7). Camera facing southwest. Photo, October 2017.

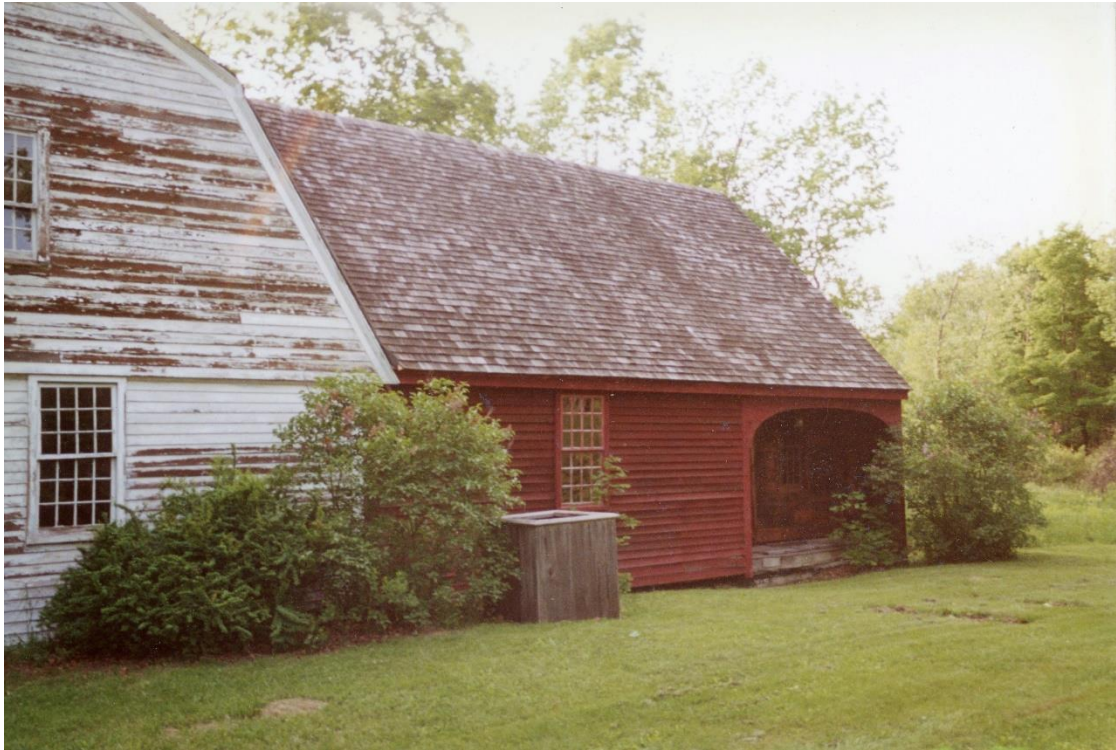
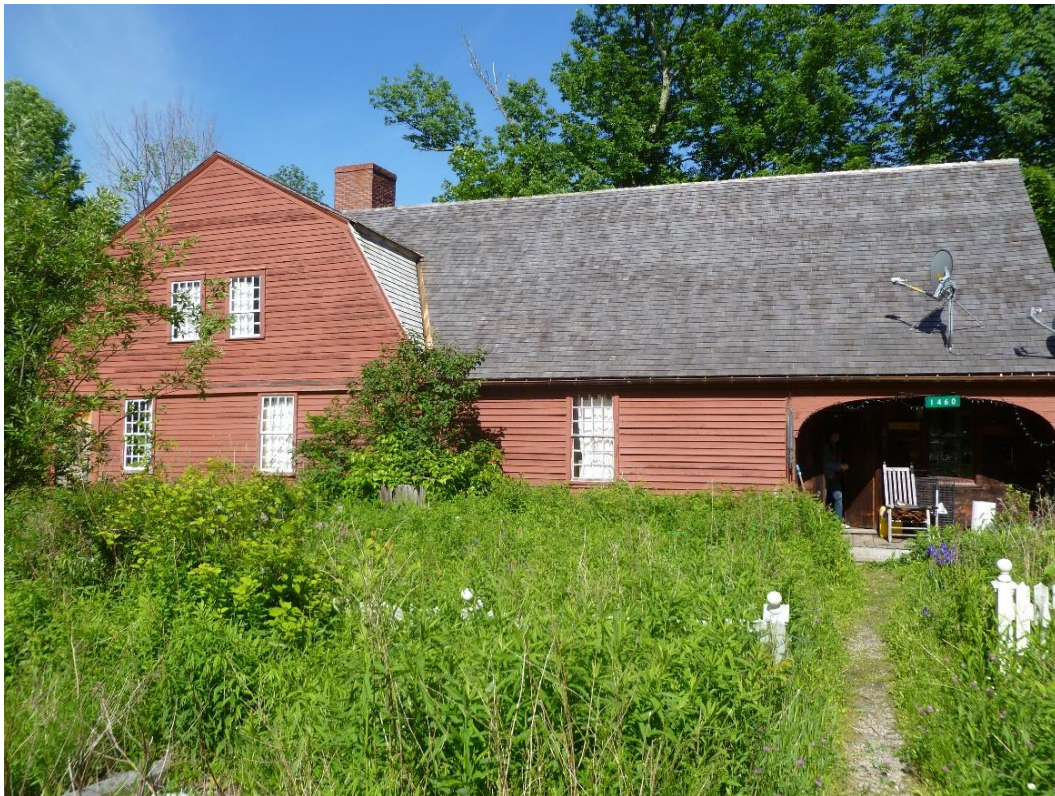
Figure 3.9. Daniel Rose House, 1741, east façade with well head accessible for Denizen Baldwin, second oldest son of Lt. Jacob Baldwin, to pass through his brother Heman’s side of the Keeping Room, by stipulation of the court, 1813. Photo, June 2001. (Lower) Three-layer cedar roof added in 2017 with Grace Ice & Water Shield underlayment, one layer of royal cedar breather, two layers of red cedar perfection for “three sheets (of shingles) to the wind” in the old tradition, with crafted gutters and leaders to last more than sixty years. Photo, June 2019.

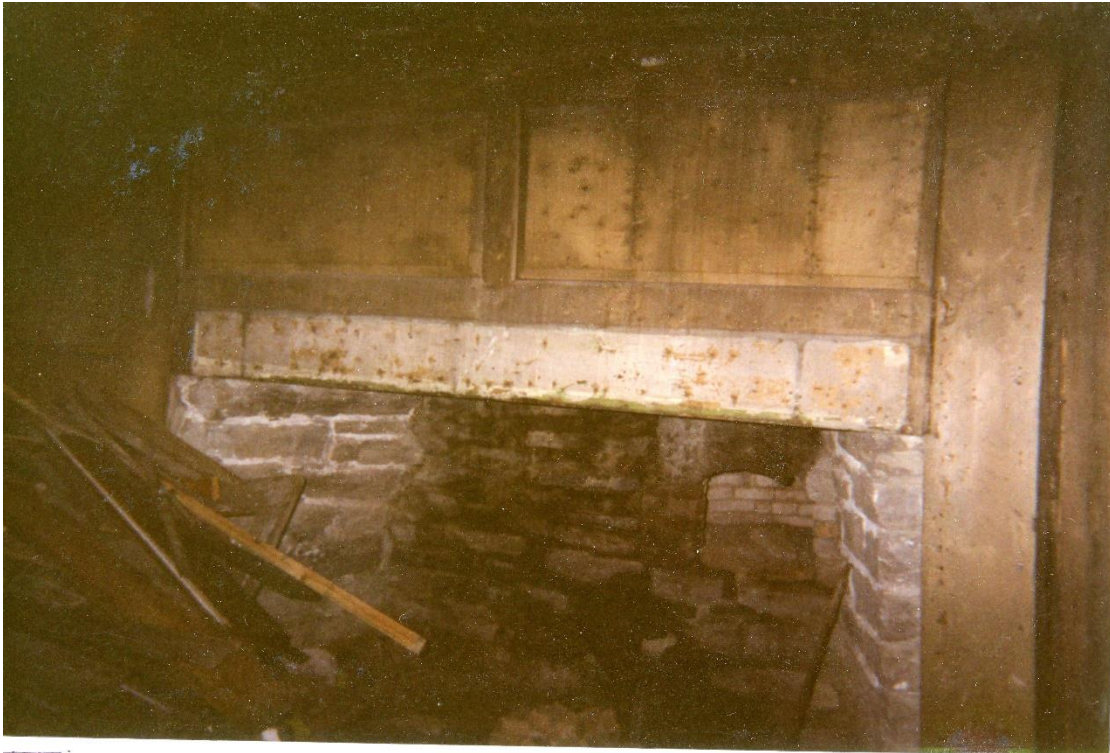
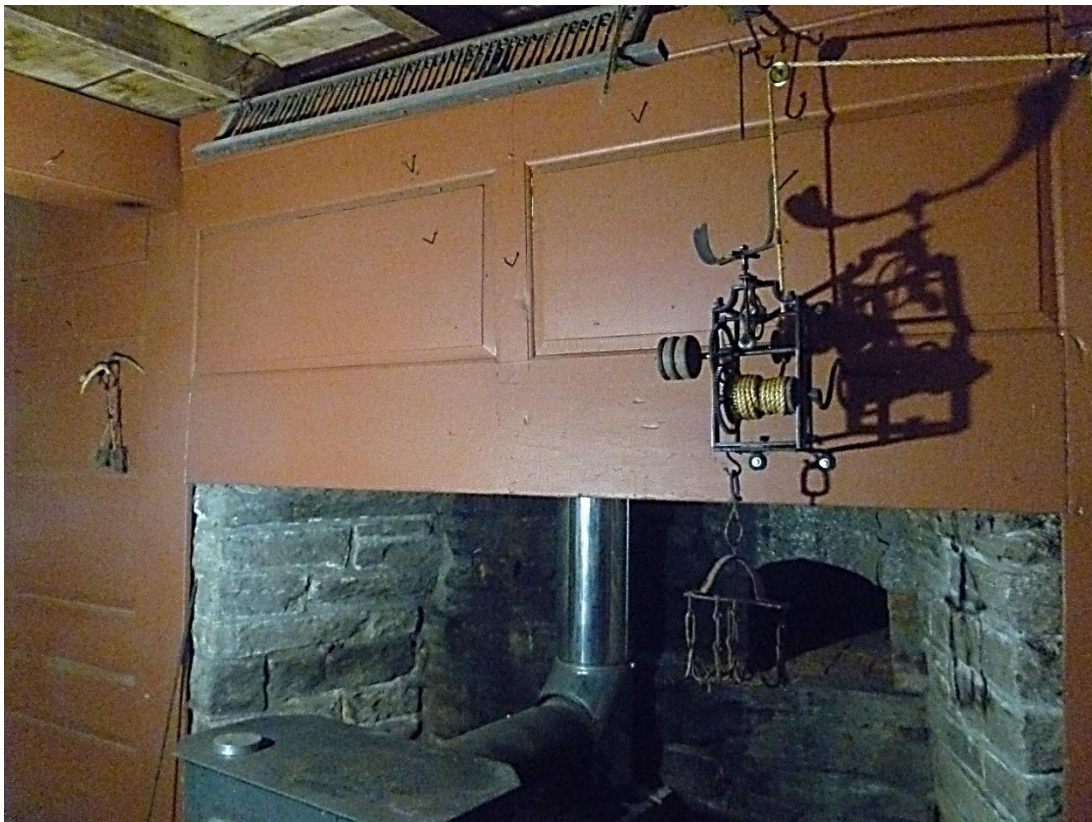
Figure 3.11. Keeping Room with Bake Oven and roasting clock jack repaired with hearts to reflect motif of Tavern Room door, Daniel Rose House, 1741. The two raised panels above the hearth demarcate the east and west sides of the room, offering a ‘line’ for the rights of privilege in 1813, during the court’s apportionment of Lt. Jacob Baldwin’s estate, for his two eldest sons Heman and Denizen Baldwin. (Upper) Camera facing southwest, July 2004. (Lower) After restoration by Bill Phelon. Photo, September 2019.

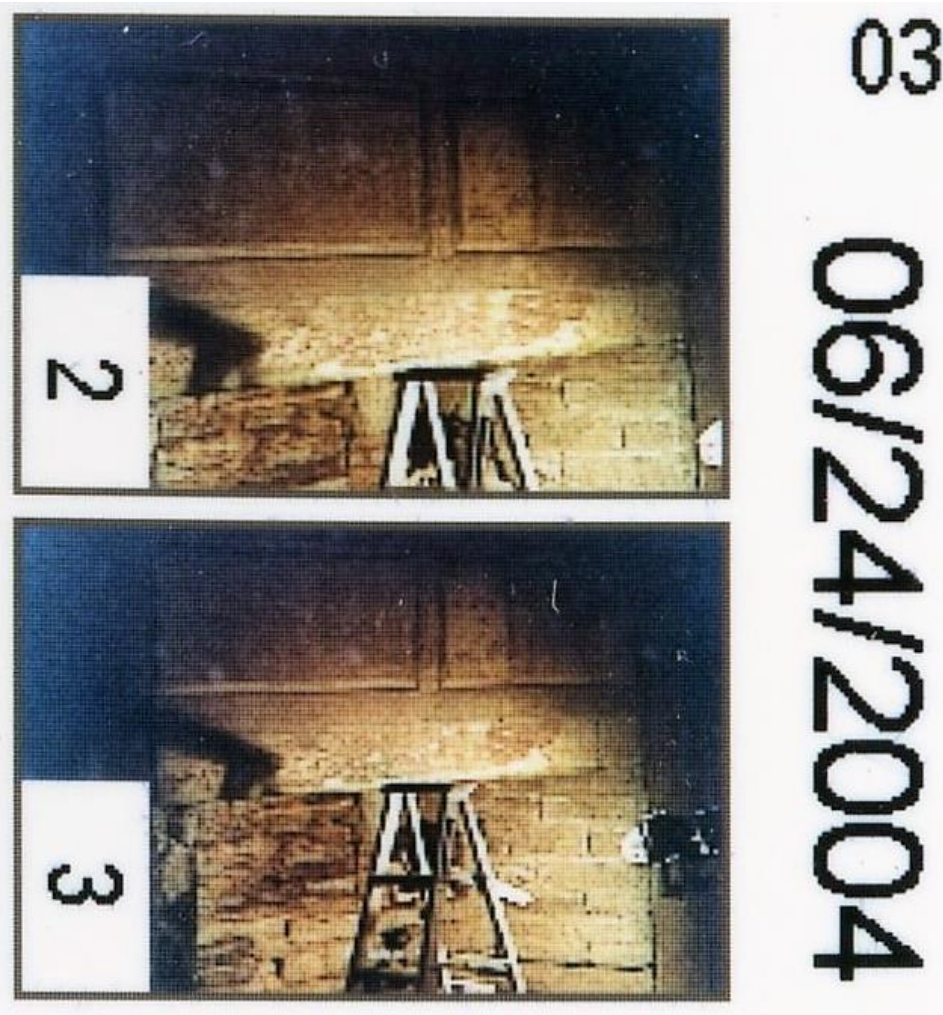
Figure 3.12. Keeping Room with Bake Oven, Daniel Rose House, 1741. Note two raised panels above hearth, original wood never previously painted. Ladder in place for restoration of flat stone by Bill Phelon and stonemasons. Photos, July 2004 following purchase of the house in 2004.

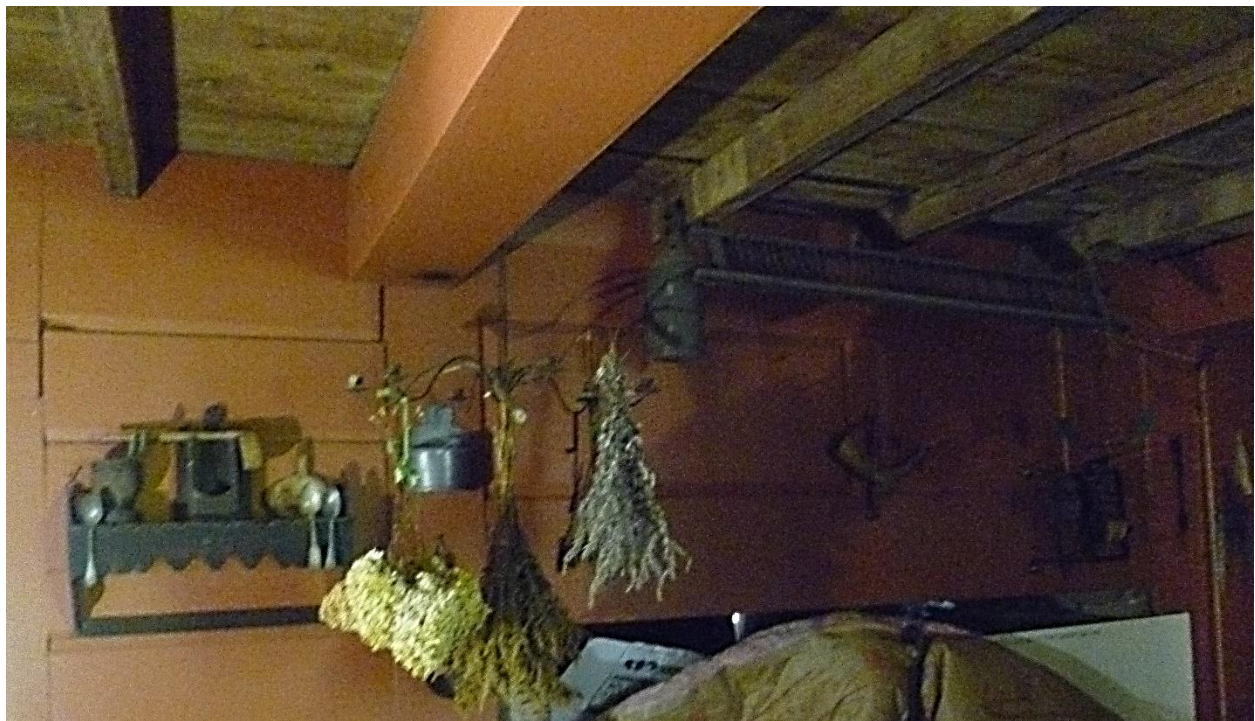
Figure 3.13. Keeping Room, Daniel Rose House, 1741. According to the Legacy Inventory, 1985 (MACRIS file), the Keeping Room has “Feather edge pine sheathing throughout open beam and sheathed ceiling. Raised panels above fireplace.” Panels above the hearth believed to be original wood never previously painted: “Evidence shows wood was left unpainted.” (Upper) Pre-restoration photos, July 2004. (Lower) Post-restoration, camera facing southwest, June 2019.

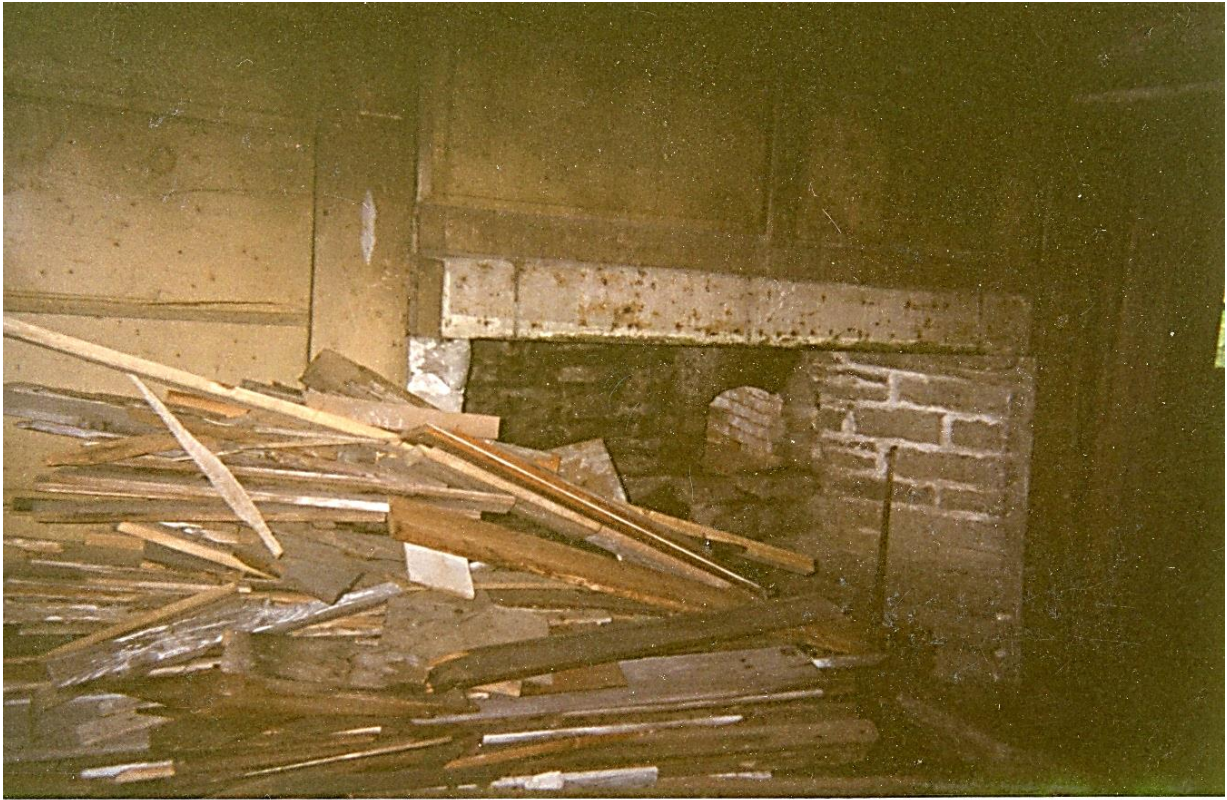
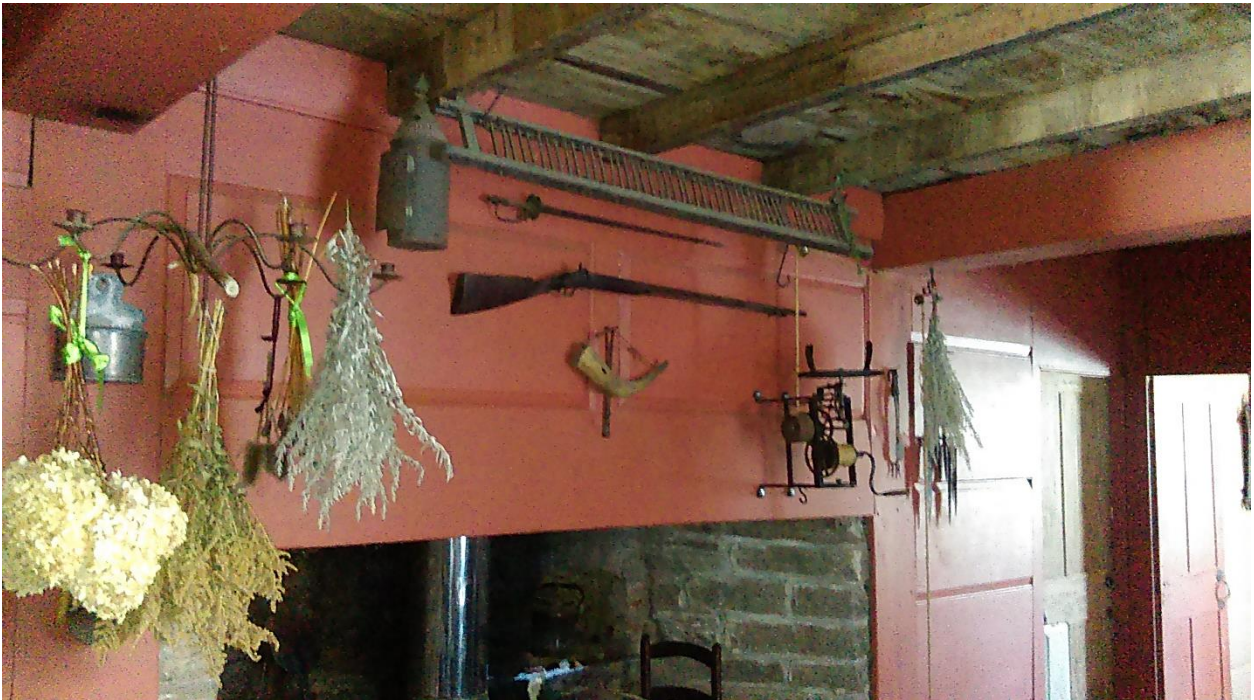
Figure 3.14. Pre- and post-restoration: Keeping Room, Daniel Rose House, 1741, home to six soldiers of the American Revolution and childhood home of two U.S. Navy Midshipmen in the War of 1812. (Upper) Restoration by Bill Phelon, in progress. Camera facing southwest, July 2004. (Lower) Post-restoration, photo by Bobbie-Jo Day, August 2017. The Rose-Baldwin-Baker-Phelon House is in the West Granville National Register Historic District.
