The Daniel Rose House, 'Fort Rose', 1741

Before and After Restoration

By William Brian "Bill" Phelon

The Daniel Rose-Jacob Baldwin-Francis G. Baker-Phelon House

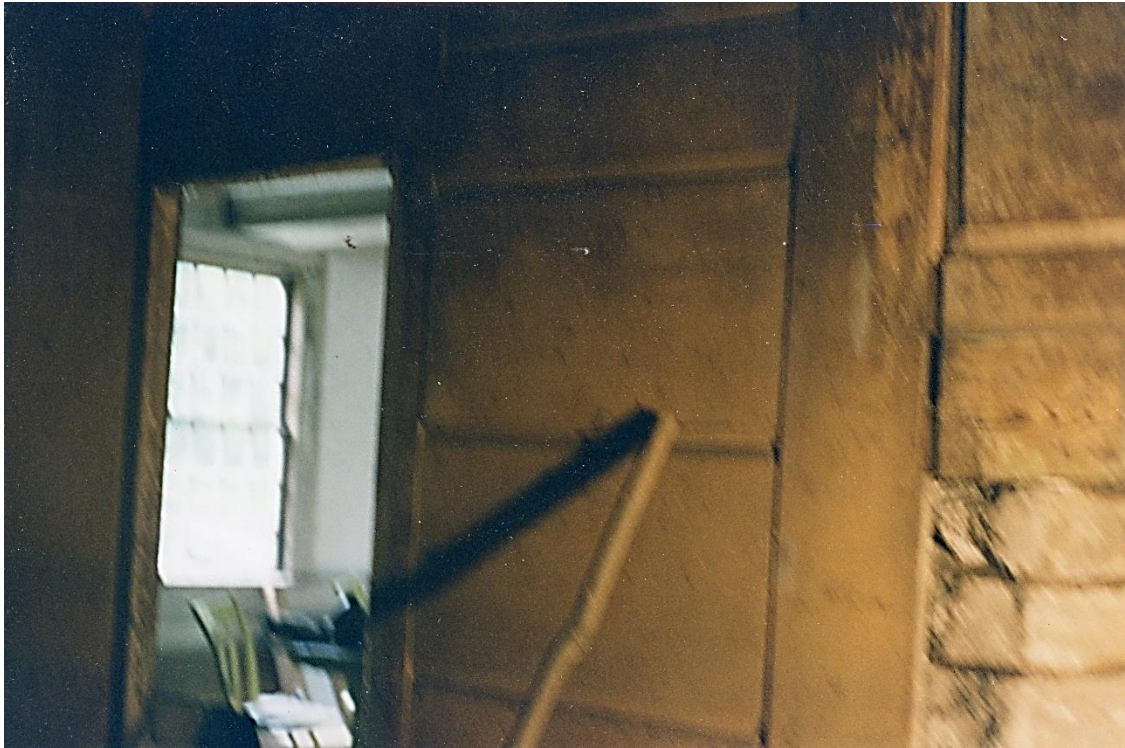
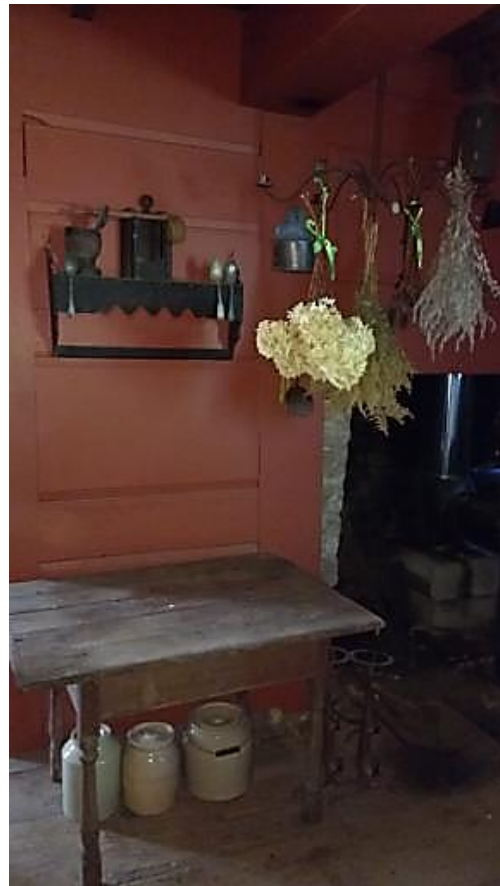
Figure 3.15. Keeping Room, Daniel Rose House, 1741. According to the 1985 Legacy Inventory, there is “Feather edge pine sheathing throughout; open beam and sheathed ceiling. Raised panels above fireplace.” (Upper) Photo, July 2004 during restoration, camera facing southeast toward window of Tavern Room (the Southeast Front Parlor). (Lower) Post-restoration, photo, August 2017.

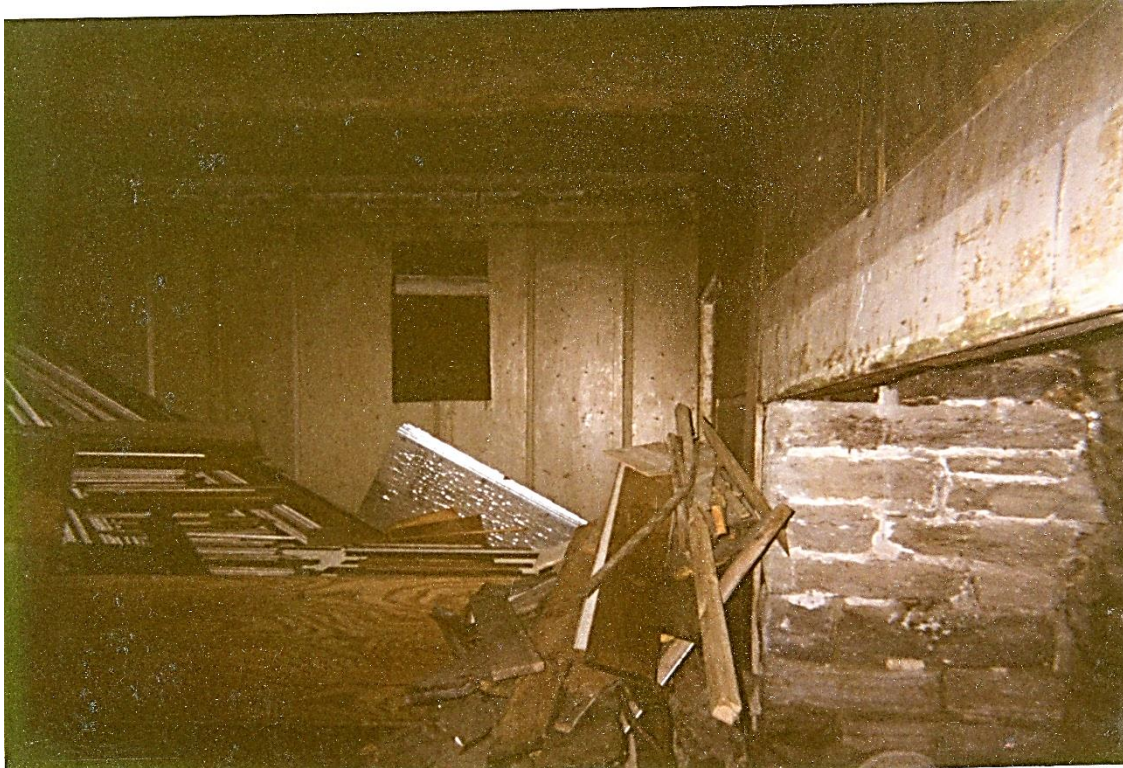
Figure 3.16. (Upper) Pre-restoration Keeping Room, Daniel Rose House, 1741 with restoration in progress. Photo, July 2004. (Lower) Post-restoration, camera facing southeast to Tavern room that became Heman Baldwin's side of the house as stipulated in the 1813 court settlement of his father Lt. Jacob Baldwin's estate to ensure each of six children received equal portions. There is a 'cutout' in the vertical paneling (see Fig. 3.17 for closeup) to a small room north of, and adjacent to, the cage bar (see rails through 'cutout' at lower arrow) in the northeast corner of the Front Southeast Parlor (Tavern Room). The cutout may have been an early form of a restaurant 'window' or 'hand-through' used for serving meals for the tavern while children were in the Keeping Room where cooking was in progress. Photo, September 2019.

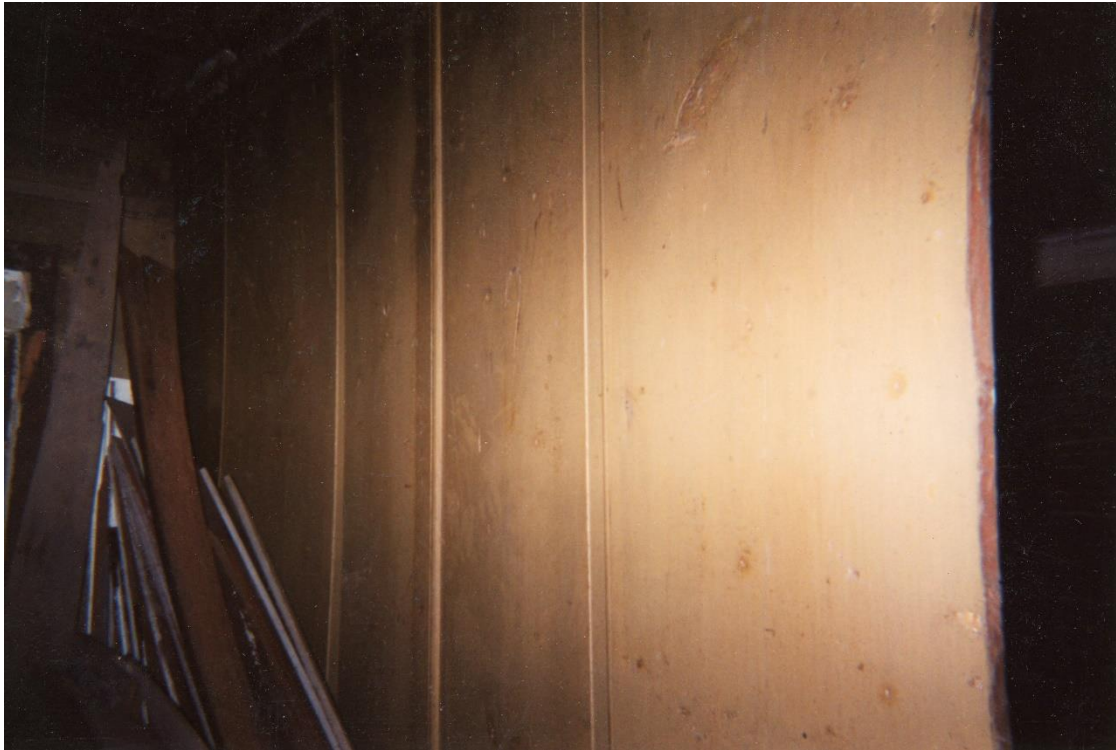
Figure 3.17. Keeping Room, Daniel Rose House, 1741. Restoration by Bill Phelon. (Upper) Pre-restoration: original wide vertical feather edge pine sheathing on east wall to the left of the ‘cutout’ seen in previous frame. Camera facing east, July 2004. (Lower) Post-restoration, photo, August 2017.

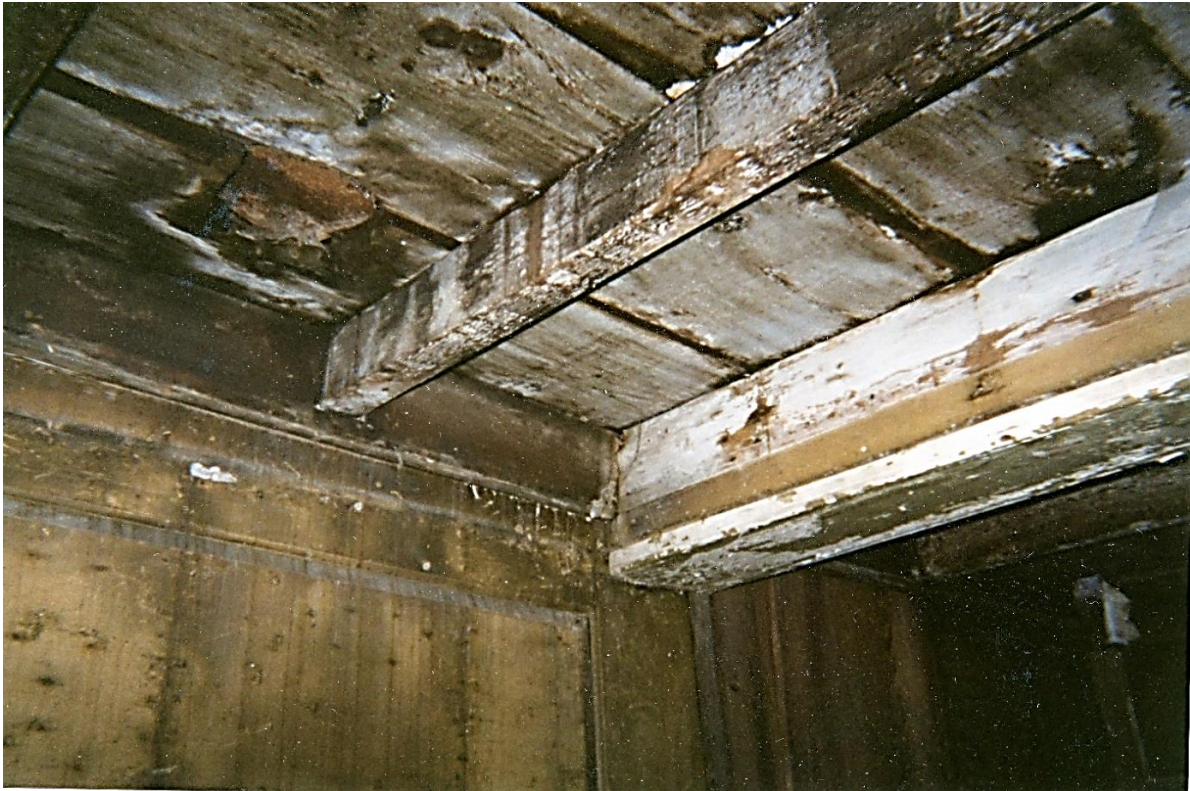
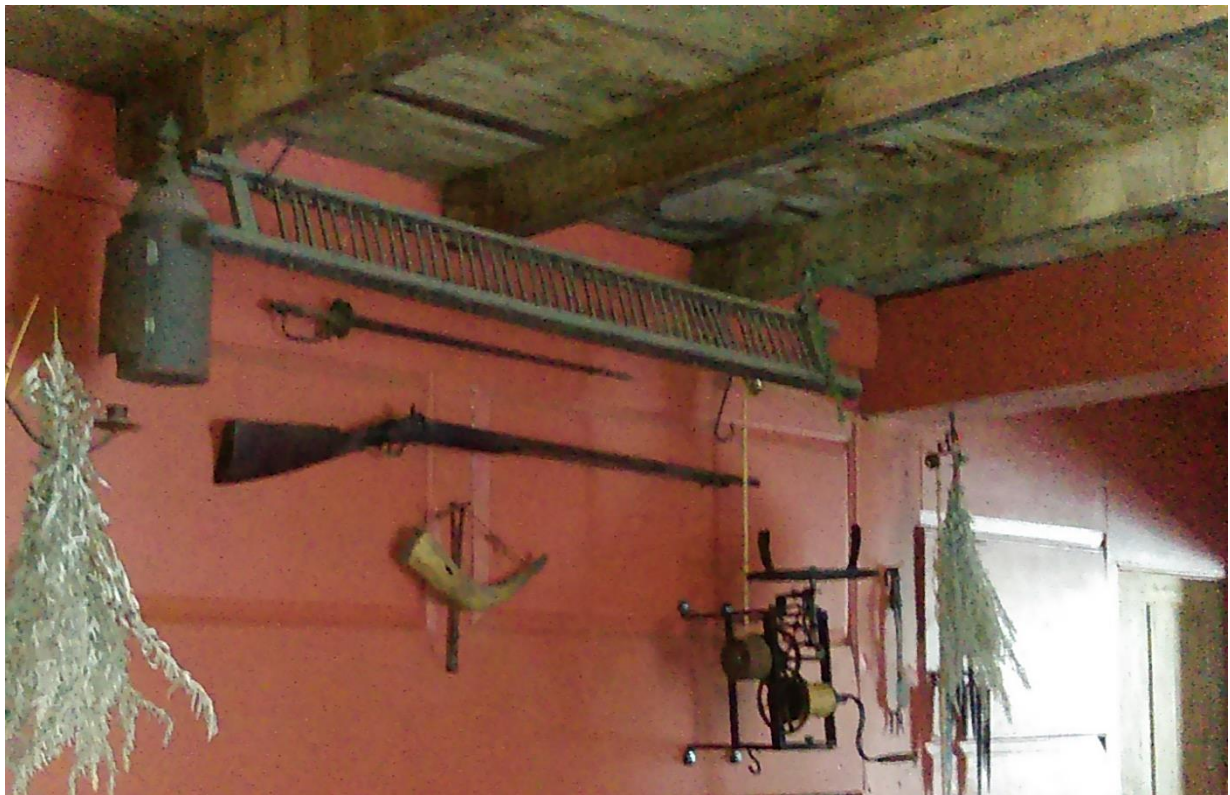
Figure 3.18. Pre- and post-restoration, Keeping Room, Daniel Rose House, 1741, musket pointing westward. Home to six soldiers of the American Revolution, Daniel Rose and his four sons; and Lt. Jacob Baldwin who owned a ‘Hangar Gun and Bayonet,’ and ‘Spontoon and pair of spurs’, befitting his rank. This household’s Rose family members responded to the Lexington alarm and served at the Siege of Boston; the prelude to the Battle of Long Island, NY in 1776; crossed the Delaware with Washington to fight at Trenton, Valley Forge, West Point, Ticonderoga . . . Restoration by Bill Phelon. (Upper) Pre-restoration, camera facing southwest, July 2004. (Lower) Post-restoration, August 2017.

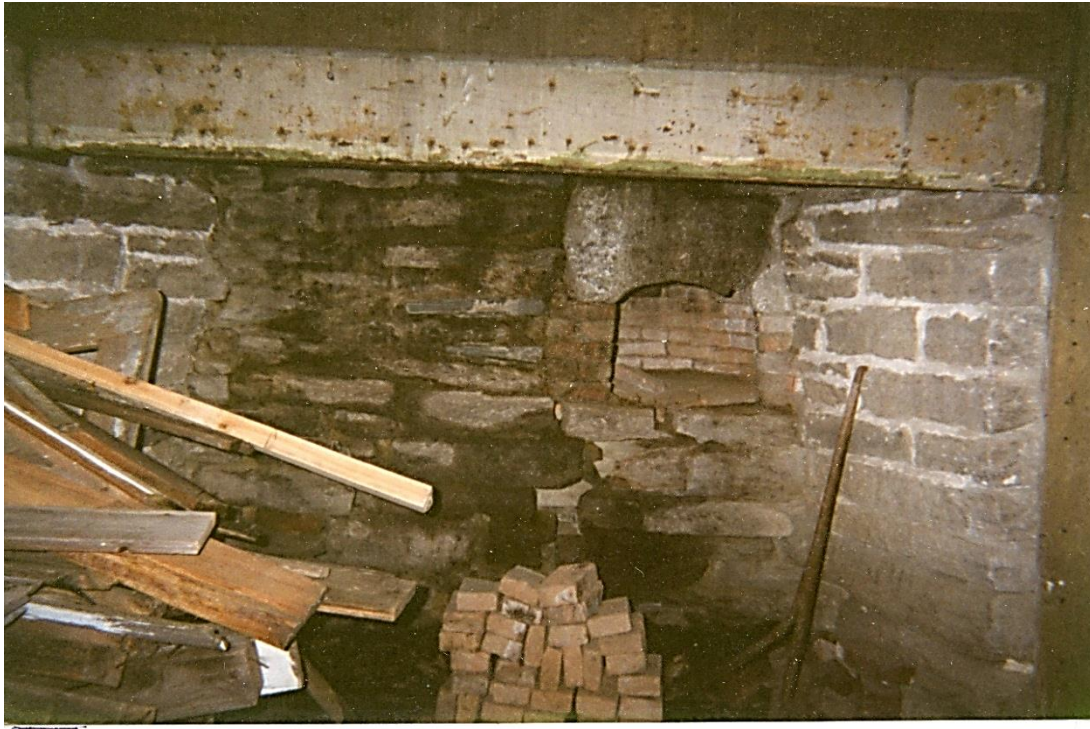
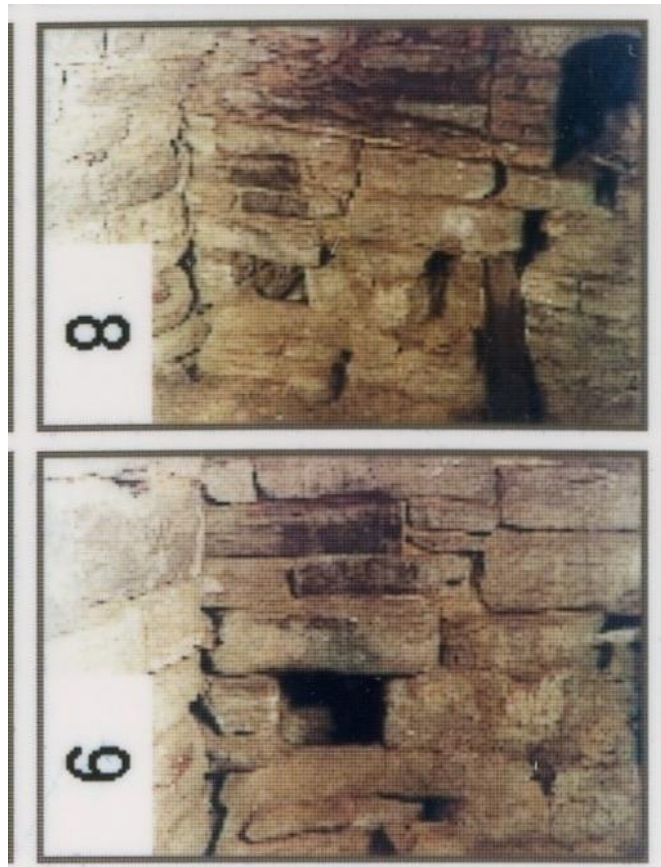
Figure 3.19. Restoration of Keeping Room, Daniel Rose House, 1741. According to Curtis (2003): “A stone chimney base and stack are features more commonly seen in Connecticut contexts and then, generally seen no later than the third quarter of the 18th century. . . . The cavernous kitchen fireplace, with its stone firebox, bake oven situated at the rear, and provision for lug poles to be suspended within the flue, is a throwback to the early 18th century.” Pre- and (Lower Left) restoration in progress, photos by Bill Phelon who pointed much of the stonework and brick, July 2004.

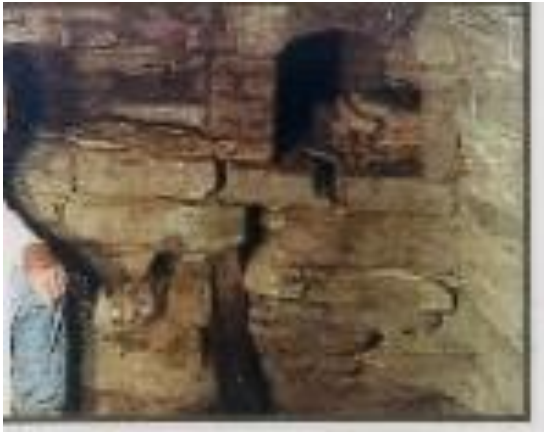
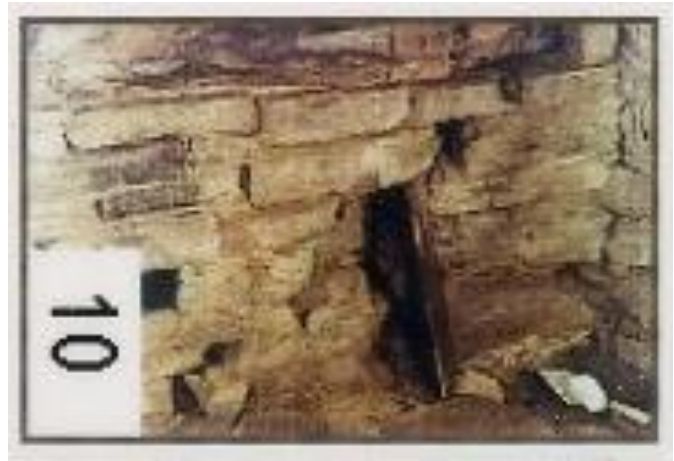
Figure 3.20. Keeping Room, Daniel Rose House, 1741. (Upper) Pre- and (Lower) restoration of the hearth and bake oven in progress (with mason's trowel, upper right photo; and chisels). Wood lintel of fireplace is across the top of photo; the bake oven has a stone lintel supported by brick. Photo, July 2004.

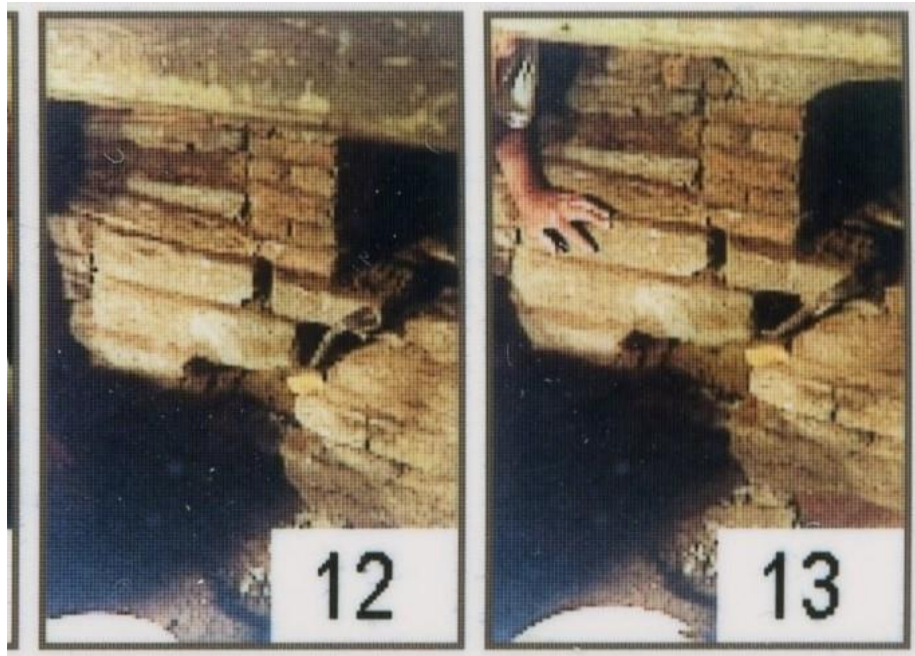
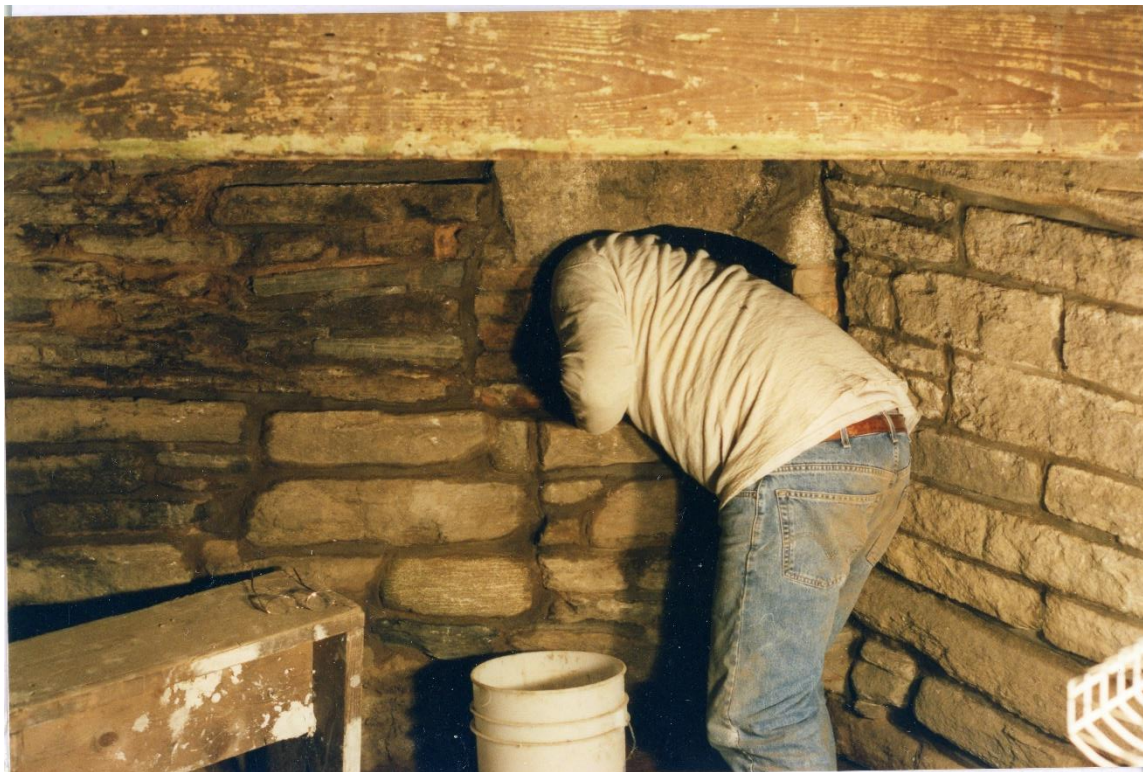
Figure 3.21. Keeping Room, Daniel Rose House, 1741. Bill Phelon at work completing the pointing of the brick interior of the bake oven. According to the Legacy Inventory of 1985, the fireplace is “built completely of flat stone.” According to Curtis, March 24, 2003: “The cavernous kitchen fireplace, with its stone firebox, bake oven situated at the rear, and provision for lug poles to be suspended within the flue, is a throwback to the early 18th century.” Pre- (“12” and “13”) and post-restoration (Lower) photos, July 2004.

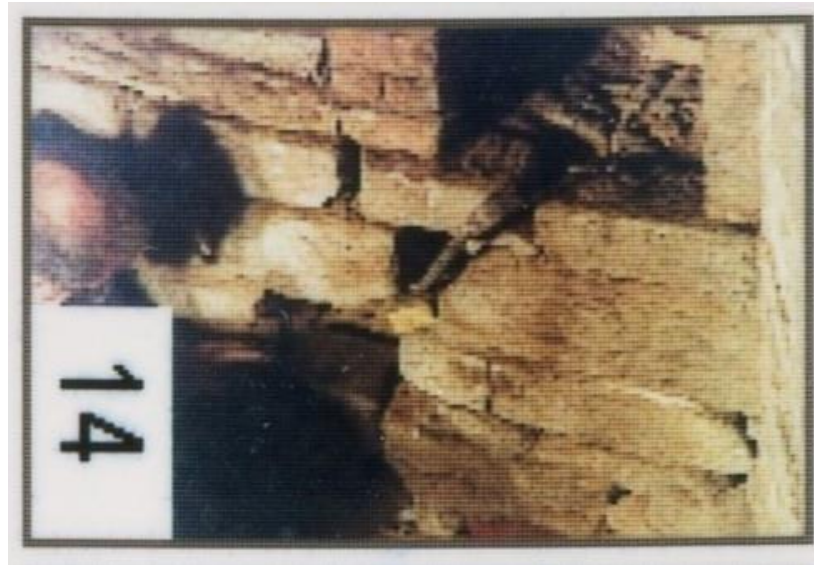
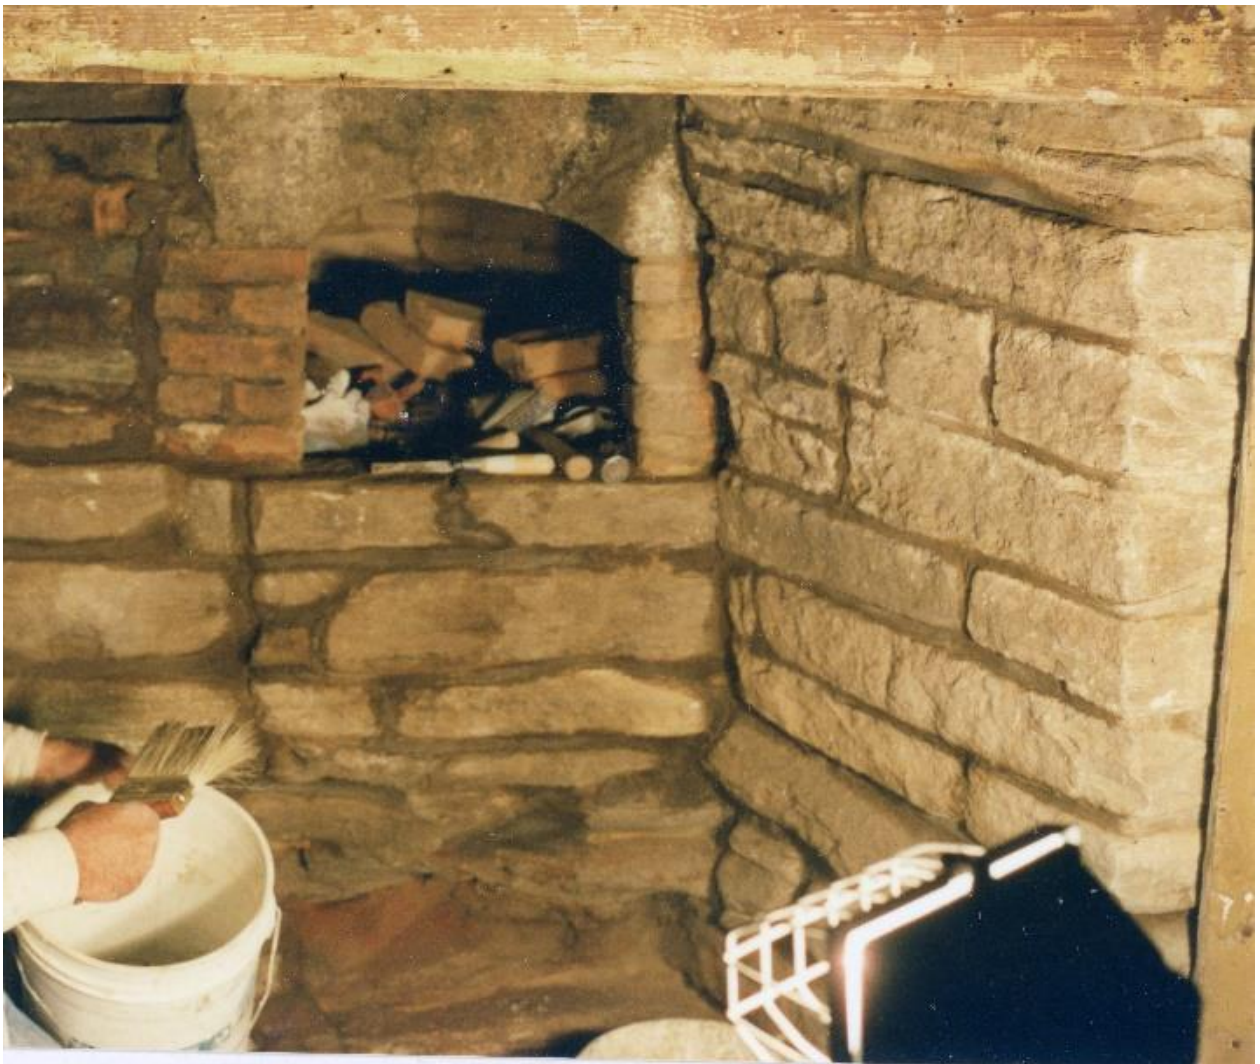
Figure 3.22. Keeping Room, Daniel Rose House, 1741. (Upper) Photo “14”: Pre-restoration assessment and preparation by a stone mason supervised by Bill Phelon; and (Lower) Restoration in progress. The stone lintel of the bake oven is supported by brick. The fireplace is built completely of flat stone with brick around and in the bake oven. Photos, July 2004.

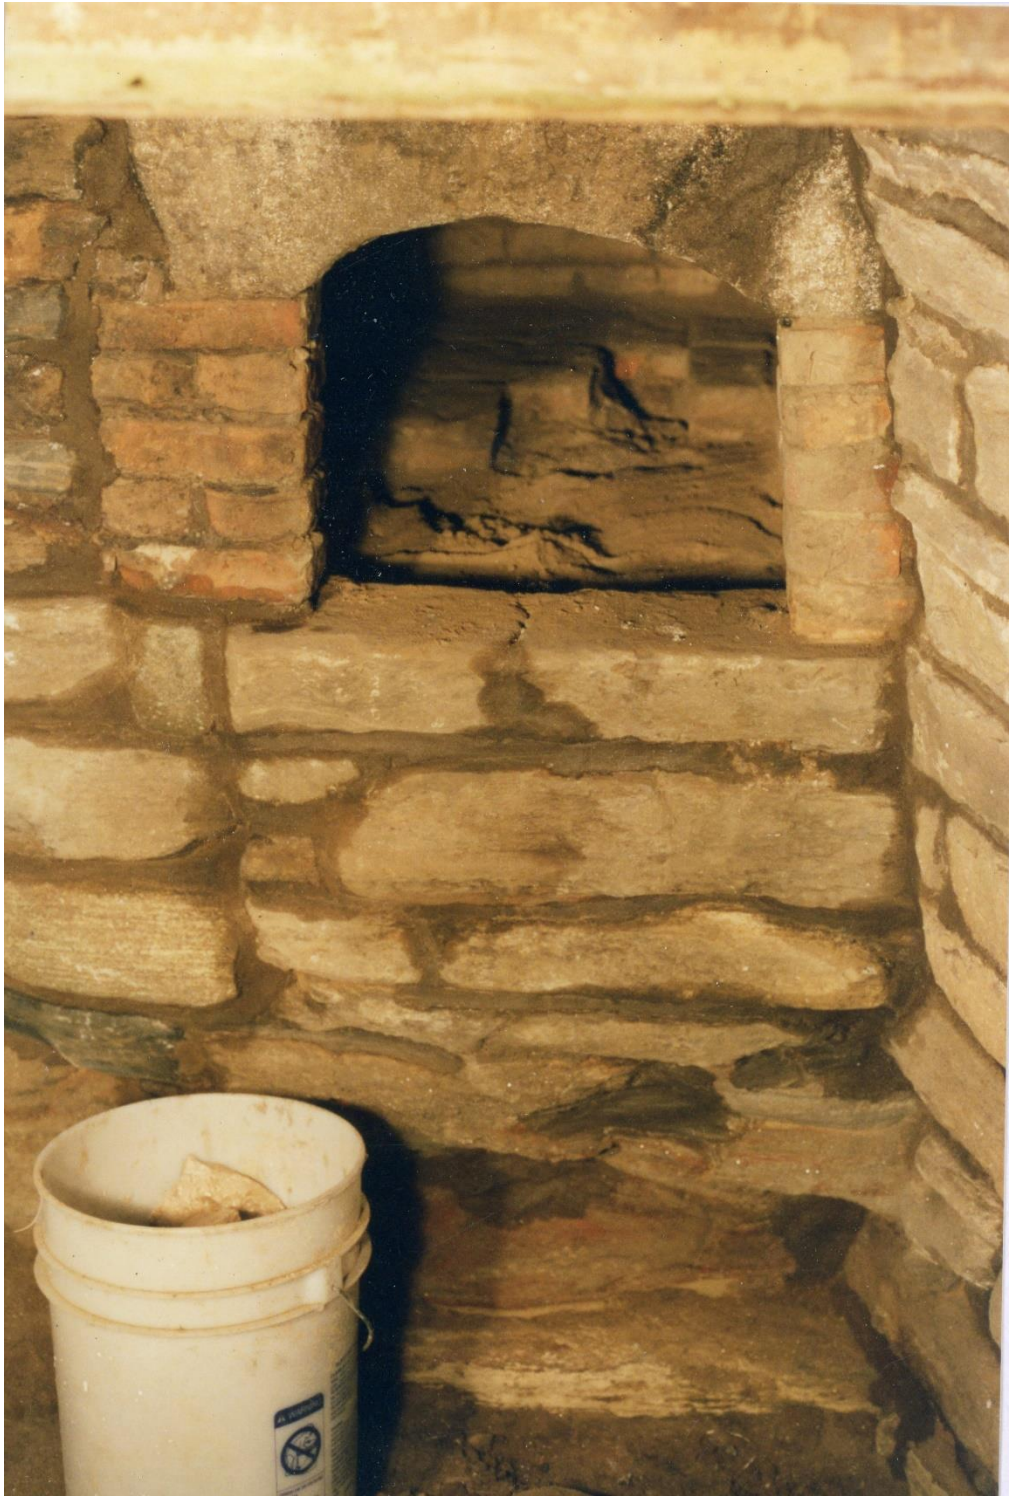
Figure 3.23. Keeping Room, Daniel Rose House, 1741. Restoration in progress. The stone lintel of the bake oven is supported by brick. The bake oven is lined with brick as restored by Bill Phelon. The fireplace is built completely of flat stone. Photo, July 2004.

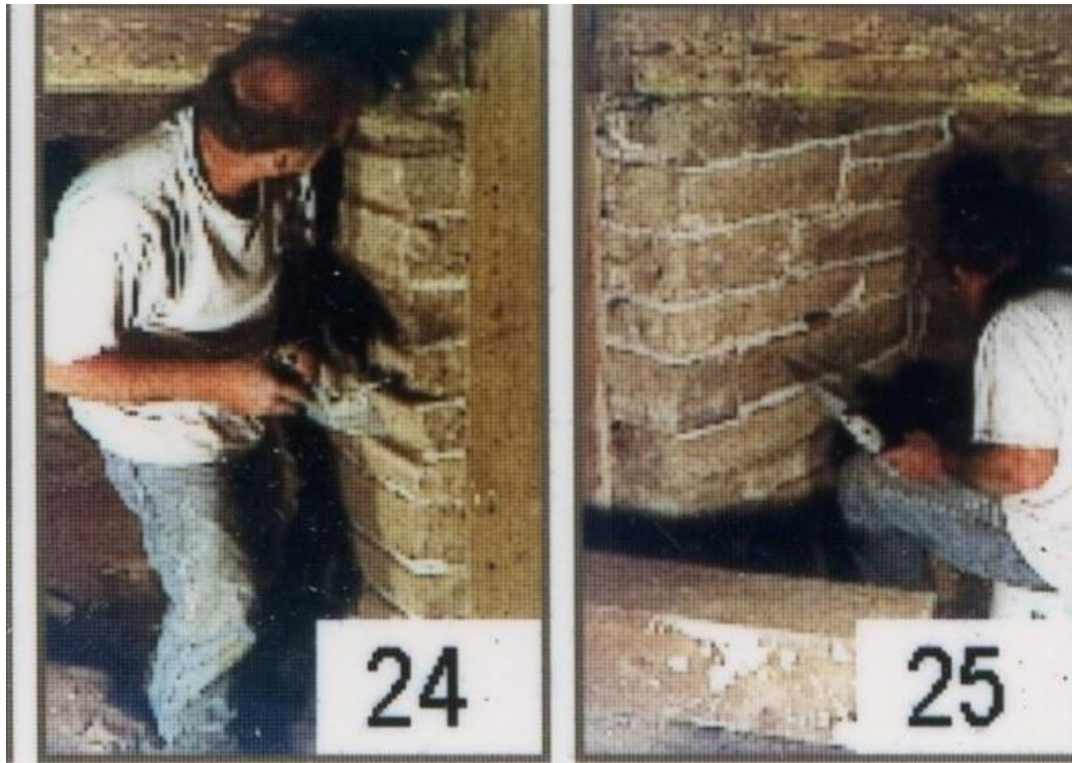
Figure 3.24a. (Upper) Photos numbered “24, 25:” Stone and brick masons at work supervised by Bill Phelon who also worked on pointing the masonry, July 2004. According to the 1985 Legacy Inventory, the “Fireplace has oven set in rear, plaster wood lintel, stones for lug pole in chimney, and built completely of flat stone;” and according to Curtis (2003), is “a throwback to the early 18th century.” Restoration photos, July 2004. (Lower) Spit jack and bake oven. Photo, September 2019.

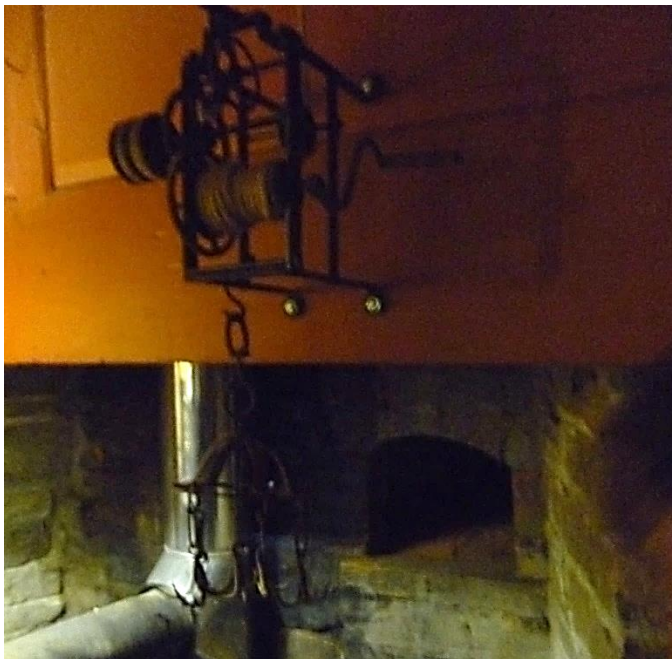
Figure 3.24b. Keeping Room, Daniel Rose House, 1741. The “cavernous” kitchen fireplace may have been like that of Deacon David Rose’s home, just a few-minutes-walk east on his adjacent settling lot, where Rev. Lemuel Haynes: “‘got his education in the chimney corner.’ This is literally true. It may be necessary to say here, that chimneys among the early settlers on the western hills in New-England were of a peculiar structure. They were built of huge stones, with a broad base, occupying at least one third of the ground covered by the building... its form... forming a kind of sitting-room for the younger members of the family... such was the ‘chimney-corner’ where Lemuel Haynes in his childhood laid the foundation of his future usefulness... here he studied his spelling-book and psalter... the Bible till he could produce by memory most of the texts that had a bearing upon the essential doctrines of grace; and could also refer, with nearly infallible accuracy, to the book, chapter, and verse where they might be found...” *Sketches of the Life and Character of the Rev. Lemuel Haynes, A.M.* by Rev. Timothy Mather Cooley (New York: Harper and Brothers, January 1, 1837, 36-37 at <https://books.google.com/books?id=5z8XAAAAYAAJ&pg=PR5#v=onepage&q&f=false>

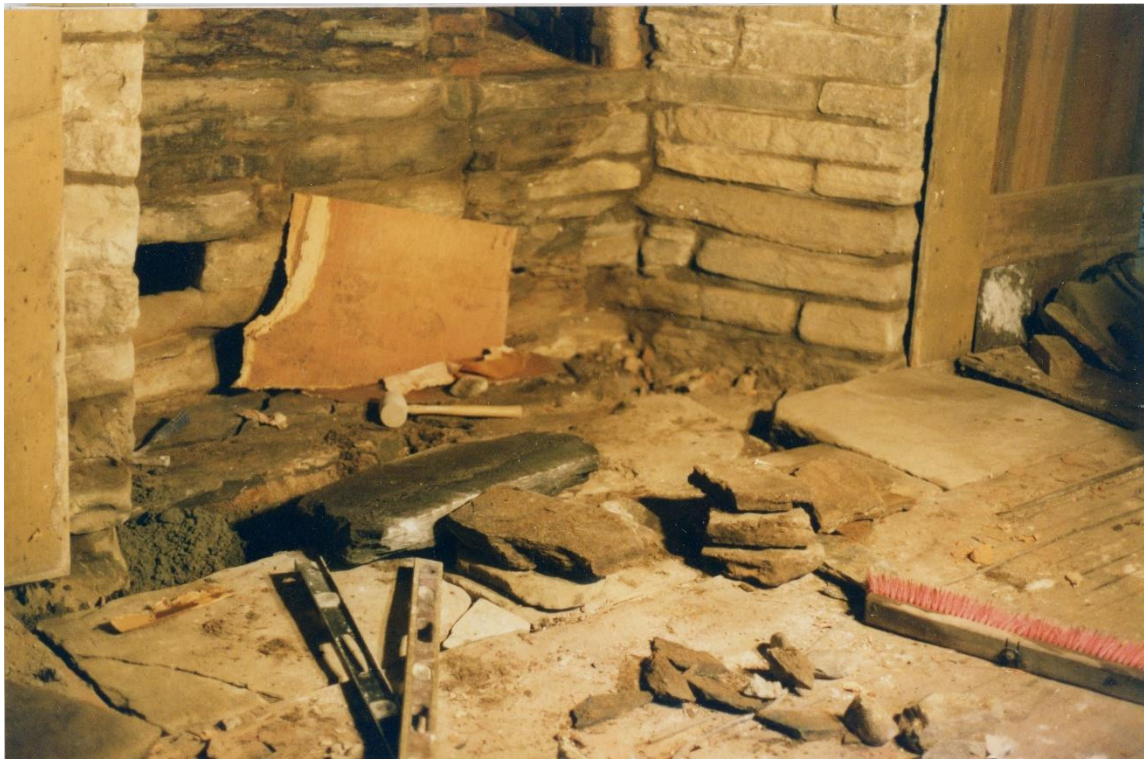
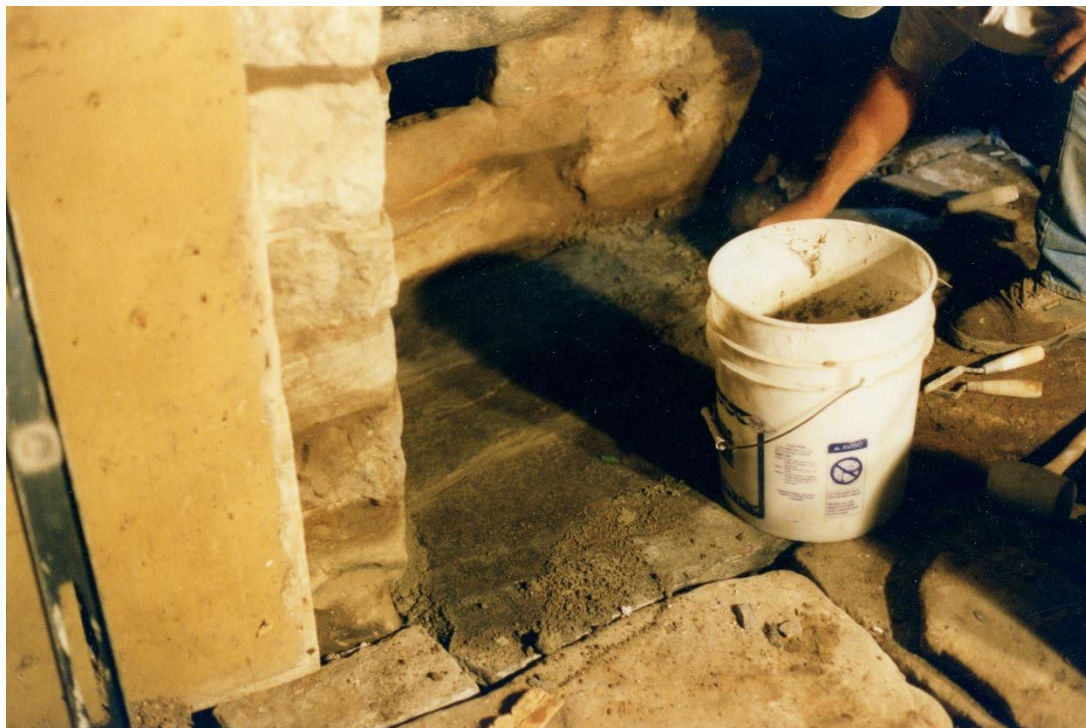
Figure 3.25. Keeping Room Hearth stone restoration, Daniel Rose House, 1741. Restoration by Bill Phelon, pointing the flat stonework after reinforcing and replacing, as needed, the supporting structure. The fireplace is extremely large and can fit two or three people in it at one time. Camera facing south (bake oven to right). Photo, July 2004.

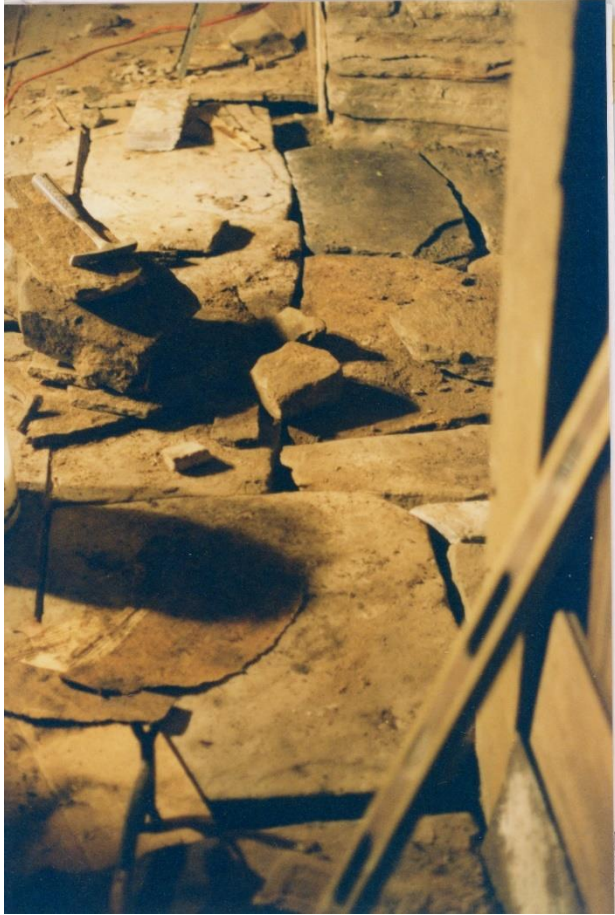
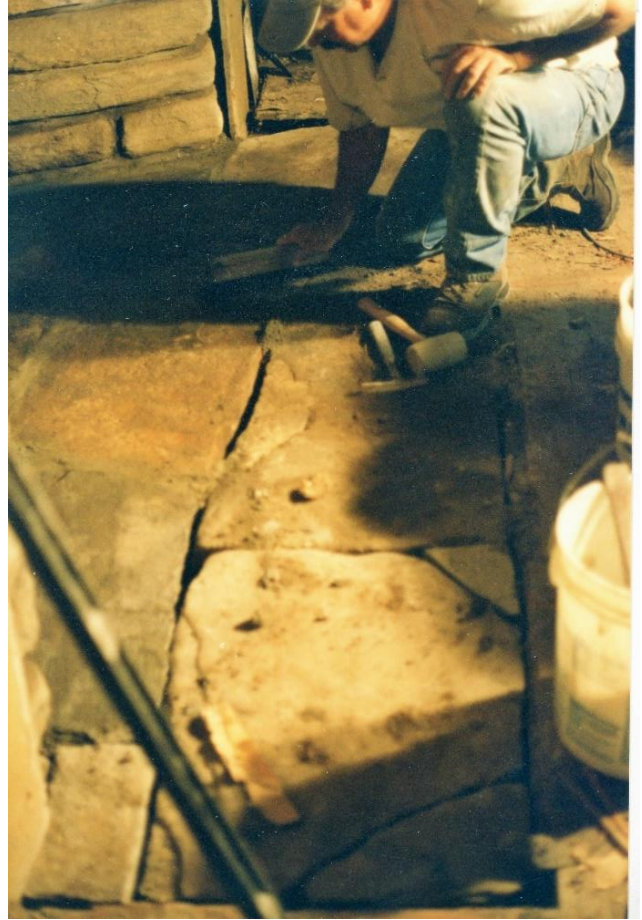
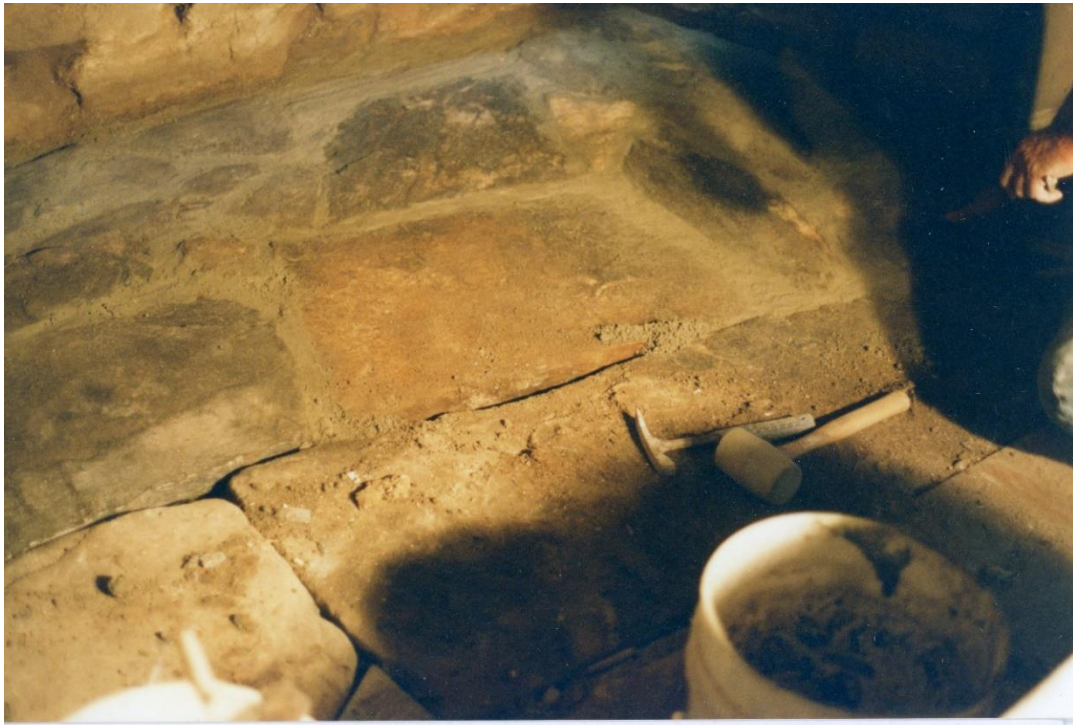
Figure 3.26. Keeping Room Hearth stone restoration by Bill Phelon at the Daniel Rose House, 1741. The fireplace is extremely large and can fit two or three people in it at one time. Photos, July 2004. Camera facing east (upper left) and west (upper right).

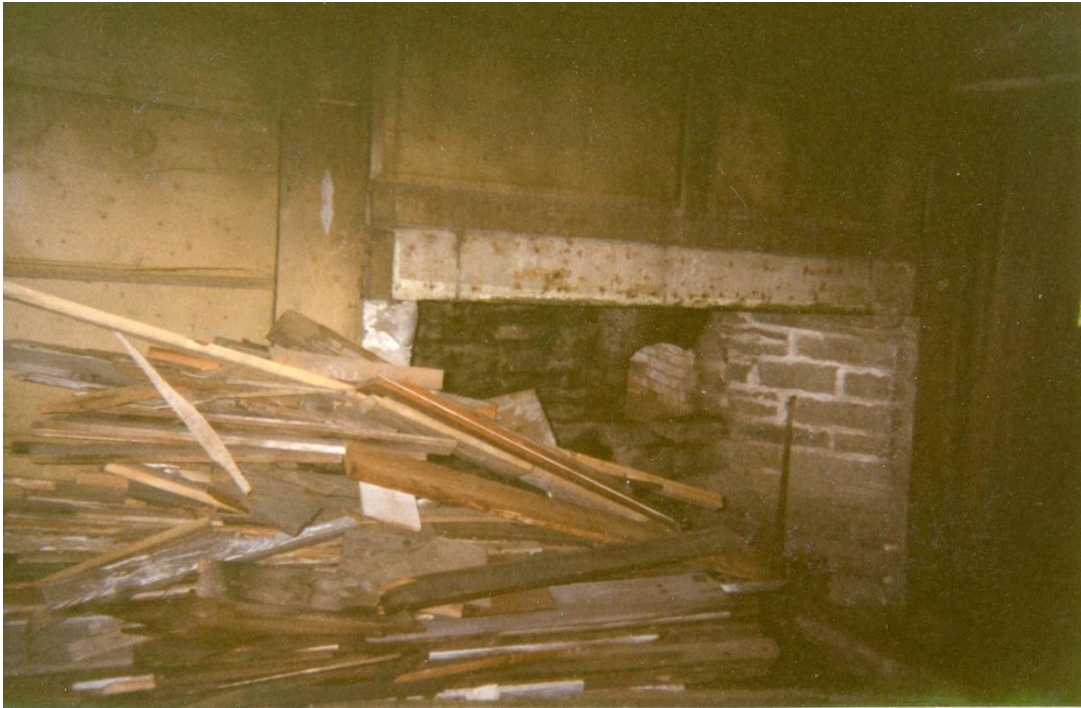
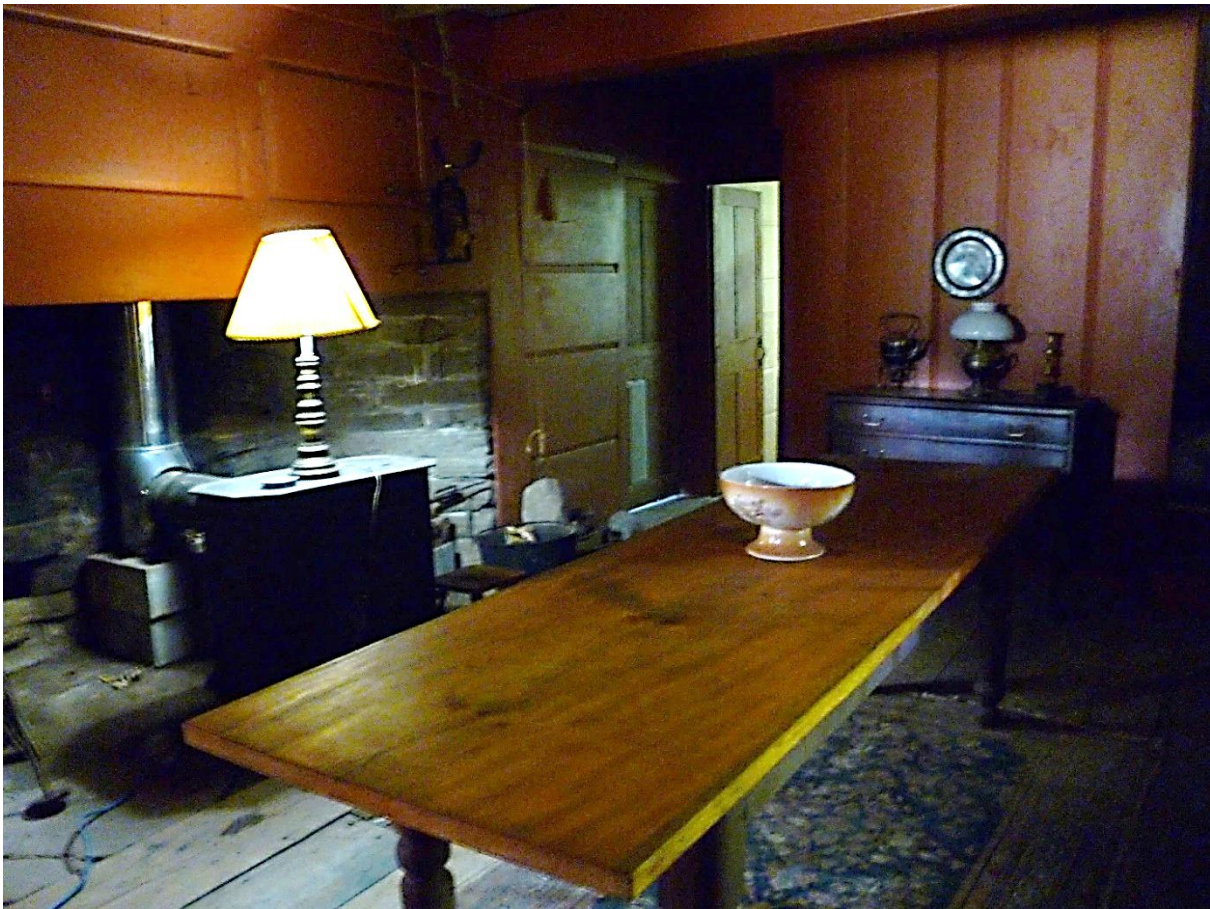
Figure 3.27. Pre- and post-restoration: Daniel Rose House, 1741, Keeping Room Fireplace and Hearth stone restoration by Bill Phelon. (Upper) Camera facing southwest, July 2004. (Lower) Keeping Room restored with Harvest Thanksgiving Table made by Bill Phelon. Open door is to the Borning Room. Photo, September 2019.

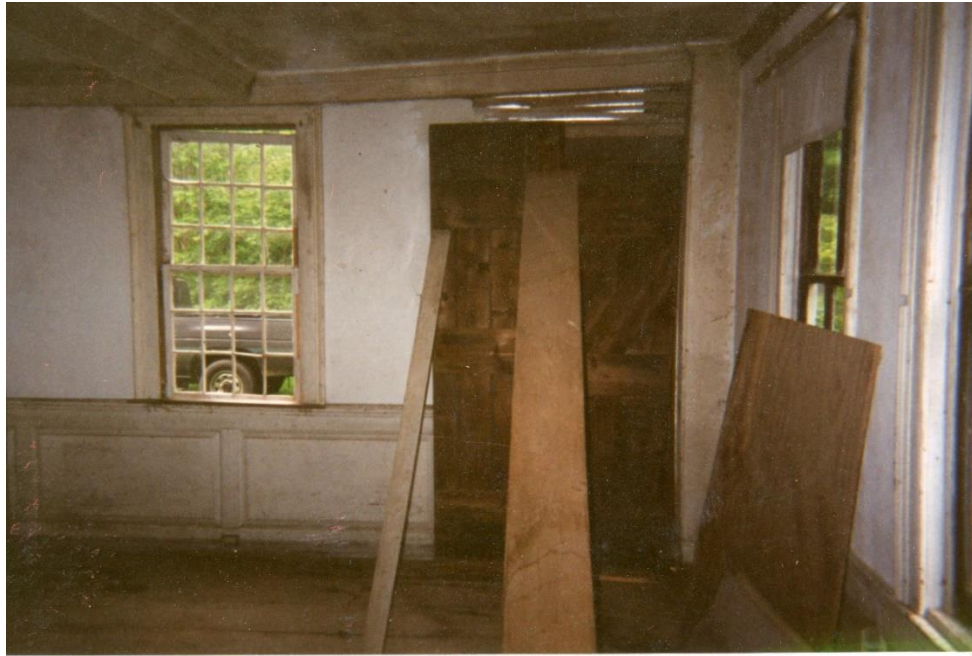
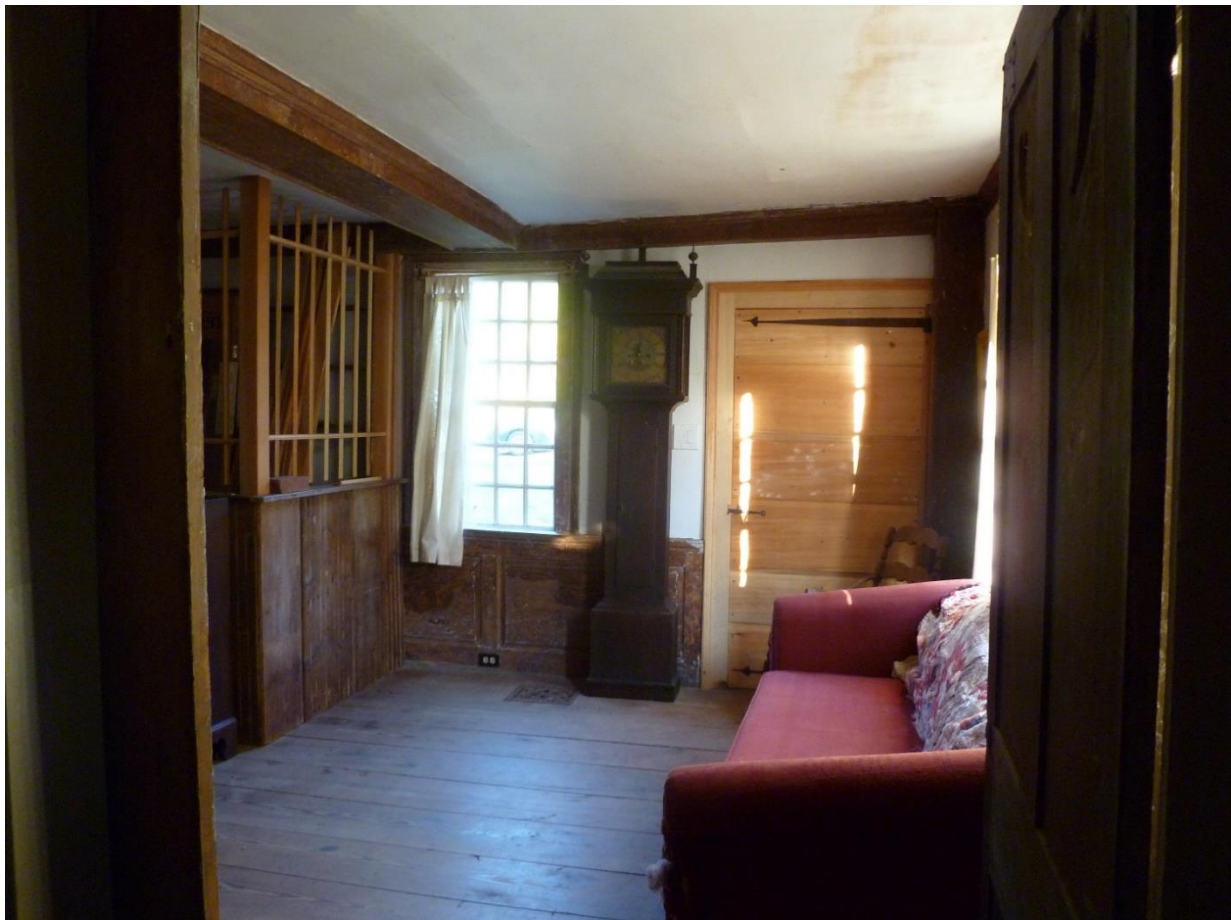
Figure 3.28. Daniel Rose House 1741. (Upper) Southeast Front Parlor (Tavern Room), interior view before restoration of original 12 over 12 front windows and repair of sashes throughout; craftsmanship of a reconstructed coffin door to replace original and restore entry clapboarding; reconstruction of original cage bar; hand removal of layers of paint from original woodwork of wainscot, corner post and summer beam with beading; and restoration of ceiling plaster. Heart door to right. Camera facing east, June 2001. (Lower) Paint removed from dado, corner post, summer beam, and flooring. Photo, September 2019.
