The Daniel Rose House, 'Fort Rose', 1741

Before and After Restoration

By William Brian "Bill" Phelon

The Daniel Rose-Jacob Baldwin-Francis G. Baker-Phelon House

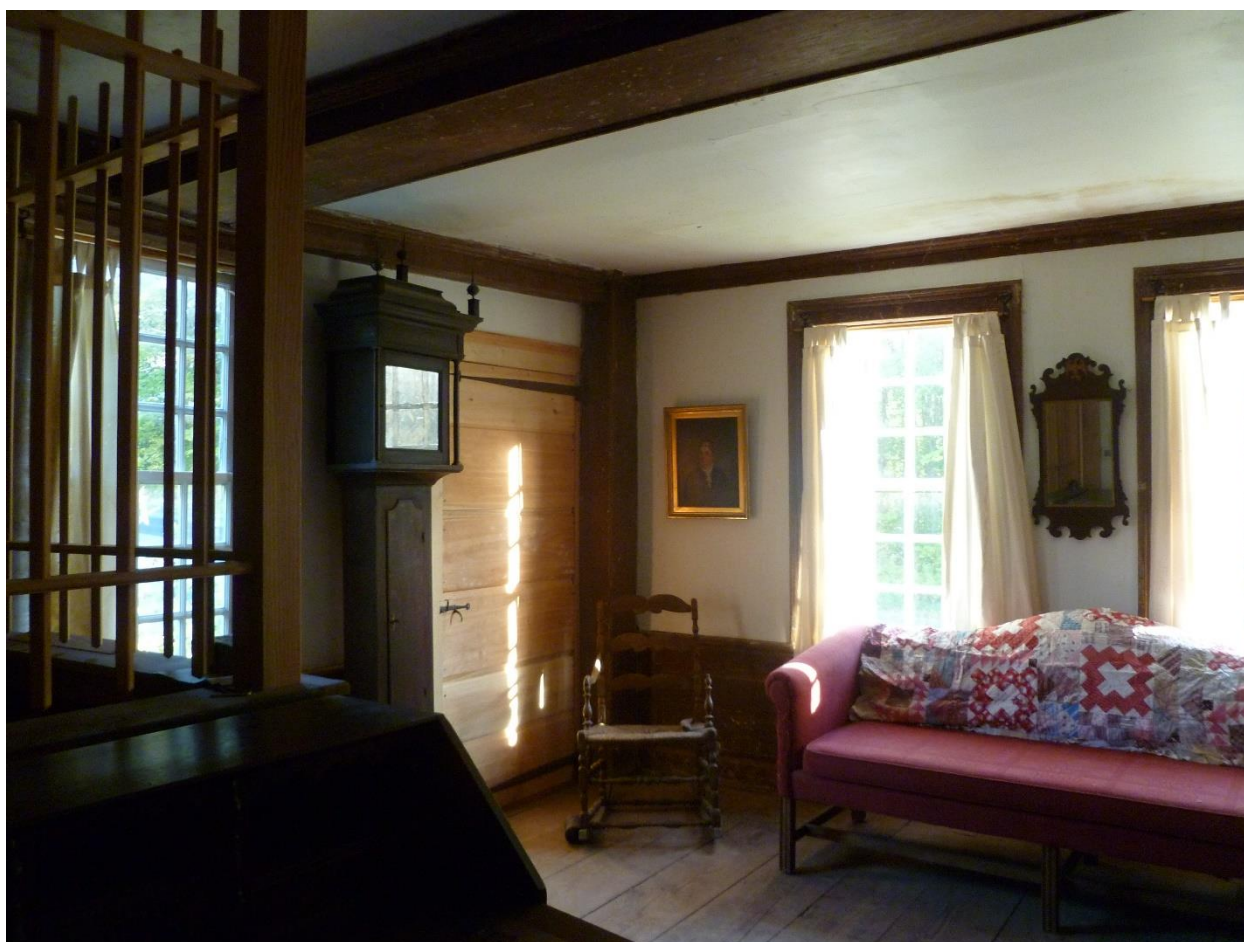
Figure 3.29. Southeast Front Parlor and Tavern Room, Daniel Rose House, 1741. Corner post and summer beam cased and molded and paneled dado with plaster above were restored by Bill Phelon with layers of paint removed. The Cage Bar reconstructed to meet specs of structural evidence of enclosure and shelves in the wainscot and walls and the east coffin door reconstruction were completed by Bob Bettcher, 18th century Reconstructions and Restorations, 2017 as per Bill Phelon’s direction. Photo, September 2019, Camera facing southeast. The tradition of quilts in this house dates to the green dyed wool quilt with “elaborate patterns” (now at Historic Deerfield, MA) made in 1798 by Olive Curtiss Baker, wife of Rev. Joel Baker pastor for thirty-six years of the Second Church of Christ Congregational. Olive’s quilt was owned by her son Francis G. Baker at this house before, during and after the Civil War. Francis’ daughter Laura, who grew up in the Daniel Rose House, gave her grandmother’s quilt to the Pocumtuck Valley Memorial Association before 1886 when it was exhibited in the PVMA’s Memorial Hall Museum that year, in the first museum installation of a period bedroom in the United States, possibly the world. The Baker quilt inspired the Deerfield Arts and Crafts Movement in 1896 and is now owned by the Pocumtuck Valley Memorial Association at Old Deerfield.

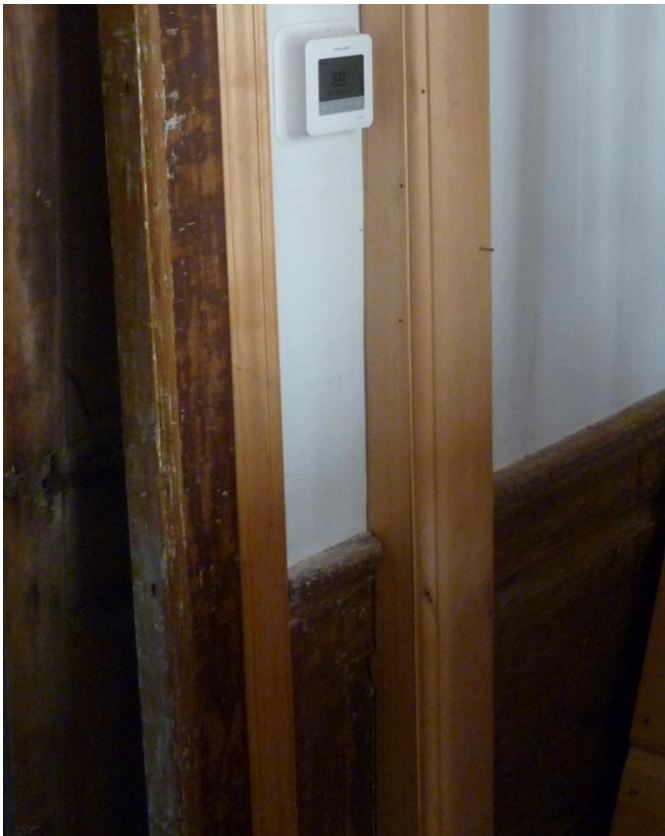
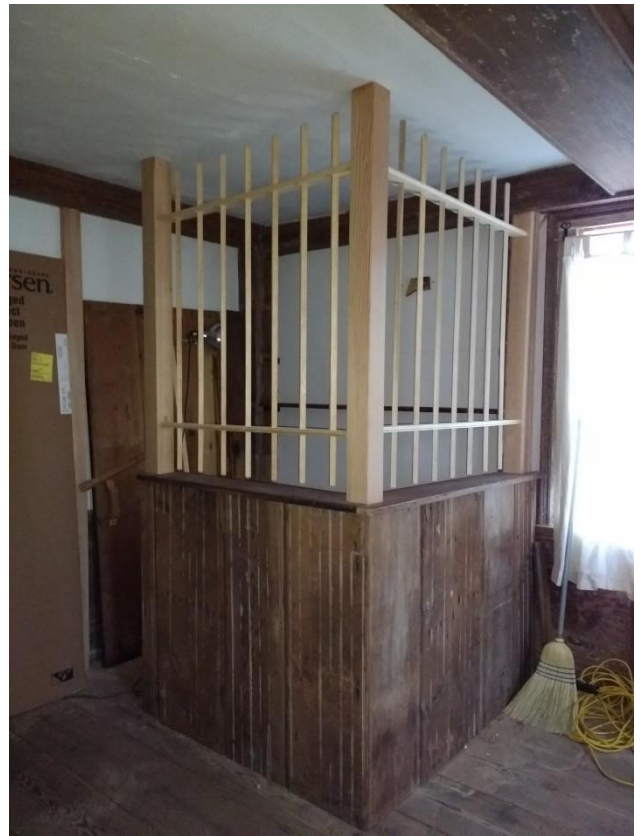
Figure 3.30. Southeast Front Parlor, Tavern Room, The Daniel Rose House, 1741. (Left) Evidence of notch in wainscoting seen here with cage bar structure reconstructed to fit the notch. According to John O. Curtis in 2003, "... the known history of the Baldwin House... having served as a Tavern... borne out by evidence for shelves and a small enclosure in the corner of the S.E. front room. These details would seem to argue for the previous presence of a small Tap Room or Bar from which potables were dispensed. At least the physical dimensions and the shelving of the 'back bar' survive to guide reconstruction if desired. The elevation would be, in part, conjectural, but there is good precedent available through study of other known examples." (Right) Cage bar reconstructed with period wood at base. Ceiling, wainscot, summer beam, corner post and floors restored by Bill Phelon. Photos, September 2019.

For another cage or 'frame' bar restoration based on cuts/grooves in the walls, see "Colonial Cage Bar Unveiled: Crucial Element of Restoration Project," Indian King Tavern (1750), published online 1999, Hadenfield, NJ.

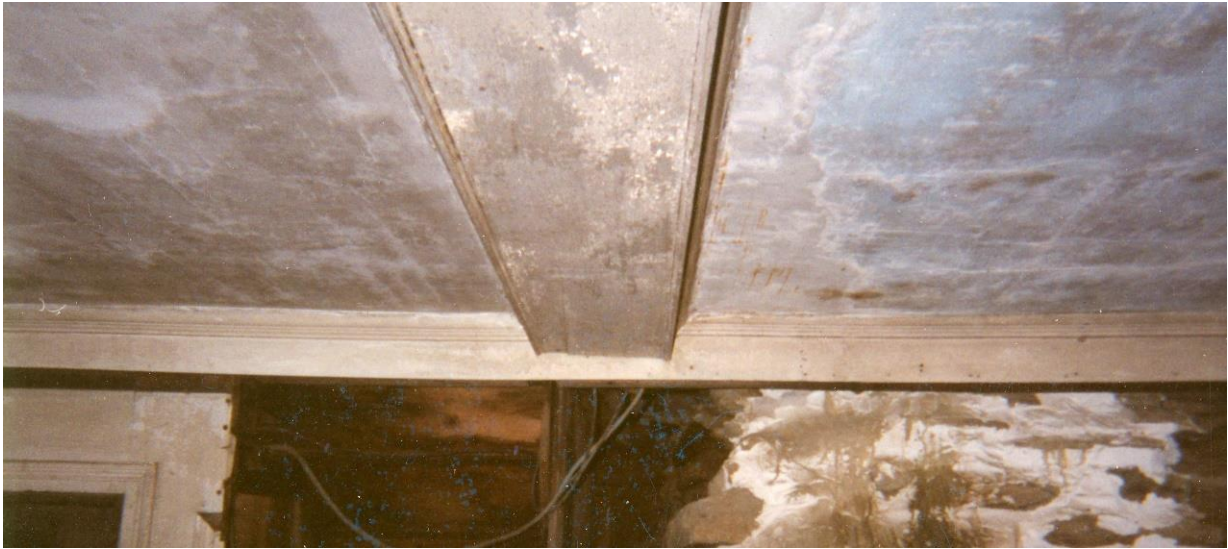
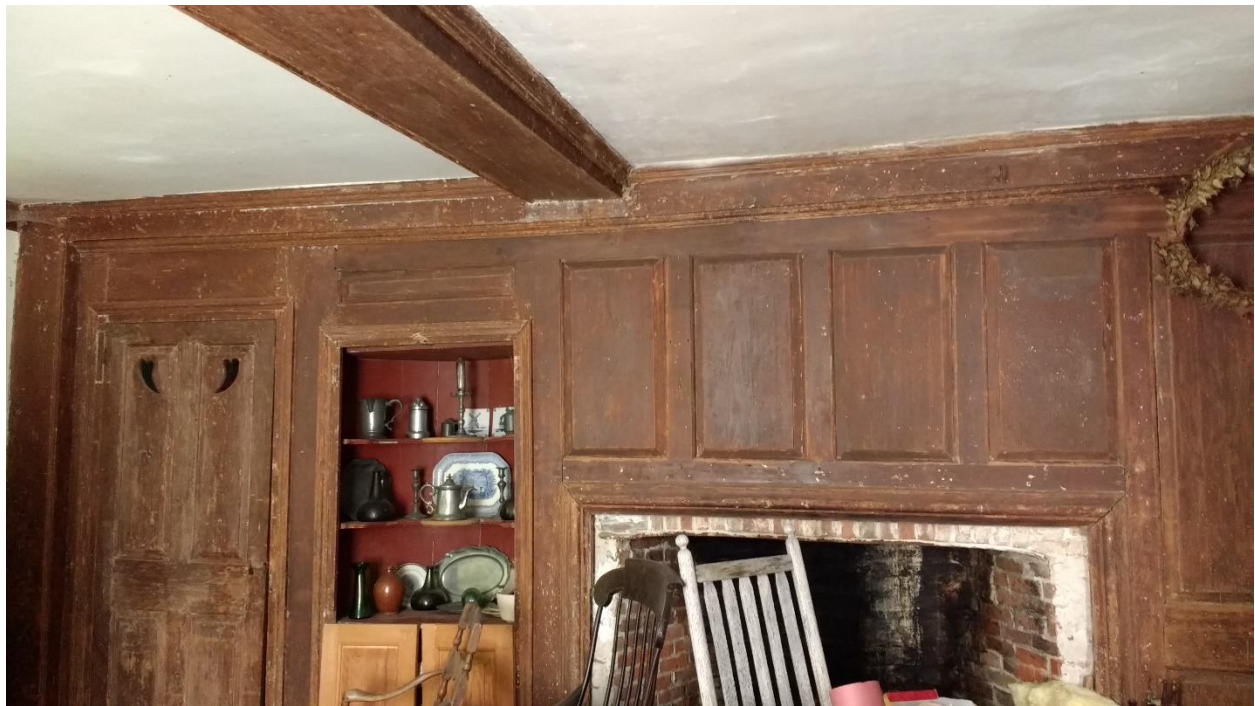
Figure 3.31. Tavern Room, Southeast Front Parlor, Daniel Rose House 1741. (Upper) Photo unlabeled, believed to be Tavern Room beam with breast wall removed to reveal chimney. Photo, July 2004. (Lower) Original wood surfaces of chimney breast wall with raised panels, encased chamfered and beaded summer beam and corner post restored by Bill Phelon. Original wood surfaces, flooring restored. Hearts in shape of powder horns are carved in the door of this home to six Revolutionary War veterans. Artilleryman Abner Rose and his wife Abigail Stebbins Rose were married in her birthplace, Springfield, MA, on February 8, 1781 (intentions published October 28, 1780) during the American Revolution and according to Abigail, “they removed immediately to Granville and lived in the family of his Father.” Camera facing west. August 2017.

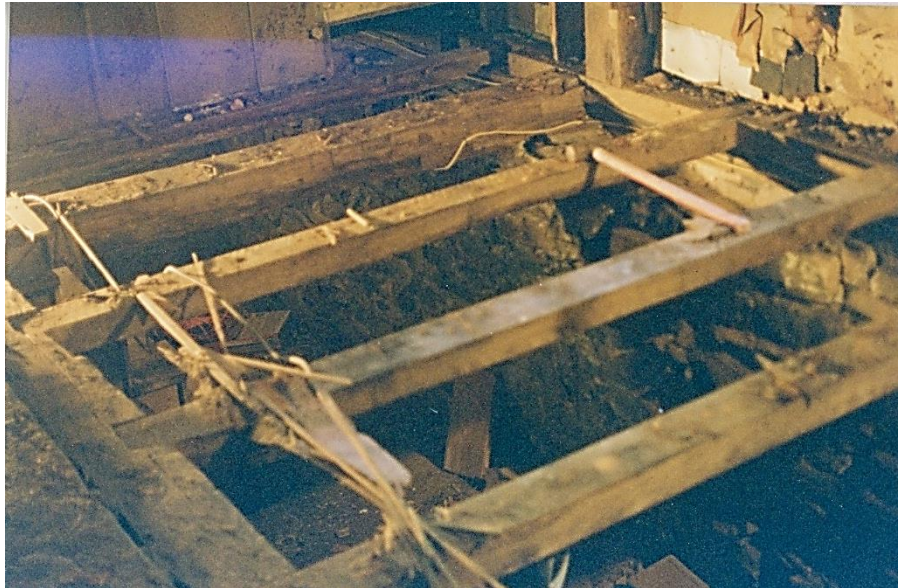
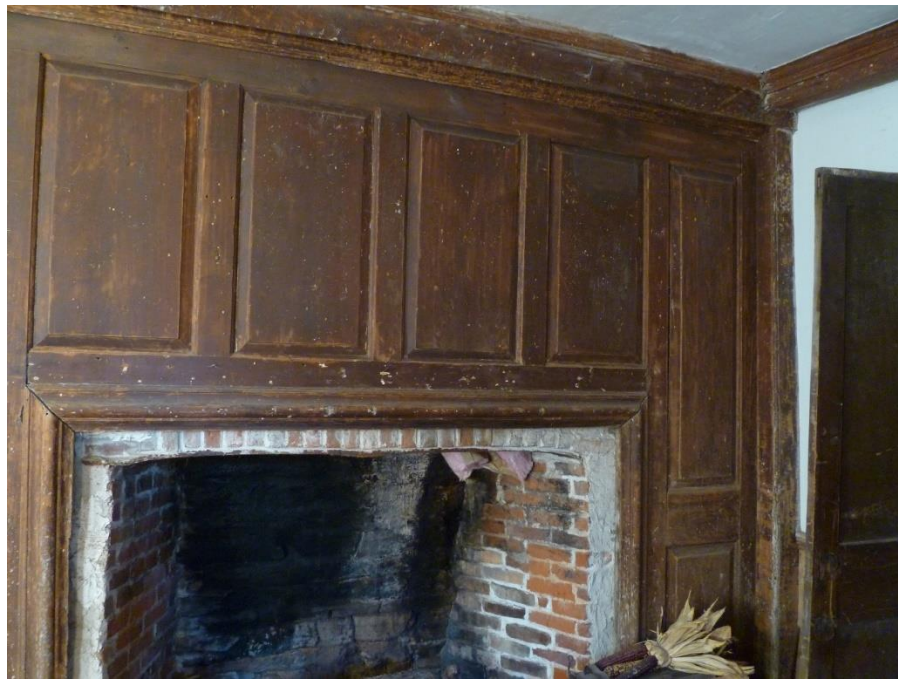
Figure 3.32. Daniel Rose House, 1741. (Upper) Restoration floor stabilization and reconstruction in progress, photograph unlabeled; room unspecified. Photo, 2004. The Legacy Inventory of 1985 noted that in the Southeast Front Parlor, the “Floor has been replaced—original red paint remains under latter layers.” (Lower) Southeast Front Parlor chimney breast wall raised panels with layers of inappropriate paint removed by Bill Phelon. Abner Rose ran a tavern in this room in 1784, and probably before and after. On July 12, 1776 in a prelude to the Battle of Long Island in defense of New York, Abner’s gun battery, at Fort Defiance, went up against the 44-gun *HMS Phoenix*, and the *HMS Rose* (ironically, it bore his surname) and smaller tenders that attacked the American position. The carriage of an overheated gun recoiled faster than expected and rolled over his foot and split the leg to the calf. The injury to Abner’s foot and leg caused lifelong lameness. He described the day in vivid detail in a letter home to his father Daniel Rose: “3 tenders were passing our Battery up the River it Being the first Battery they had to pass & all the guns moved out . . .” See Abner Rose’s letter to Daniel Rose and family at Granville, August 17, 1776 in Phelon Geske, “Main Road 1442, Daniel Rose House, PART 2,” March 2020 in the *Granville History Digital Collection*. Colonel, soon to be Brigadier General Henry Knox also wrote to his wife of the artillerymen wounded and killed that day – their number included Abner Rose who, although lamed, would recuperate and continue to serve.

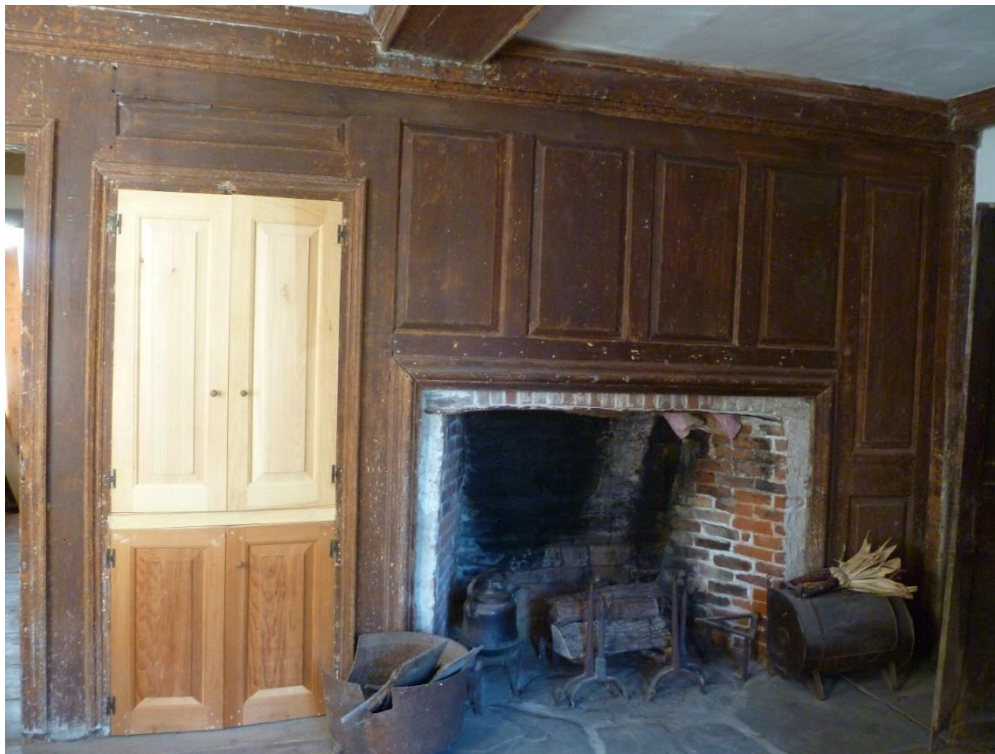
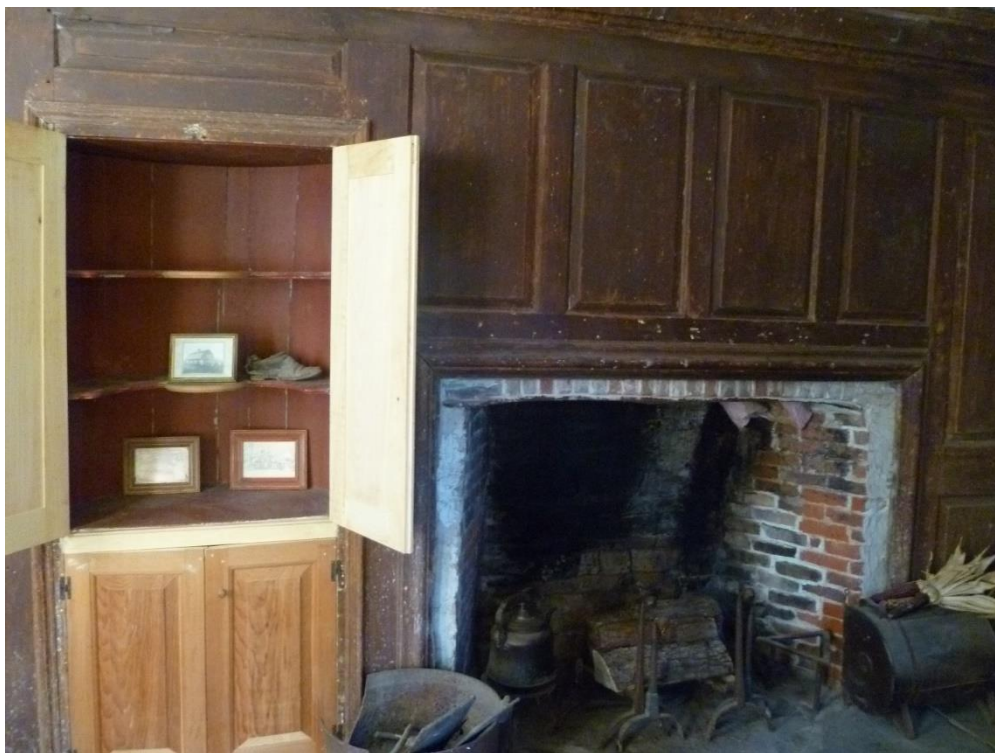
Figure 3.33. Southeast Front Parlor and Tavern Room, wood floor, summer beam, and chimney breast wall with raised panels was restored with old layers of paint removed by Bill Phelon. Cupboard doors were reconstructed, with old hinge marks still extant for proportion. Front hall is through door to the left (upper photo). The Legacy Inventory of 1985 documented the “floor to ceiling wall cupboard with scalloped shelves on upper half.” Camera facing west. Photos, September 2019.

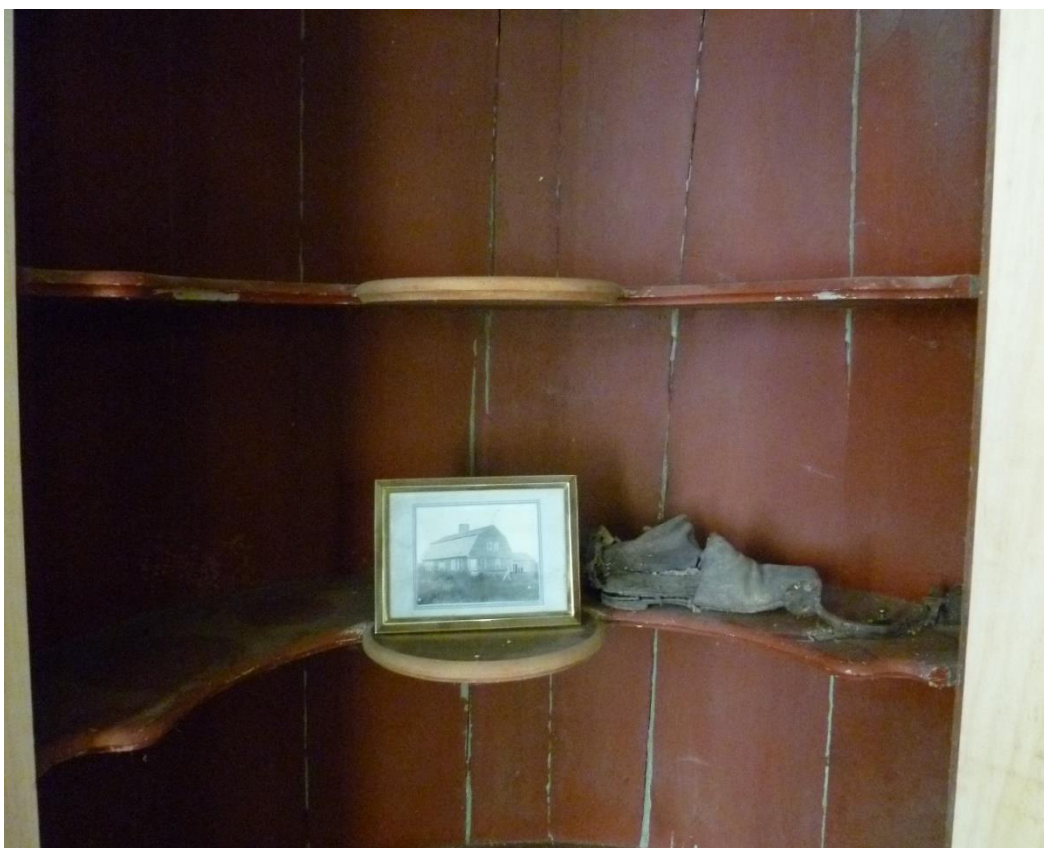
Figure 3.34. Southeast Front Parlor and Tavern Room, Daniel Rose House, restored cupboard in chimney breast wall. Camera facing west. Photo, September 2019.

The shoe in this cupboard was discovered in a wall by Bill Phelon during restoration. The unpainted scallops of the shelves (one, supporting the photograph of the Daniel Rose House) were carefully reconstructed to the original shape and detailed edge (see upper scallop). The photograph in the cupboard appears to be the ca. 1912 image that is seen in the MACRIS file, “Main Road, 1442, Rose, Baldwin, *Baker... Phelon Place*, PART 1, in the *Granville History Digital Collection* of the Granville Public Library Historical Room.

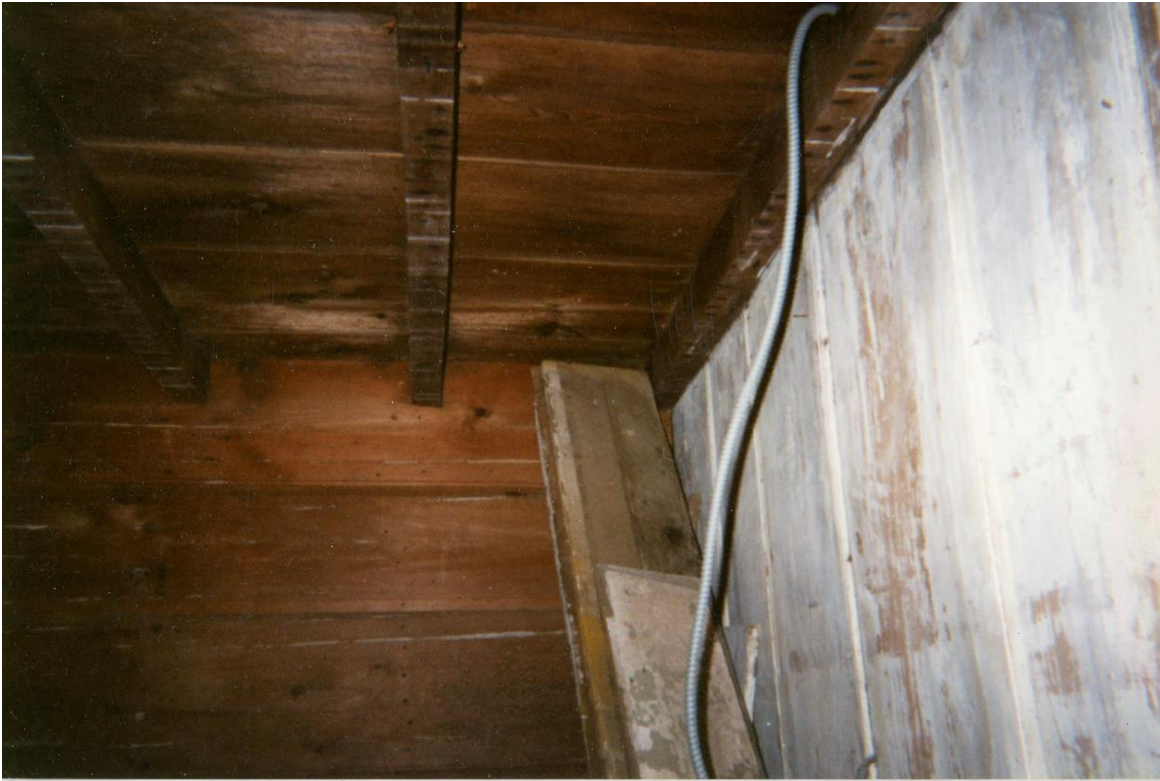
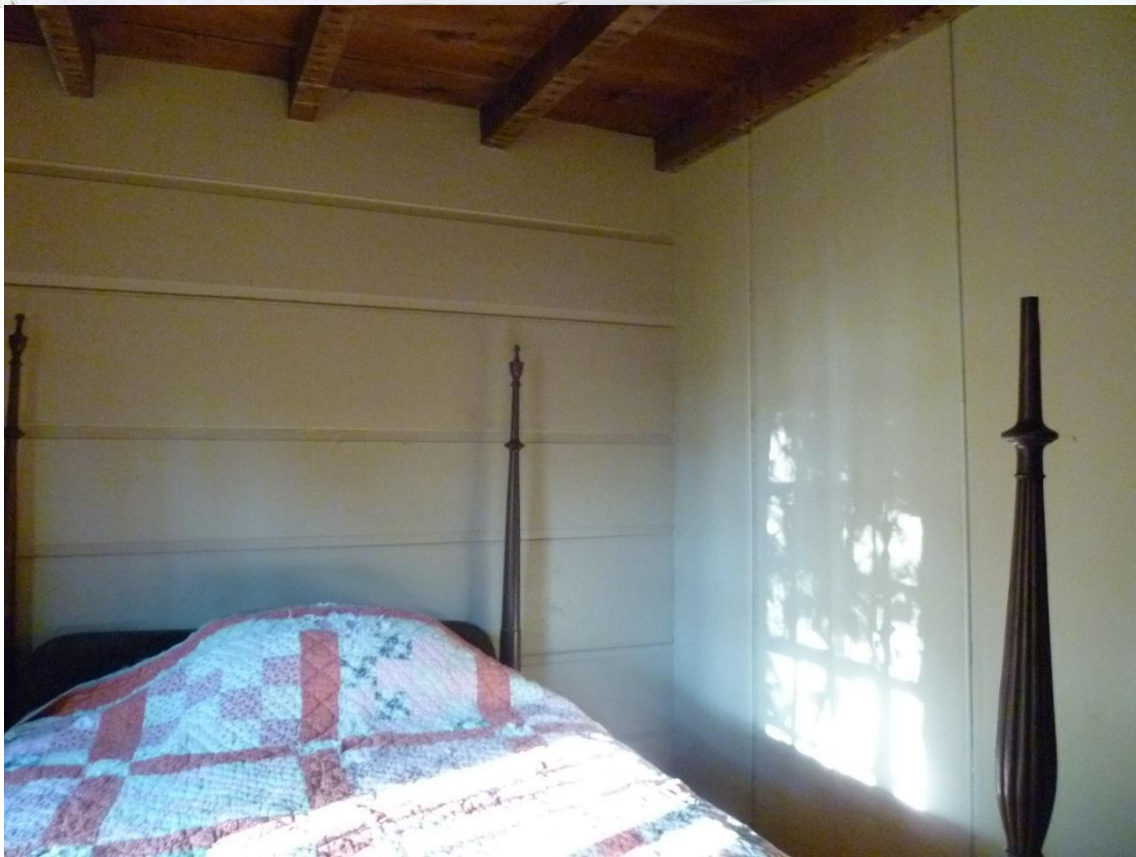
Figure 3.35. Borning Room located west off the Keeping Room. Horizontal (north wall to left and vertical (east wall to right) feather edge pine sheathing and smooth planed sub flooring visible overhead, as mentioned in the 2003 Curtis report at the Granville Public Library Historical Room. (Upper) Photo during restoration, 2004. Camera facing northeast. (Lower) Photo, September 2019.

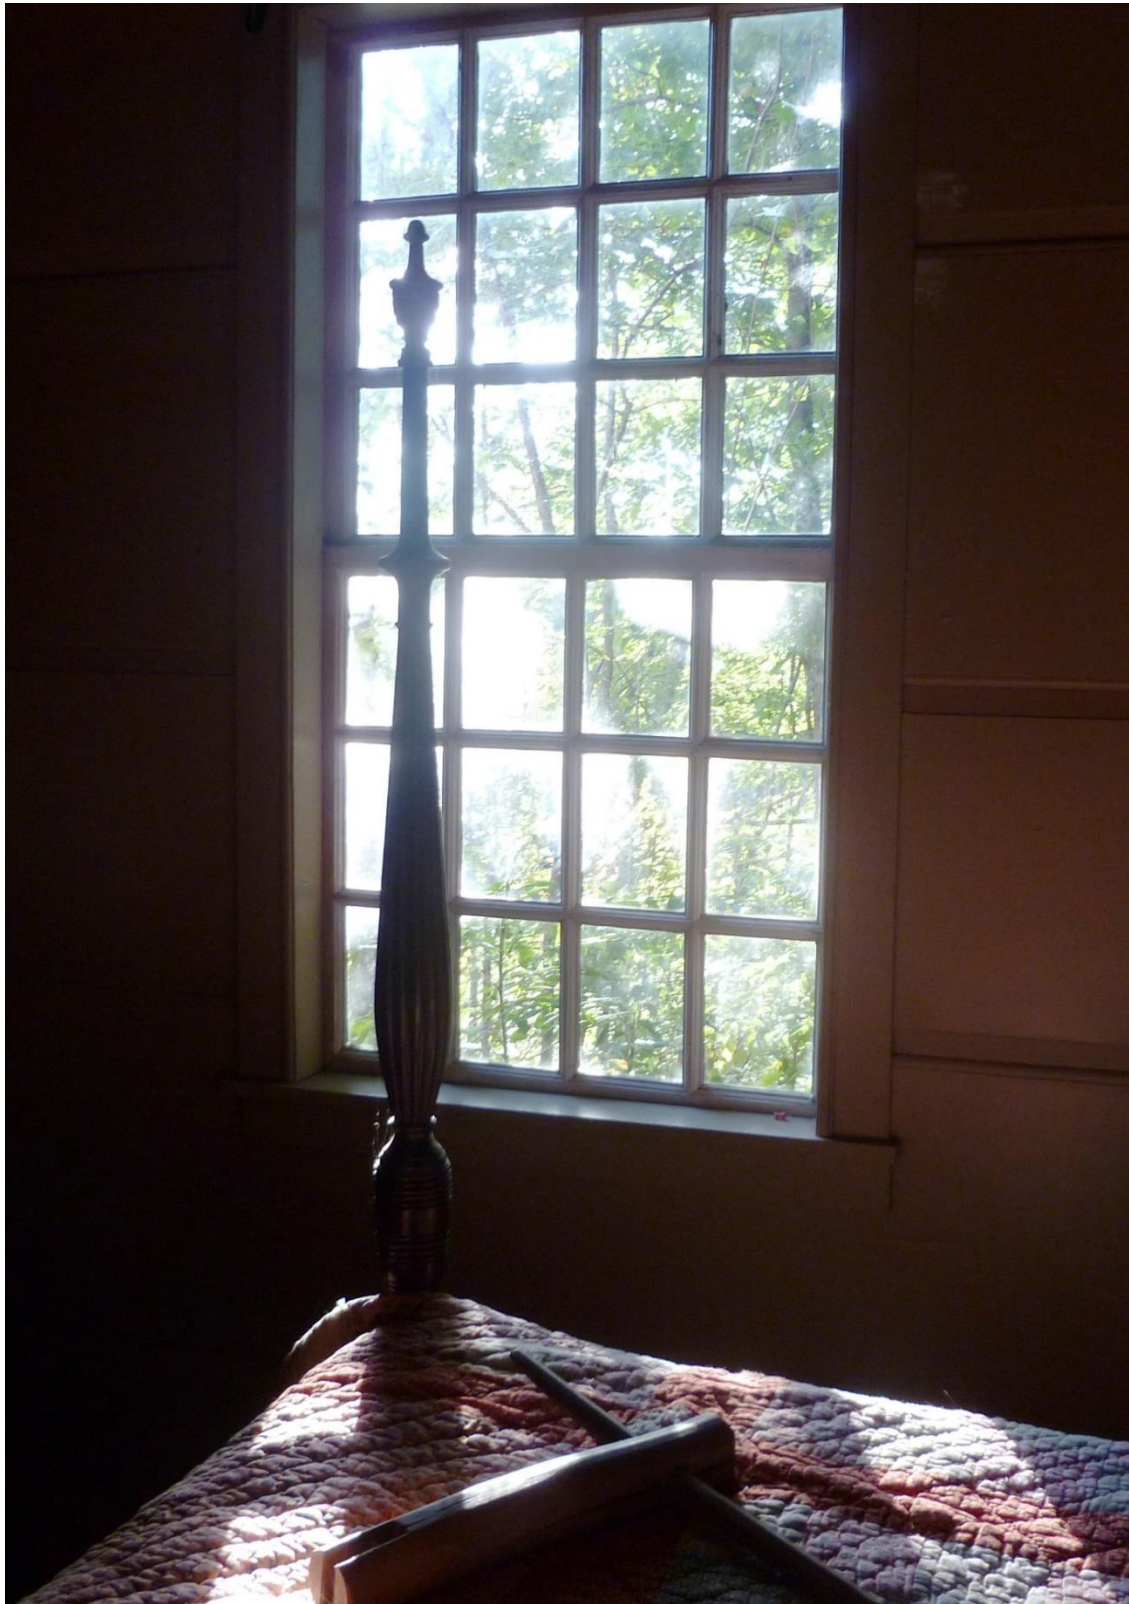
Figure 3.36. Borning Room located west, off the Keeping Room. Leona Clifford of Granville related a story that for one childbirth in the David Rose family, no candles were lit that night when the new baby arrived due to fear of Indian attack. The story could have pertained to Elizabeth Rose's sister-in-law Achsah, wife of Daniel. This window's view is from the western slope of Prospect Mountain and a light could be seen by a distant enemy. Camera facing southwest. The Borning Room is above the west cellar wall with ports for gun mounts; an eight-pound cannon ball was found by a neighbor at the foot of the hill. Photo, September 2019. On story of childbirth, see File #1646, Leona A. Clifford, "Long Ago Days," (Part 4 of 4), February 1986, *Granville History Digital Collection*.

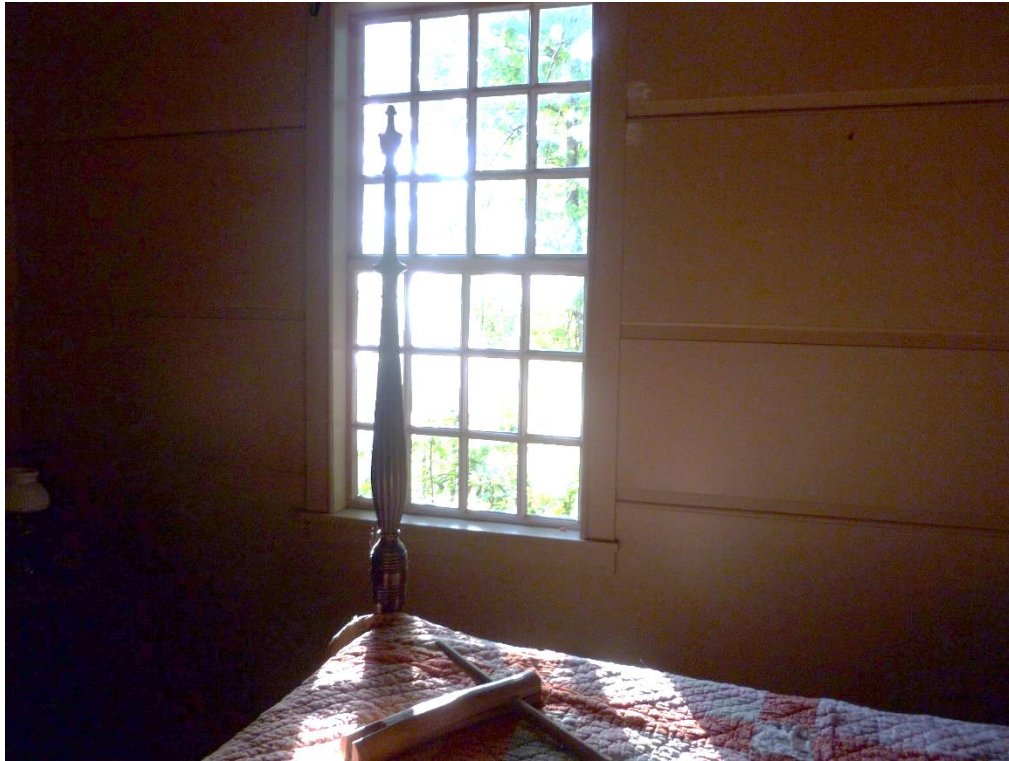
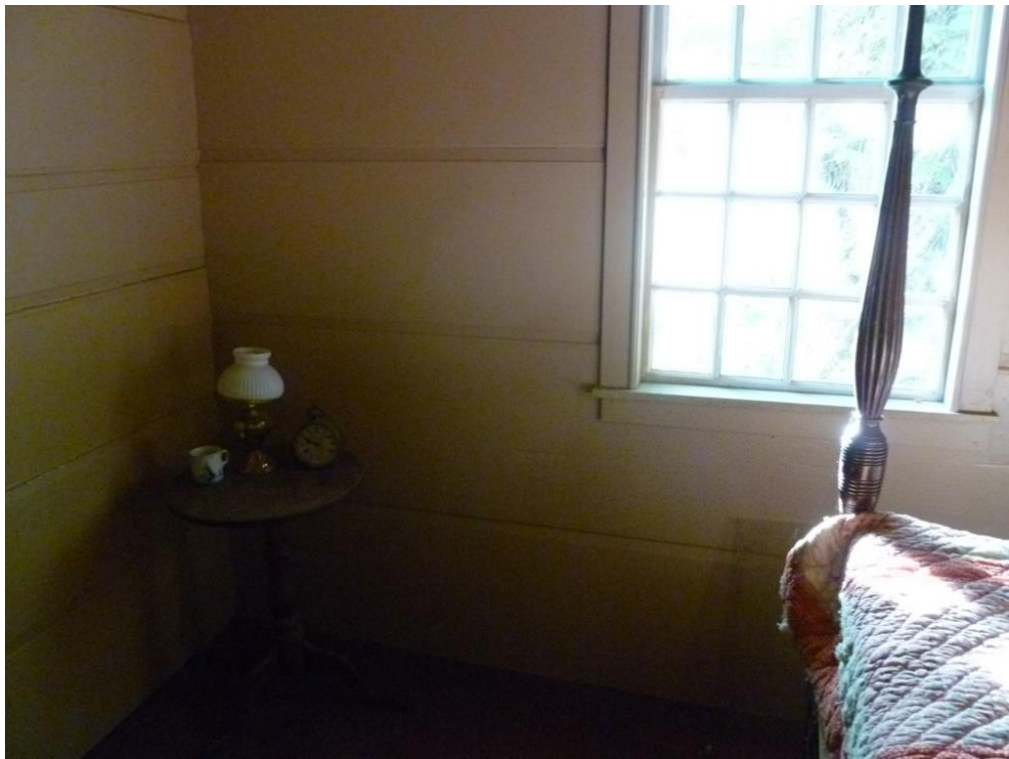
Figure 3.37. Achsah, known as ‘Achsy’ Rose gave birth to eleven children, seven born during the French and Indian Wars, in this Boring Room located west, off the Keeping Room. Horizontal pine sheathing on three walls, seen here (Upper) on west wall and (Lower) at southwest corner walls. The horizontal feather edge pine sheathing that was unpainted in 1985, required extensive restoration and painting. According to the Legacy Inventory of 1985, the original flooring remains. Photos, Sept. 2019. The quilt tradition in this room dates to the Olive Curtiss Baker quilt made in Granville in 1798; it was owned in this house by Olive’s son, Francis Graves Baker and given by his daughter, Laura who grew up in this house, to the Pocumtuck Valley Memorial Association before 1886 when the quilt was exhibited in Deerfield at Memorial Hall Museum where it is now.

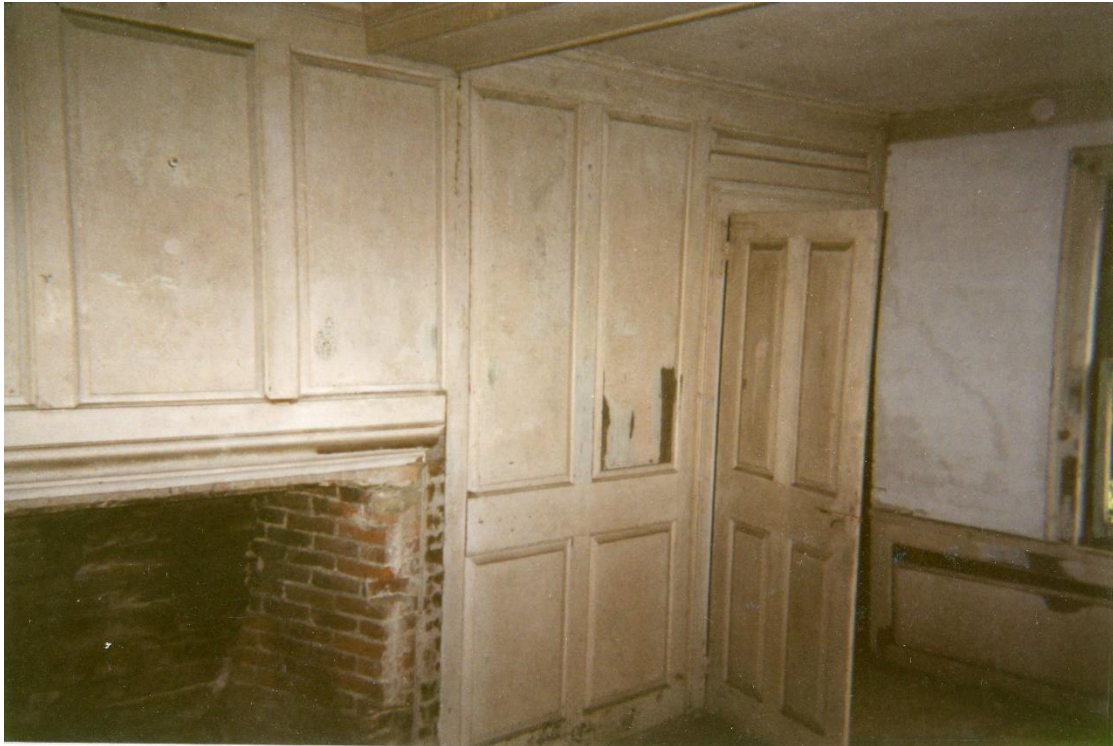
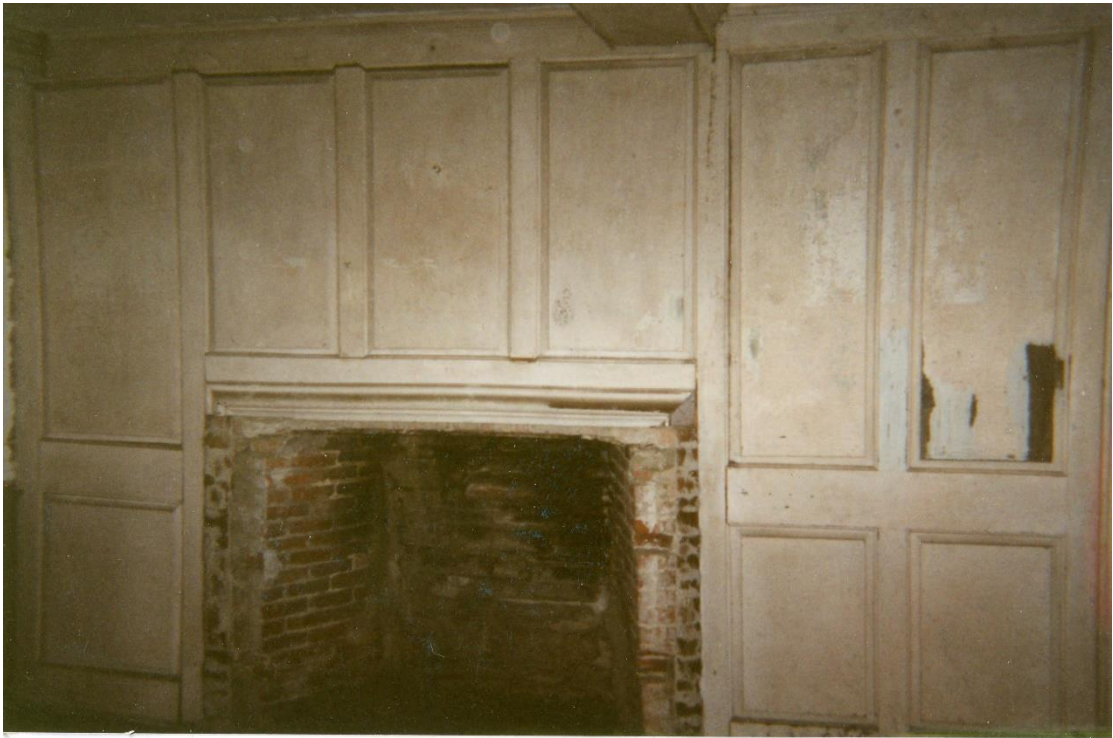
Figure 3.38. Southwest Front Parlor, Daniel Rose House. Color analysis on one panel to the right indicated original green paint, as also found in the front hallway (Fig. 3.41). This paint color is reminiscent of the green dyed wool quilt (now at Historic Deerfield, MA) made by Olive Curtiss Baker in 1798 and owned by her son Francis G. Baker at this house before, during and after the Civil War – the quilt inspired the Deerfield Arts and Crafts Movement. According to Legacy Inventory, 1985, the “Parlor Fireplace breast wall is field with bolection molding around fireplace opening. Perimeter is covered with wood panel dado plaster above. Ceiling beams, summer beams and corner post are cased and molded. Floors are wide pine boards original.” (Upper) Camera facing southeast. (Lower) Camera facing east, 2004.

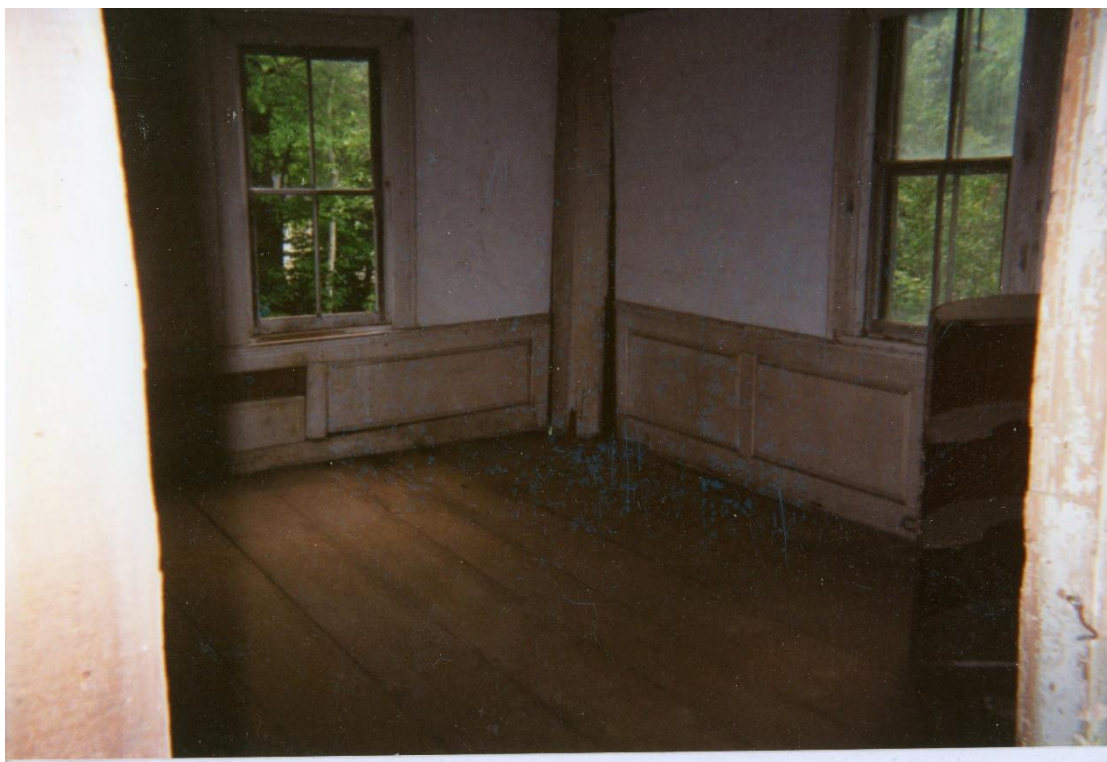
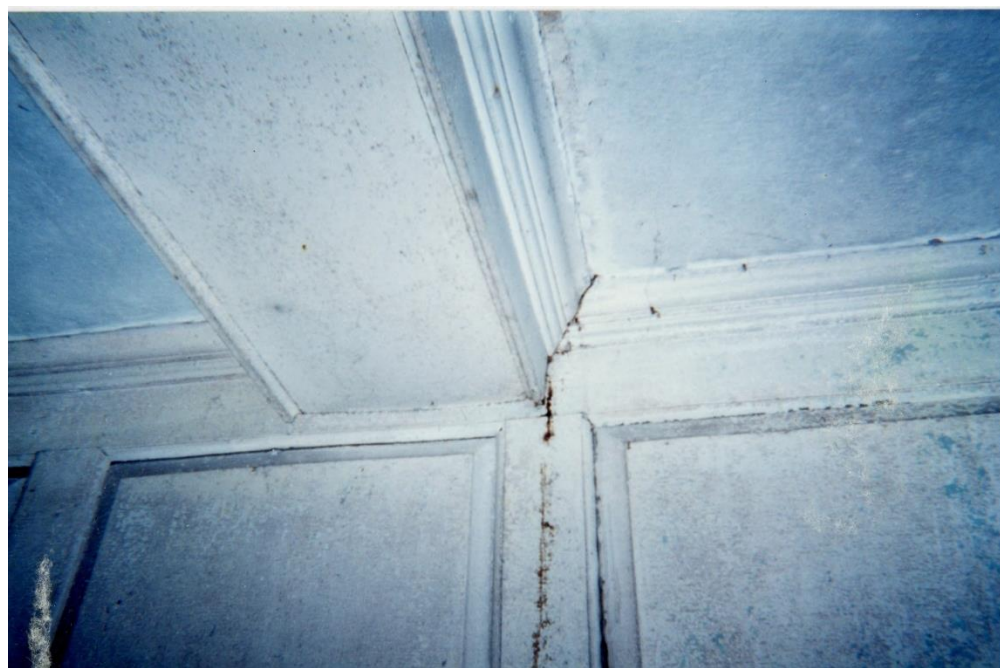
Figure 3.39. Pre-restoration Southwest Front Parlor, Daniel Rose House. According to the Legacy Inventory, 1985, the “Perimeter is covered with wood panel dado plaster above. Ceiling beams, summer beams and corner post are cased and molded. Floors are wide pine boards original.” This was originally the room allocated for Denizen Baldwin in the court settlement of his father Lt. Jacob Baldwin’s estate in 1813. Denizen served as a U.S. Navy Master’s Mate in the War of 1812 aboard the victorious *USS Peacock*, which defeated *HMS Epervier* and by his action merited a Congressional presentation sword in 1814, considered one of the finest known. (Upper) Camera facing southwest, 2004. (Lower) Summer beam above fireplace breast wall: notice same crack and cream color paint (photo development blue color is inaccurate) in previous photos. Color analysis indicated original green paint on woodwork, as also found in the front hallway. Camera facing east, 2004.
