Daniel Rose House Restoration by William Brian “Bill” Phelon 2004-2019;  
Text and Photos Compiled by Corey Phelon Geske, 2020.

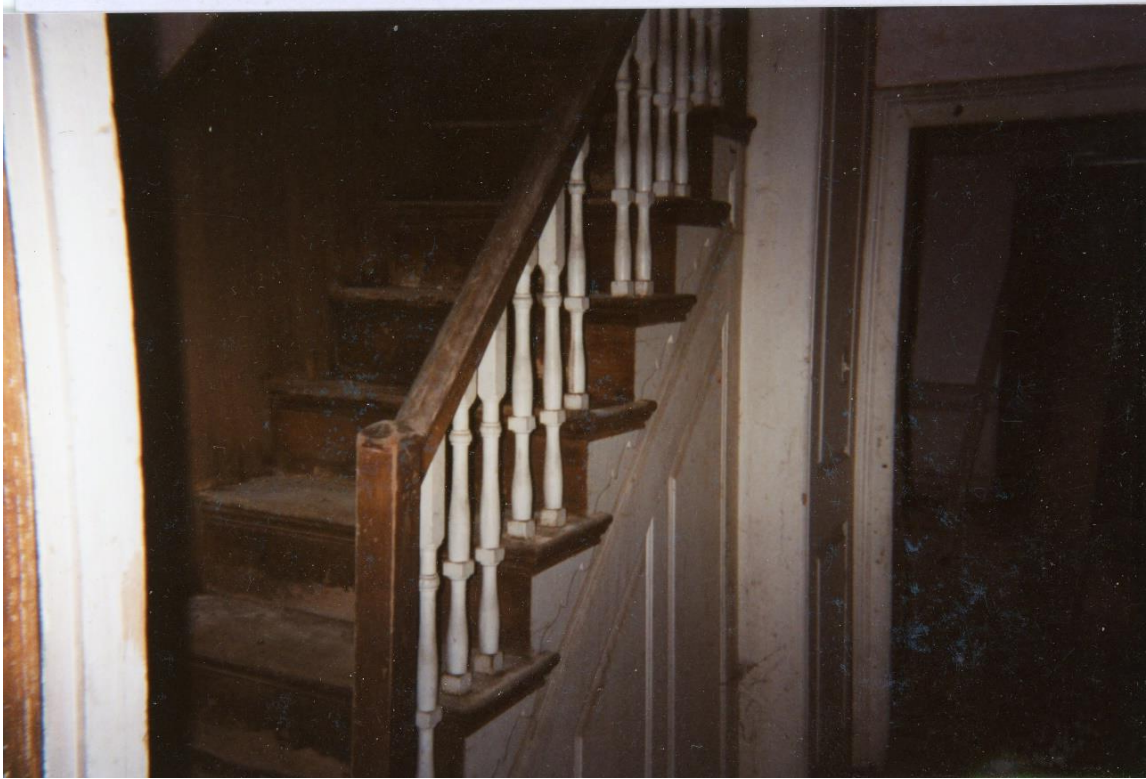
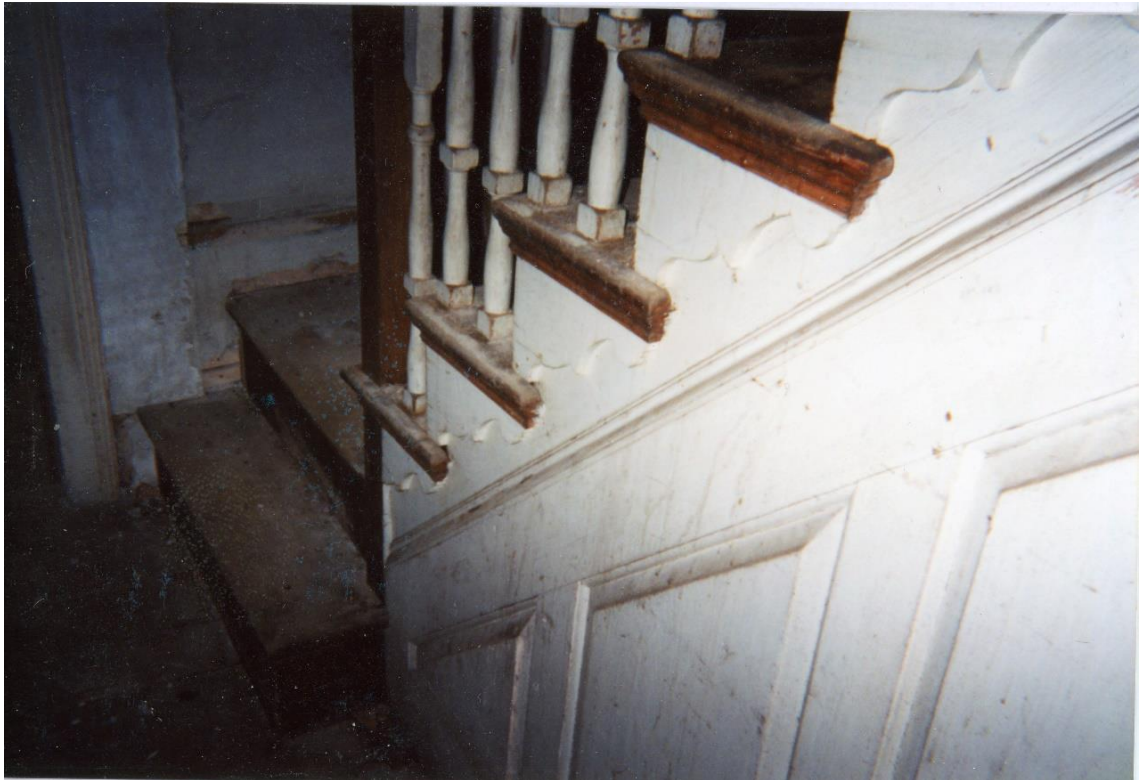
**Figure 3.40.** Pre-restoration, Daniel Rose House Front Hall “balustrade single landing staircase” as described in the 1985 Legacy Inventory, “with raised panels, turned rails and details along stair treads.” Paint analysis revealed green paint color on dado that was also originally used in the Front Southwest Parlor. (Upper) Camera facing east; (Lower) camera facing northwest with doorway to Front Southwest Parlor. Photos by William Brian “Bill” Phelon, ca. July 2004.

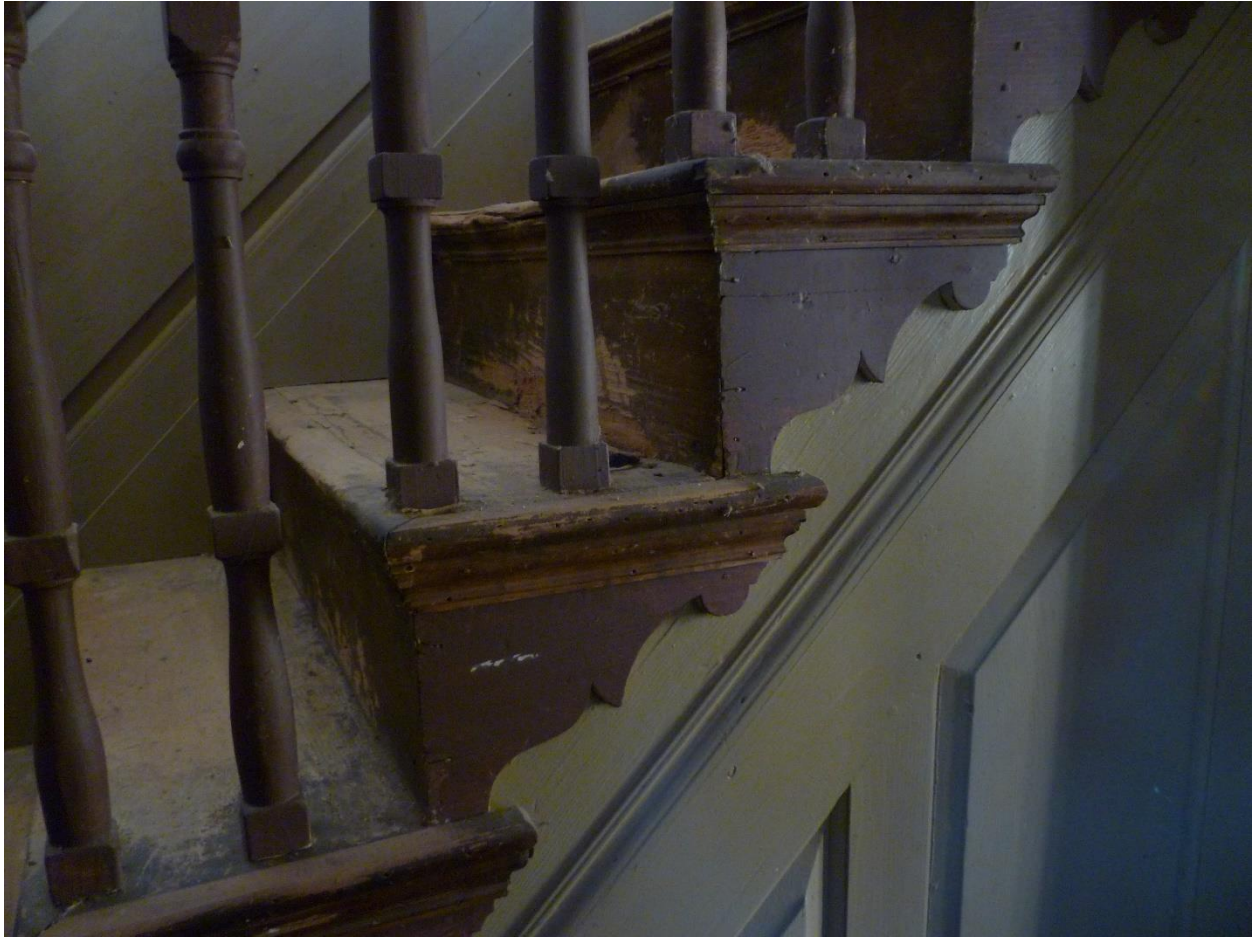
**Figure 3.41.** Daniel Rose House front hall “balustrade single landing staircase.” Layers of later paint removed from the rails, step details and dado; green paint color, also found in analysis of the Front Southwest Parlor, restored by Bill Phelon. Missing paneling and rail on fourth step, reconstructed and fitted to original locations. Camera facing north. Photo, September 2019.

This green paint color analyzed in the Southwest Front Parlor (Fig. 3.38), is reminiscent of the green dyed wool quilt with “elaborate patterns” (now at Historic Deerfield, MA) made in 1798 by Olive Curtiss Baker, wife of Rev. Joel Baker pastor for thirty-six years of the Second Church of Christ Congregational. Olive’s quilt was owned by her son Francis G. Baker at this house before, during and after the Civil War. Francis’ daughter Laura, who grew up in the Daniel Rose House, gave her grandmother’s quilt to the Pocumtuck Valley Memorial Association before 1886 when it was exhibited in the PVMA’s Memorial Hall Museum that year, in the first museum installation of a period bedroom in the United States. The Baker quilt inspired the Deerfield Arts and Crafts Movement in 1896 and is now owned by the Pocumtuck Valley Memorial Association at Old Deerfield.

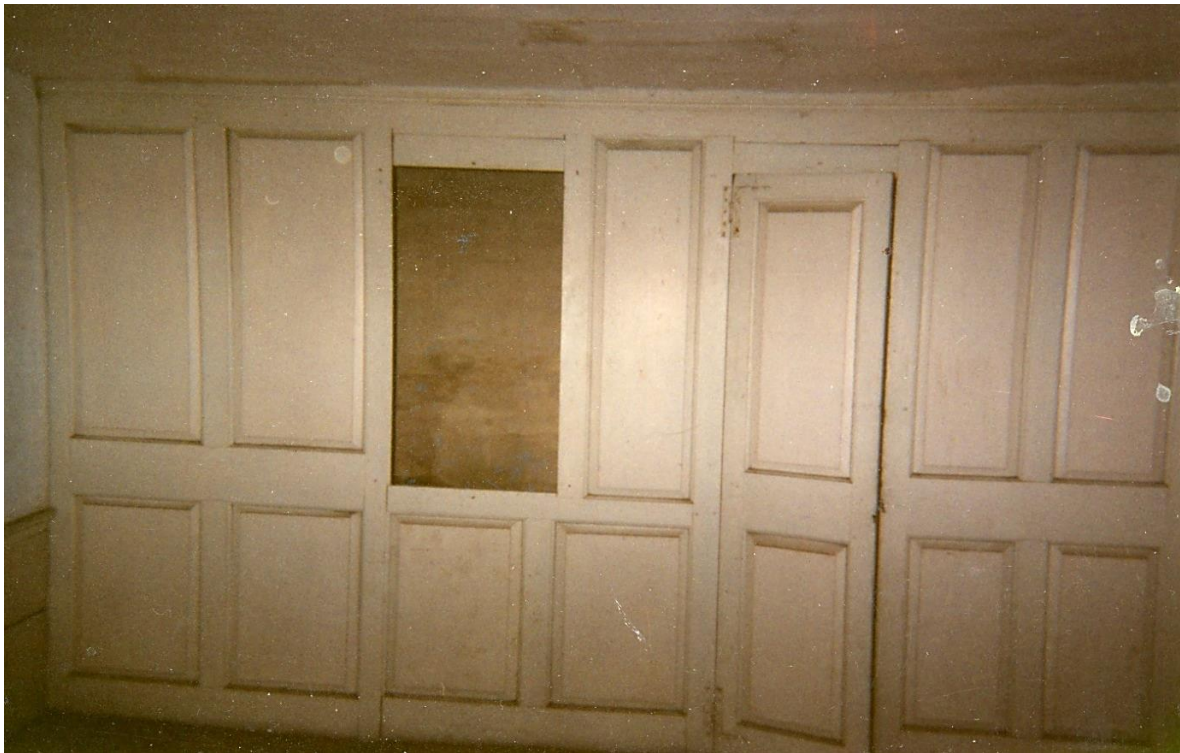
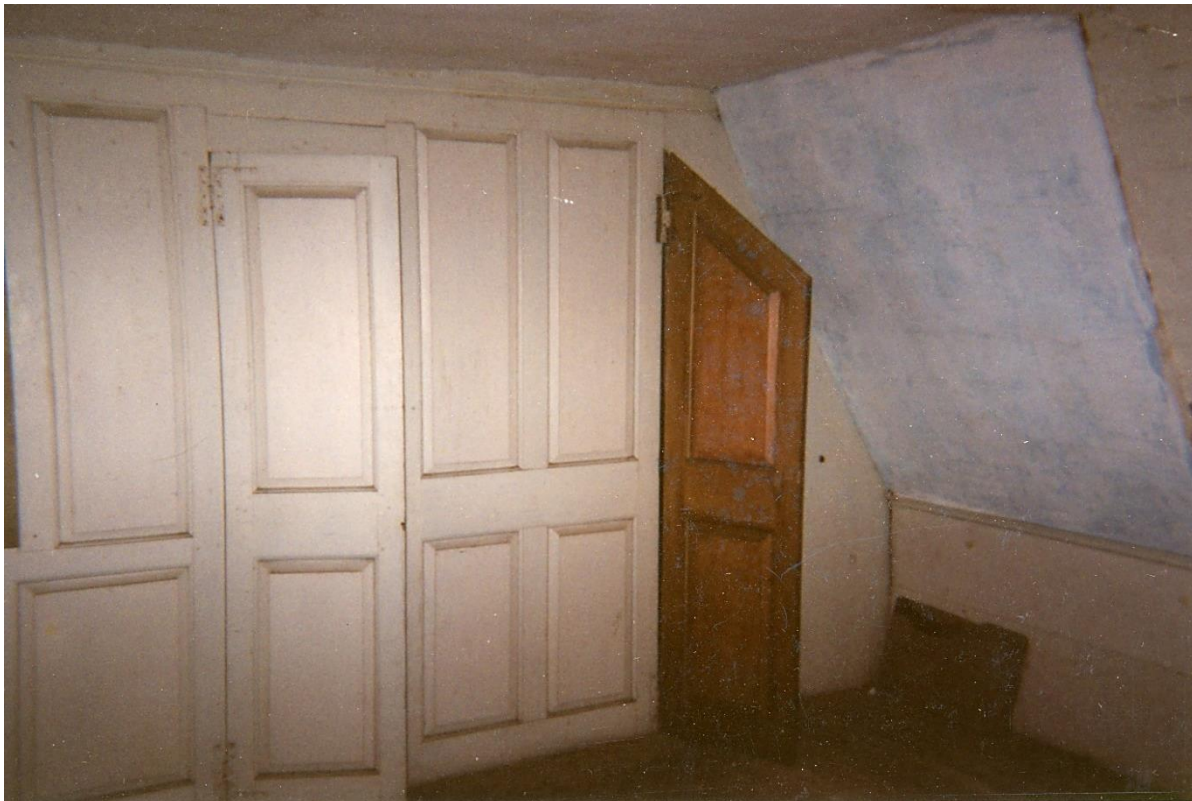
**Figure 3.42.** Daniel Rose House, Upstairs Southwest Bedchamber. According to the Legacy Inventory, 1985, the breast wall has “field raised panels.” (Upper) Breast wall, east. Camera facing east. (Lower) East Breast wall continued and south east front (gambrel) wall. Camera facing southeast. Painted panel door partially open to the left, accesses chimney stonework; natural wood color panel door to right accesses front stair landing. Photos, ca. July 2004.

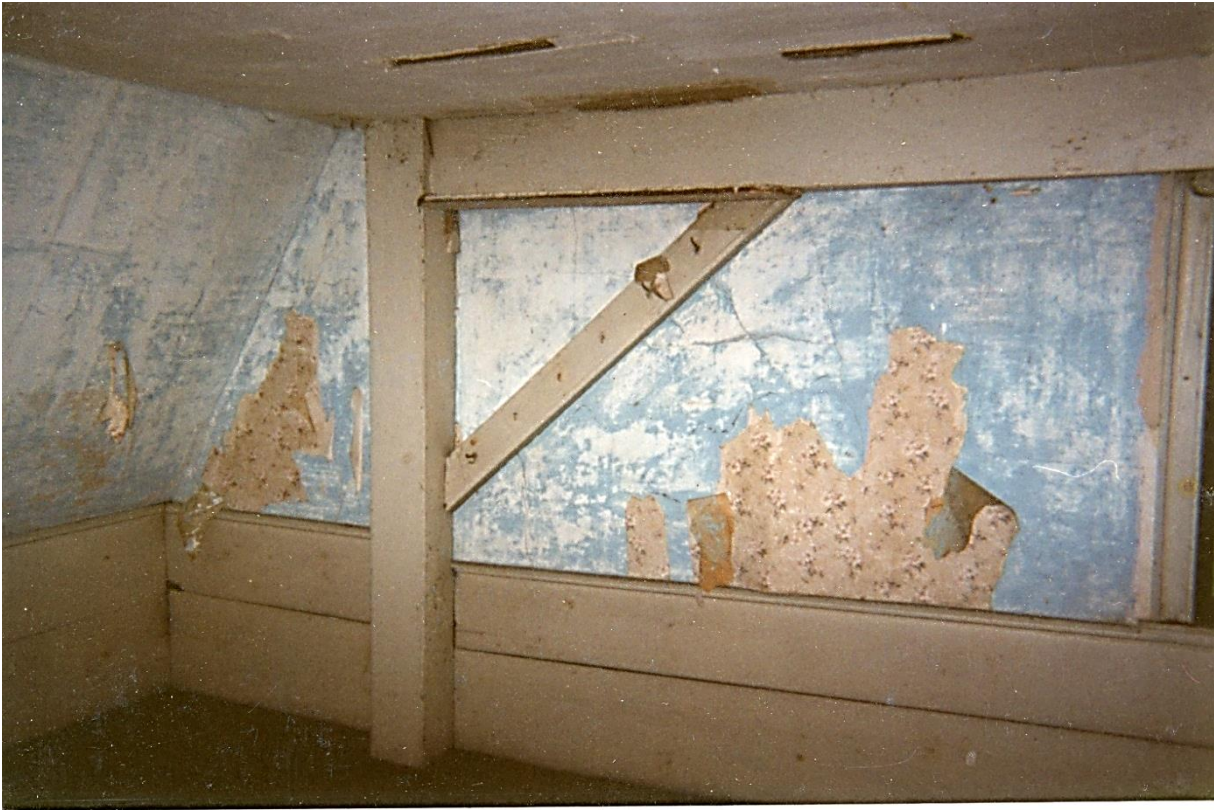
**Figure 3.43.** Daniel Rose House, 1741: Upstairs Southwest Bedchamber. (Upper) Southwest portion of front (gambrel) wall (left) and west wall (right) with two board dado and part of casing for 12/8 window facing west (seen in photo to right). Original wide white pine floors. Camera facing southwest. Wallpaper removal appears to have revealed blue paint on plaster. Photo, ca. July 2004. (Right) West wall with closet added to above area. Photo, September 2019. (Below) East wall of Bedchamber with shelved closet; and southeast portion of front gambrel wall -- see previous condition in Fig. 3.42. Photo, September 2019.

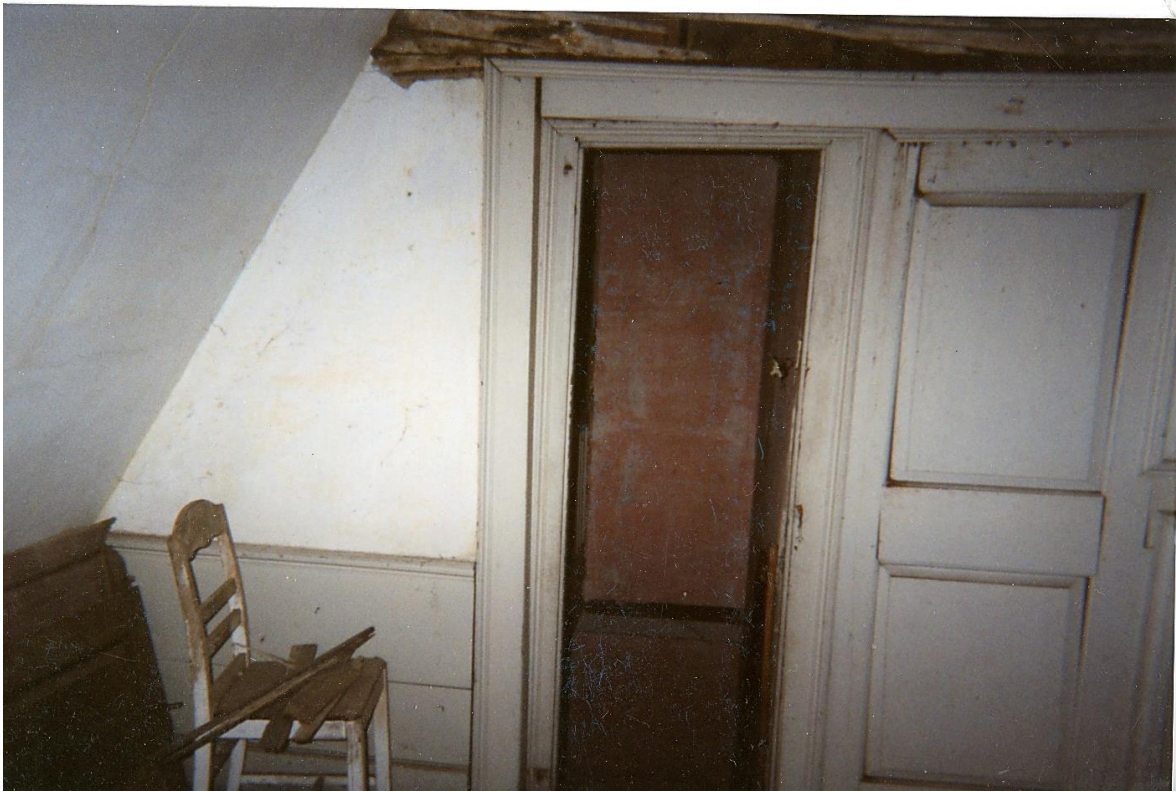
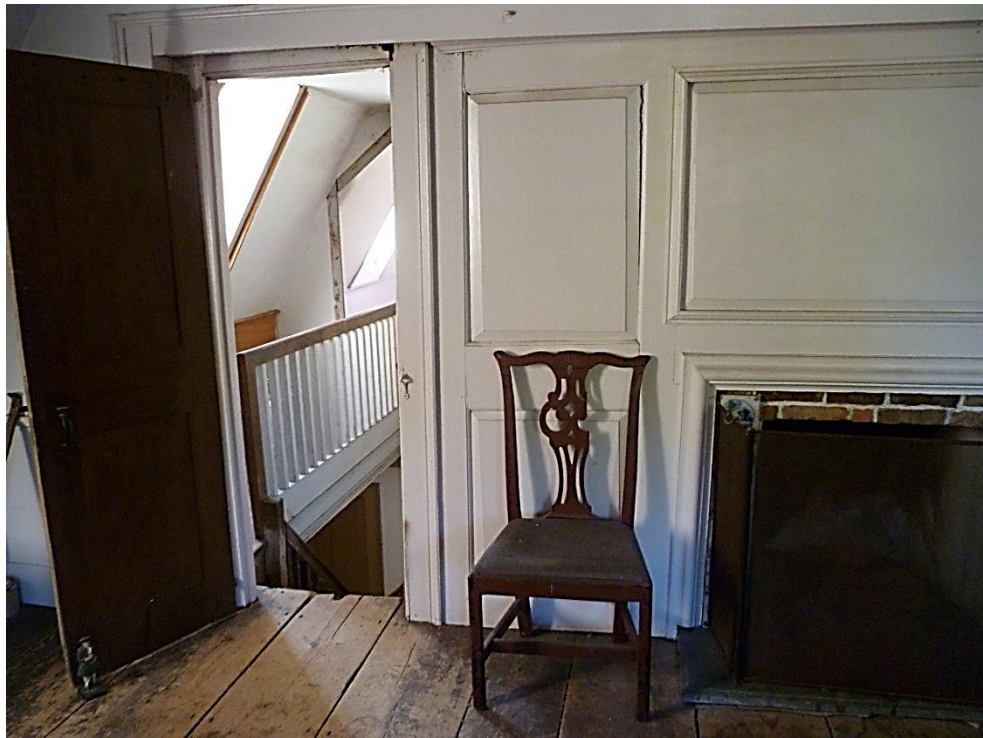
**Figure 3.44.** Front Southeast Bedchamber and Ballroom, second floor. (Upper) Sealed doorway in process of removal (see crowbar on chair) is first revealed here during restoration of chimney breast wall with fielded panels. The door to the upstairs hall landing and front stair entrance hall may have been sealed before or ca. 1813 when Lt. Jacob Baldwin's estate settlement apportioned the east half of the house (including the Ballroom) to his oldest son Heman and the west side to second oldest son Denizen. Cameras facing west. (Upper) Photo by Bill Phelon, ca. July 2004. (Lower) Photo, September 2019.

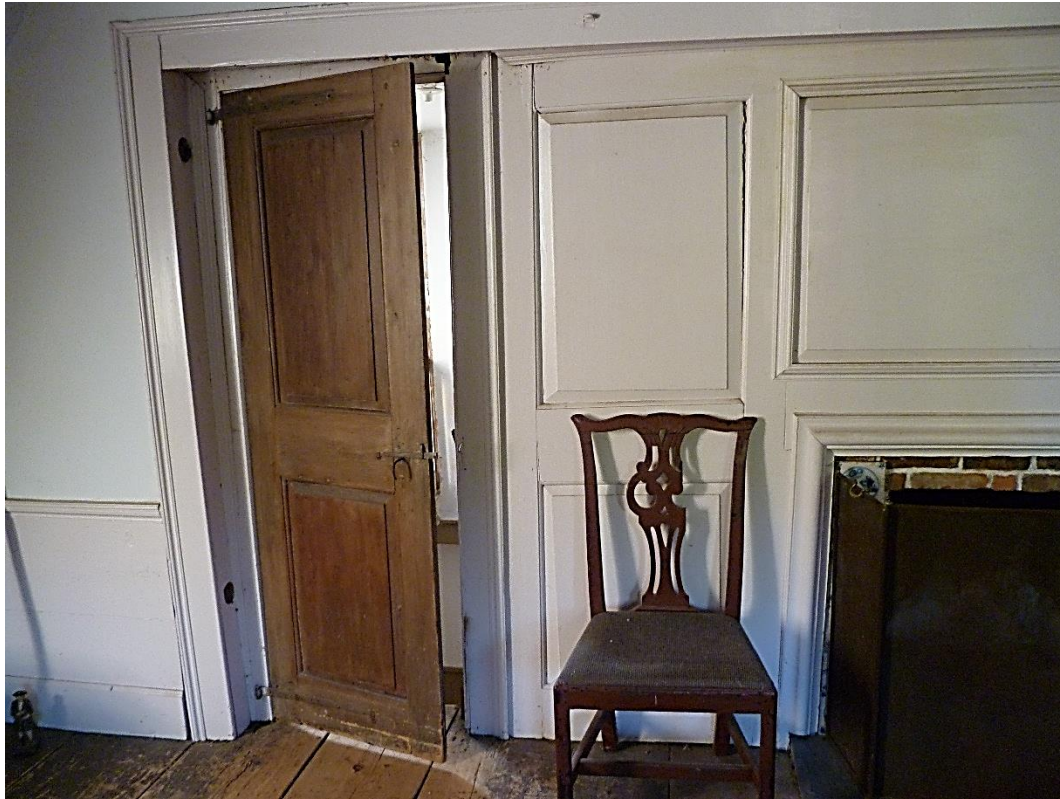
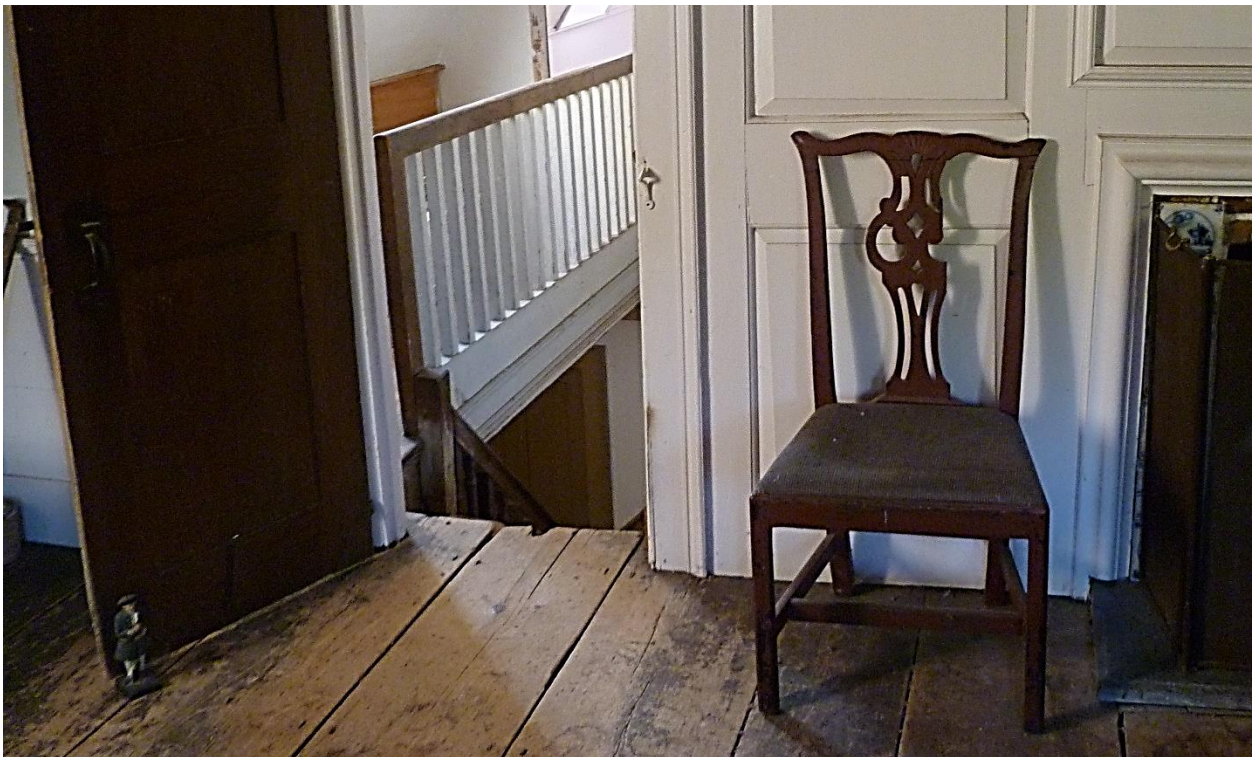
**Figure 3.45.** Front Southeast Bedchamber and Ballroom, second floor, Daniel Rose House, 1741. Sealed doorway opened to main stair landing and front entrance hall. There are now doors to left and right of the fireplace; chimney breast wall with fielded panels. Original pine floor, according to Legacy Inventory of 1985. Camera facing west. Photos, September 2019.

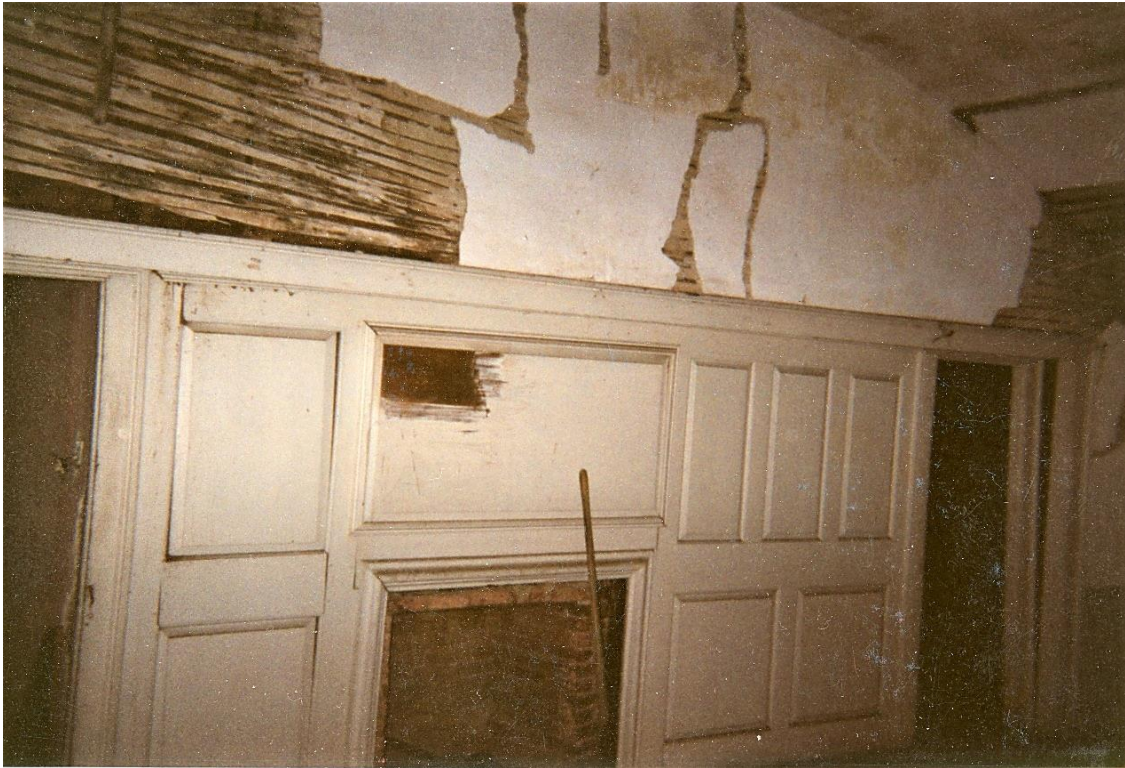
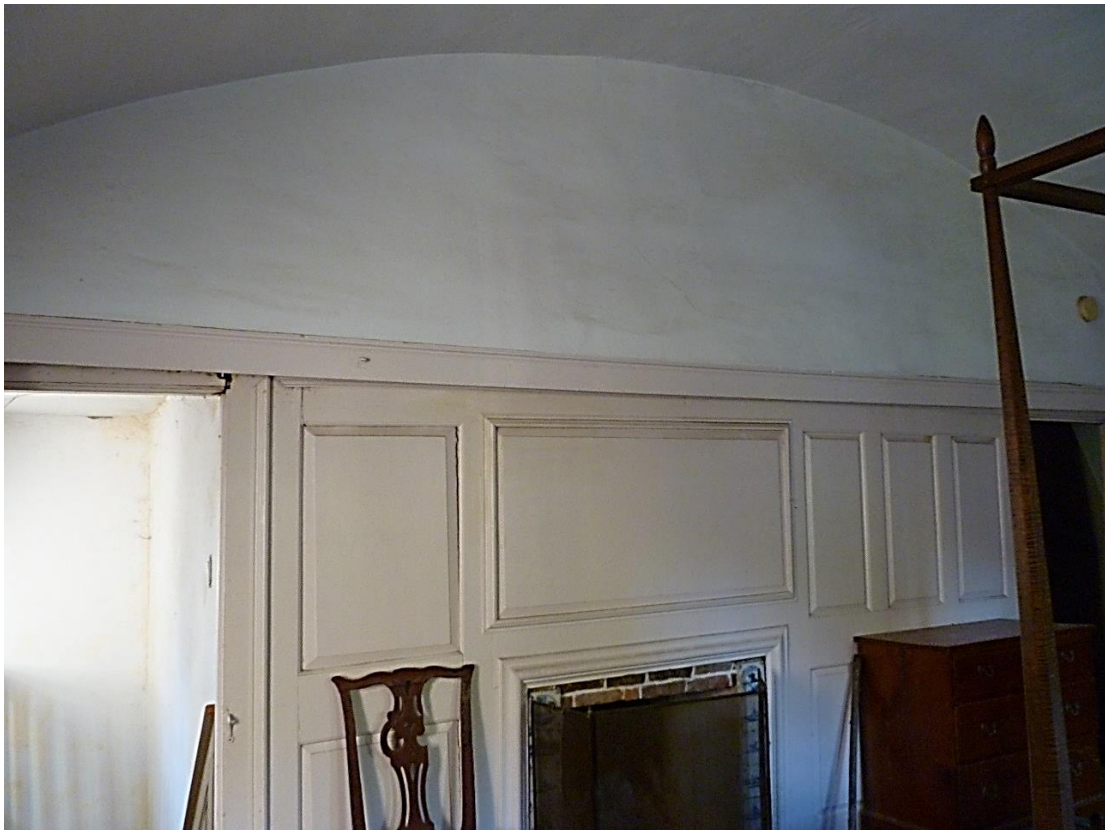
**Figure 3.46.** Ballroom, west breast wall, second-floor barrel vaulted ceiling rising to a height of twelve feet and evidencing blue paint pigment found in fallen ceiling plaster. Daniel Rose House 1741. Cameras facing northwest. Previously sealed doorway is to the left, to main stair landing and front entrance hall. (Upper) Photo, ca. July 2004. (Lower) Restoration by Bill Phelon. Photo, September 2019.

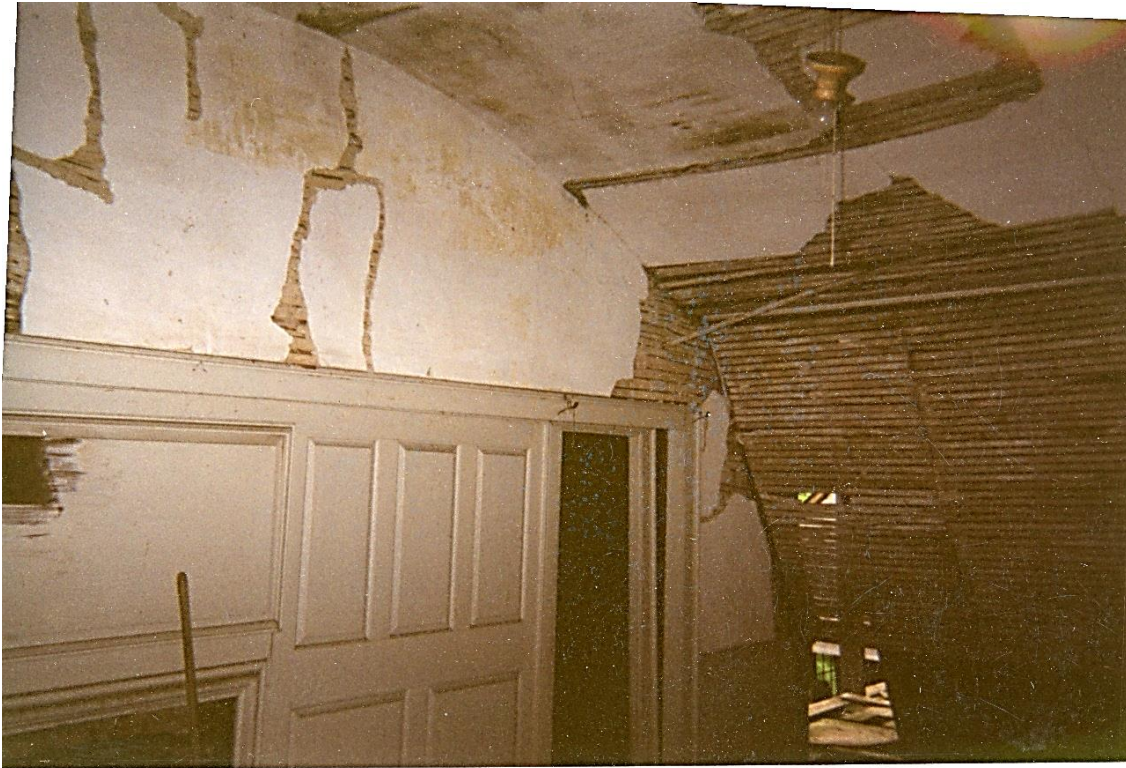
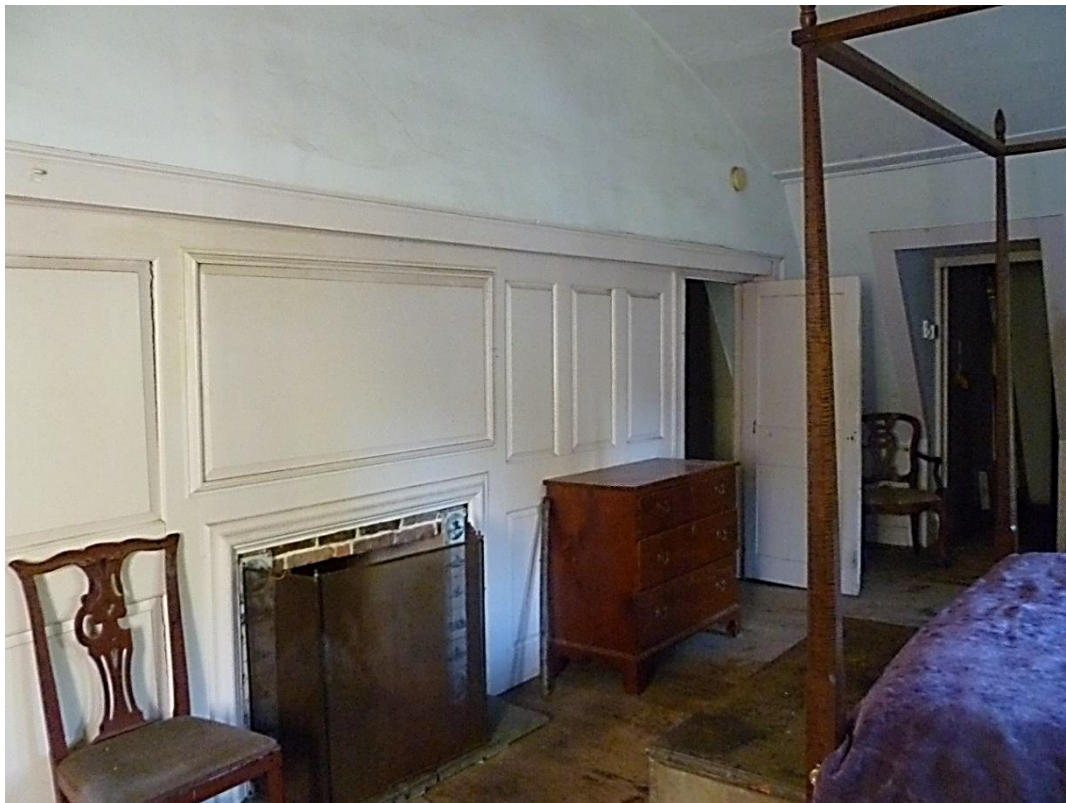
**Figure 3.47.** Ballroom, west breast wall and north gambrel wall with daylight evident during roof reconstruction and lathe in repair. Second-floor barrel vaulted ceiling rises to a height of twelve feet. Cameras facing northwest. (Upper) Photo, ca. July 2004. (Lower) Restoration by Bill Phelon. Photo, September 2019.

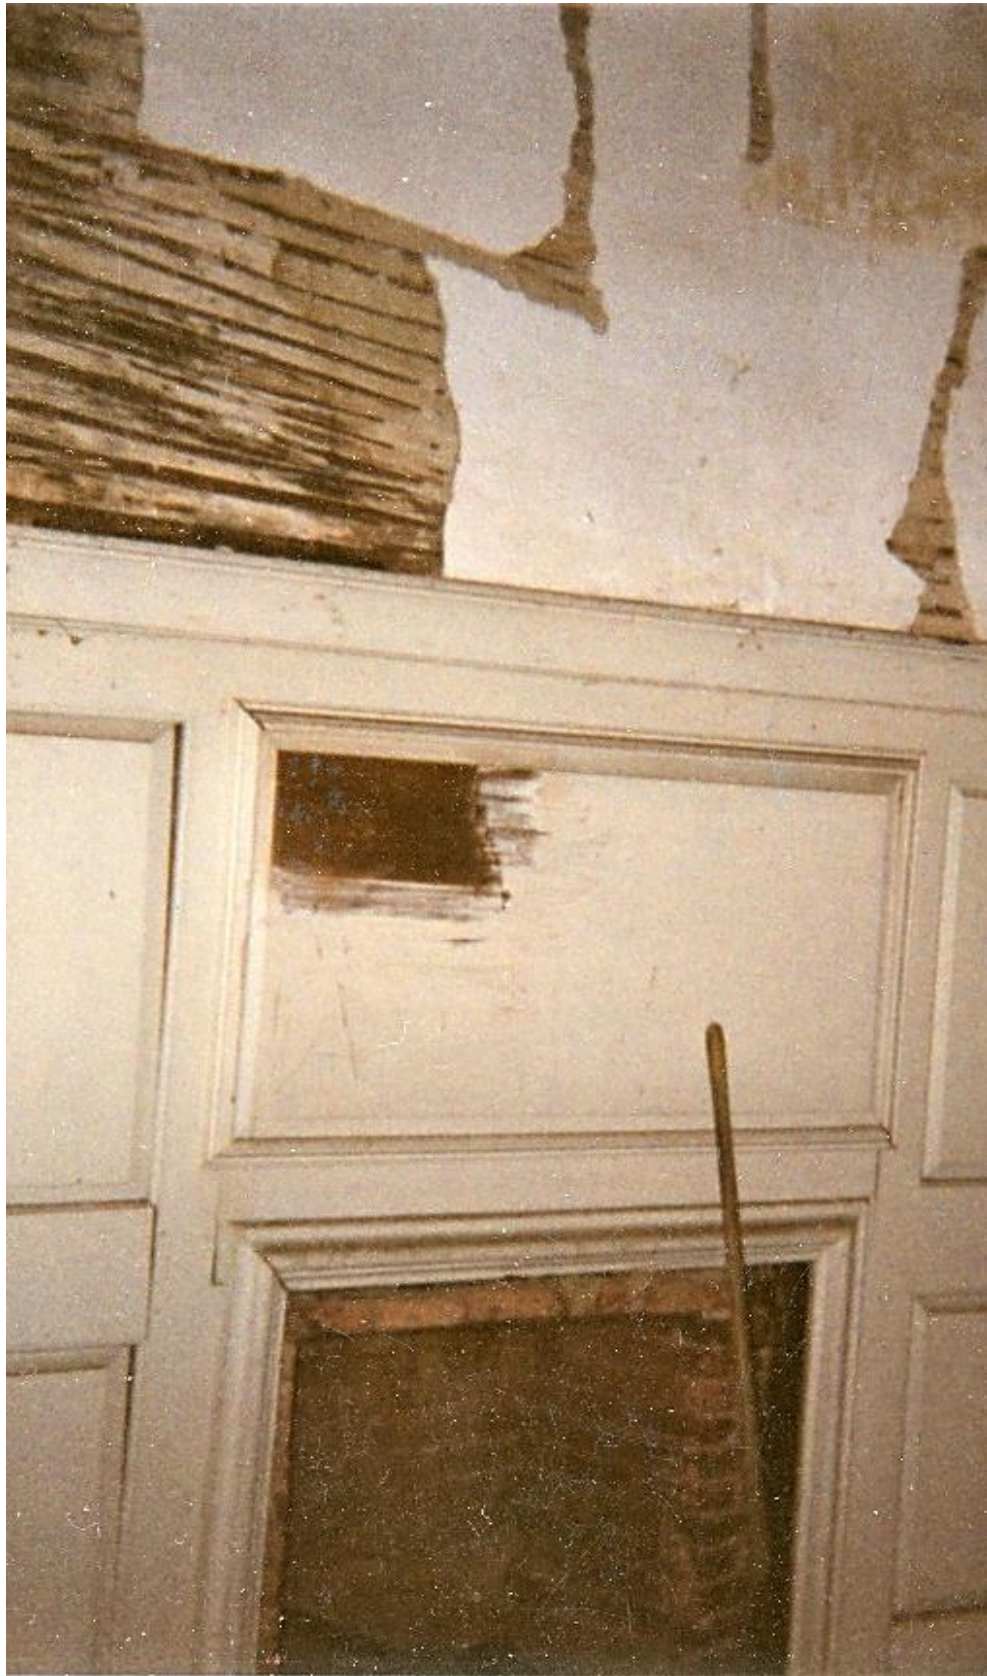
**Figure 3.48.** Front Southeast Bed Chamber, Ballroom, west breast wall of fielded panels. Fireplace brick evident. Pre-restoration; paint analysis. Camera facing west, ca. July 2004.

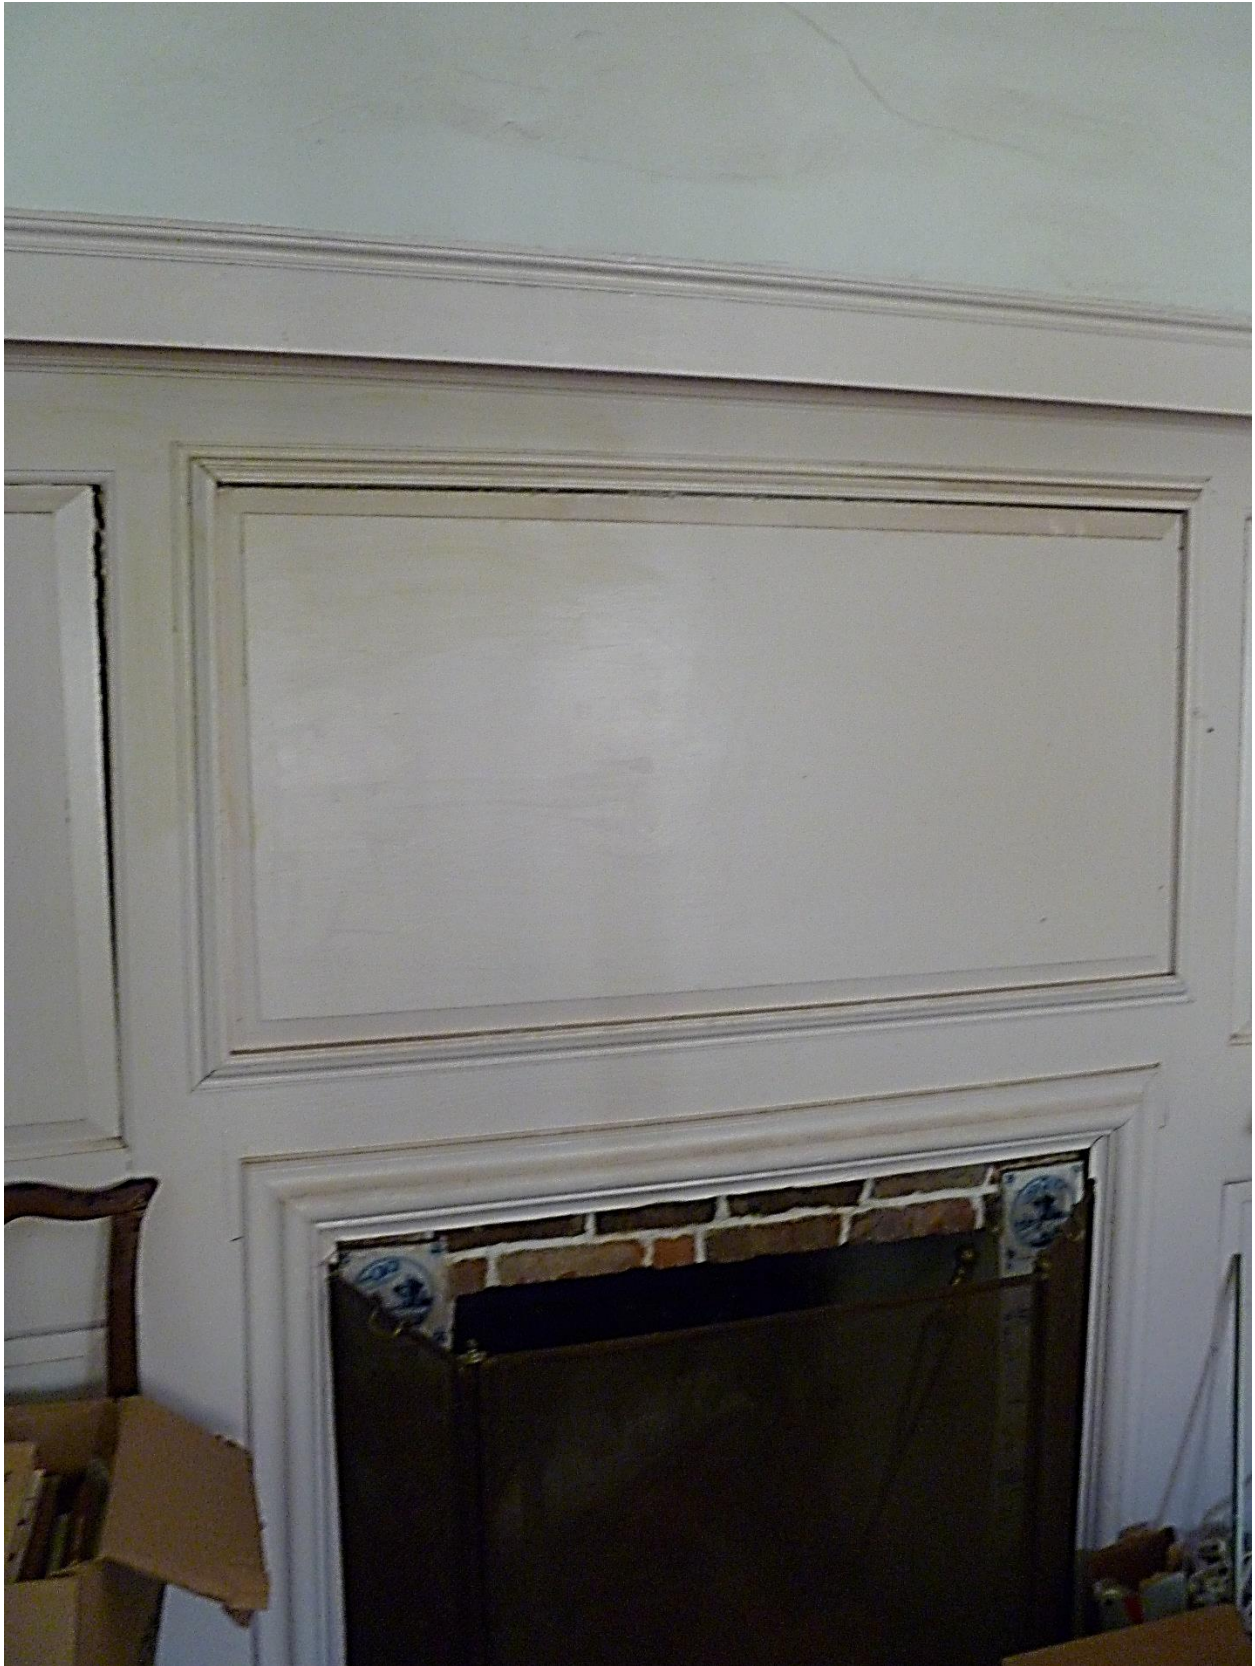
**Figure 3.49.** Front Southeast Bedchamber chimney breast wall with fielded panels and fireplace restored by Bill Phelon, Daniel Rose House, 1741. Camera facing west, September 2019.

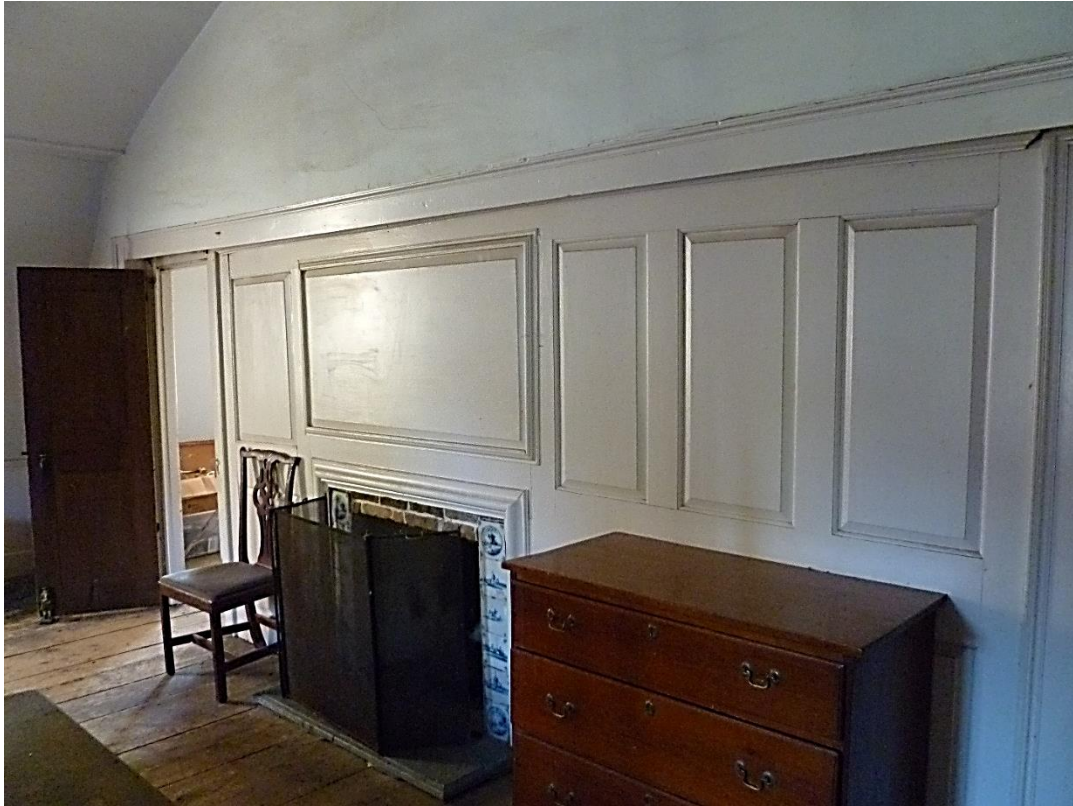
**Figure 3.50.** Ballroom, west breast wall. This Southeast Bed Chamber runs the entire width of the Daniel Rose House, with the barrel vaulted ceiling rising to a height of twelve feet. Restoration by Bill Phelon. Camera facing southwest, September 2019.

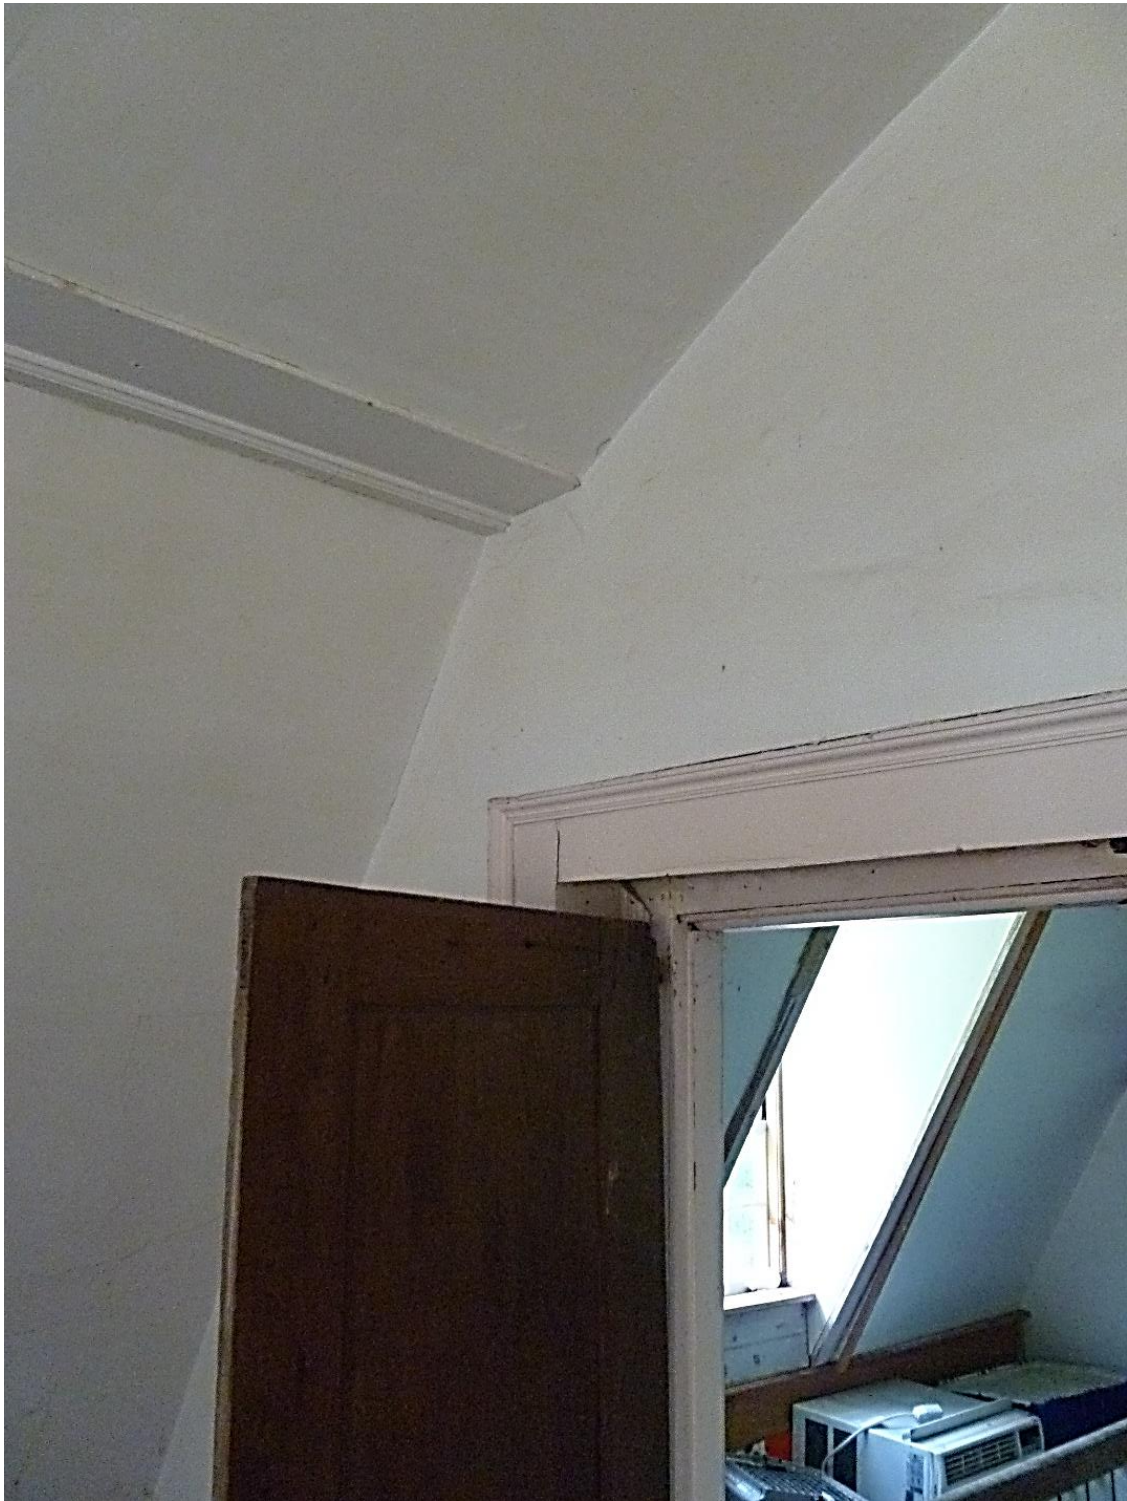
**Figure 3.51.** Front Southeast Bedchamber, Ballroom with barrel vaulted plaster ceiling, restored, ascending to twelve feet, Daniel Rose House. View to Stairway enclosure, center gable window and landing above front entryway. Camera facing southwest, September 2019.

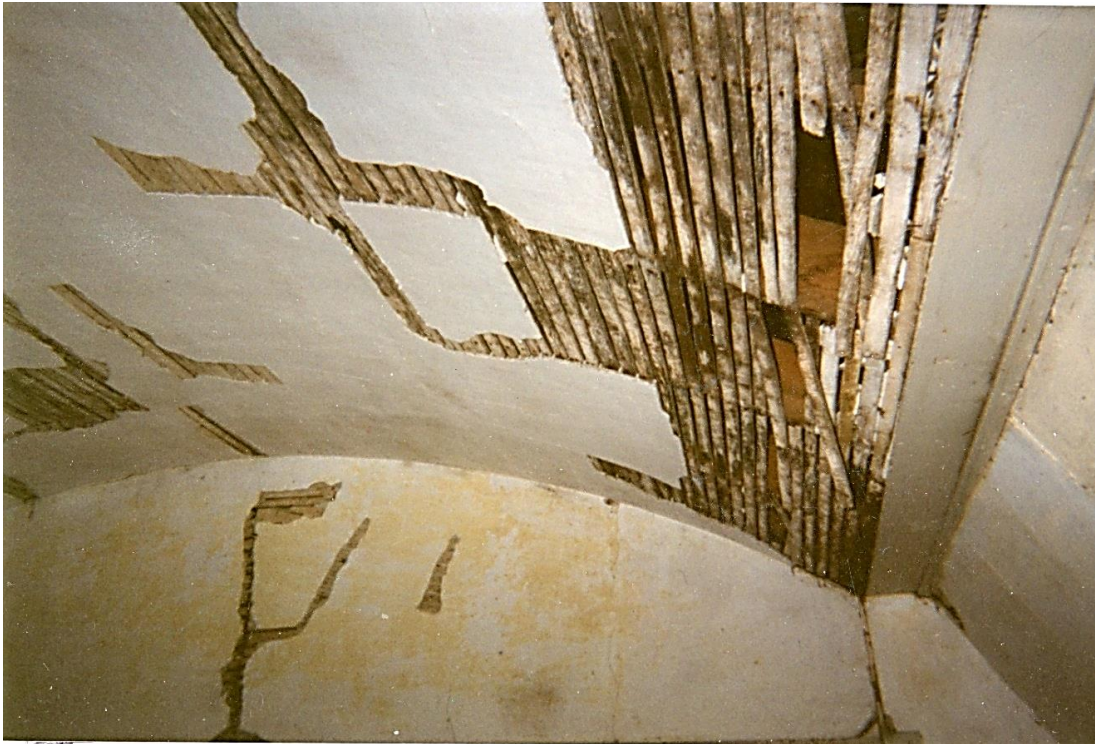
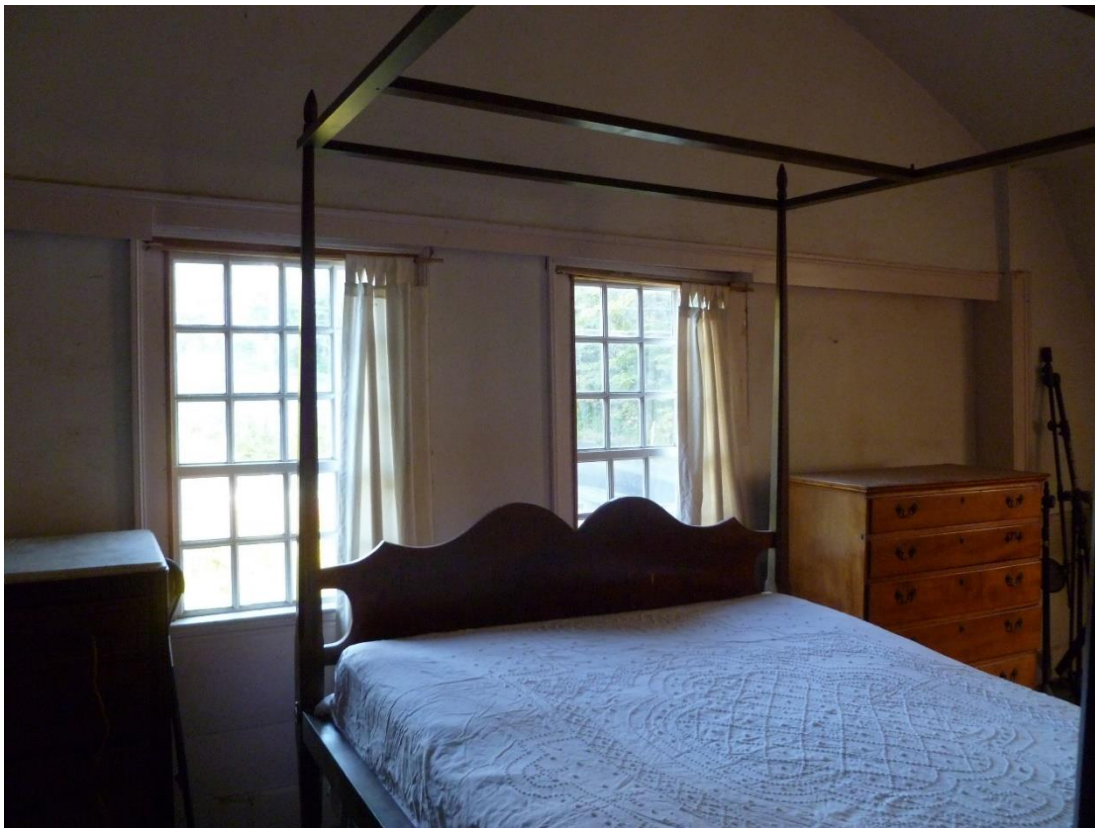
**Figure 3.52.** Front Southeast Bedchamber, Ballroom with barrel vaulted plaster ceiling, pre- and post-restoration, Daniel Rose House, 1741. Lath repaired on ceiling ascending to twelve feet, According to Legacy Inventory of 1985, the two-board dado shows evidence of a bench under windows. Additional evidence of blue paint in ceiling plaster suggests this room was possibly a Masonic Lodge meeting room. Camera facing east. (Upper) Photo, ca. July 2004. (Lower) Restoration by Bill Phelon. Photo, September 2019.
