Daniel Rose House Restoration by William Brian “Bill” Phelon 2004-2019;  
Text and Photos Compiled by Corey Phelon Geske, 2020.

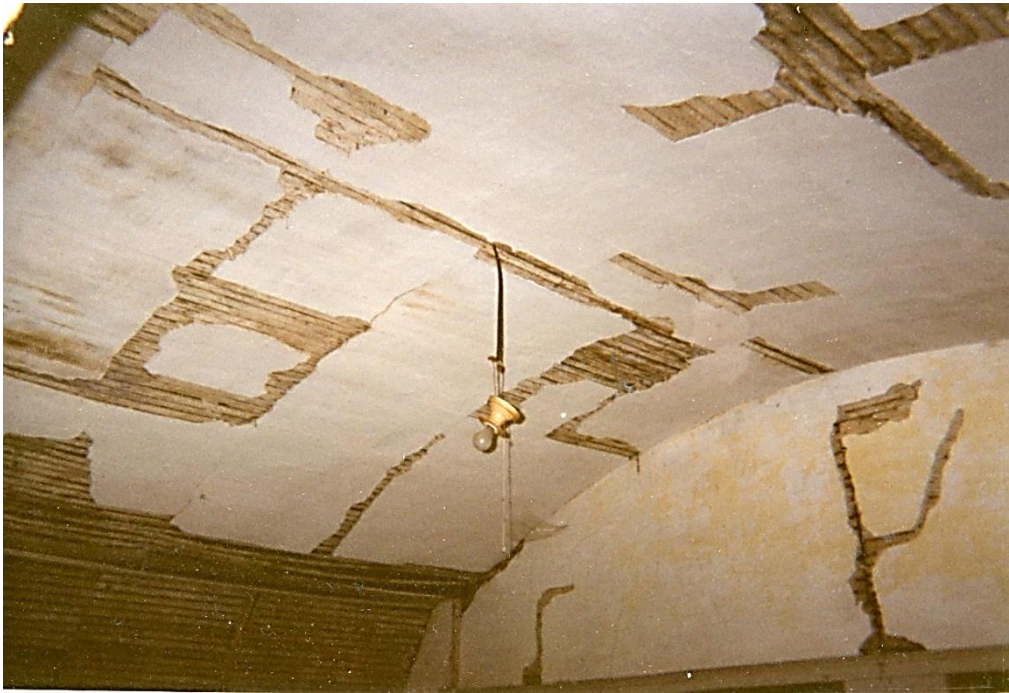
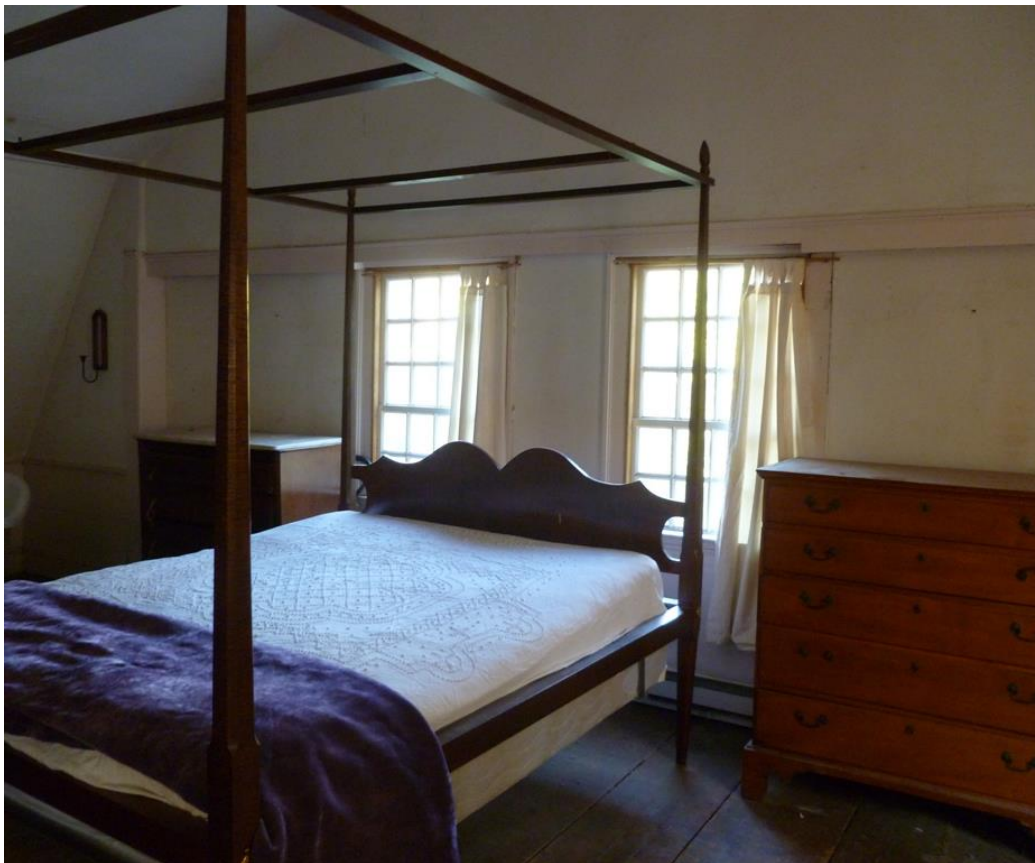
**Figure 3.53.** Daniel Rose House Front Southeast Bedchamber, Ballroom with barrel vaulted plaster ceiling. This Olive Curtiss Baker quilt could have been seen in this room during the ownership of Olive's son Francis G. Baker up until about 1870. Before 1886, Olive's granddaughter Laura Baker Wells gave the quilt to the Pocumtuck Valley Memorial Association, Deerfield, MA and it was photographed upon a four post bedstead – in the first period room museum installation in the United States. (Upper) Pre-restoration. Camera facing northeast, north gambrel wall and east wall above windows. Photo, ca. July 2004. (Lower) Photo, September 2019.

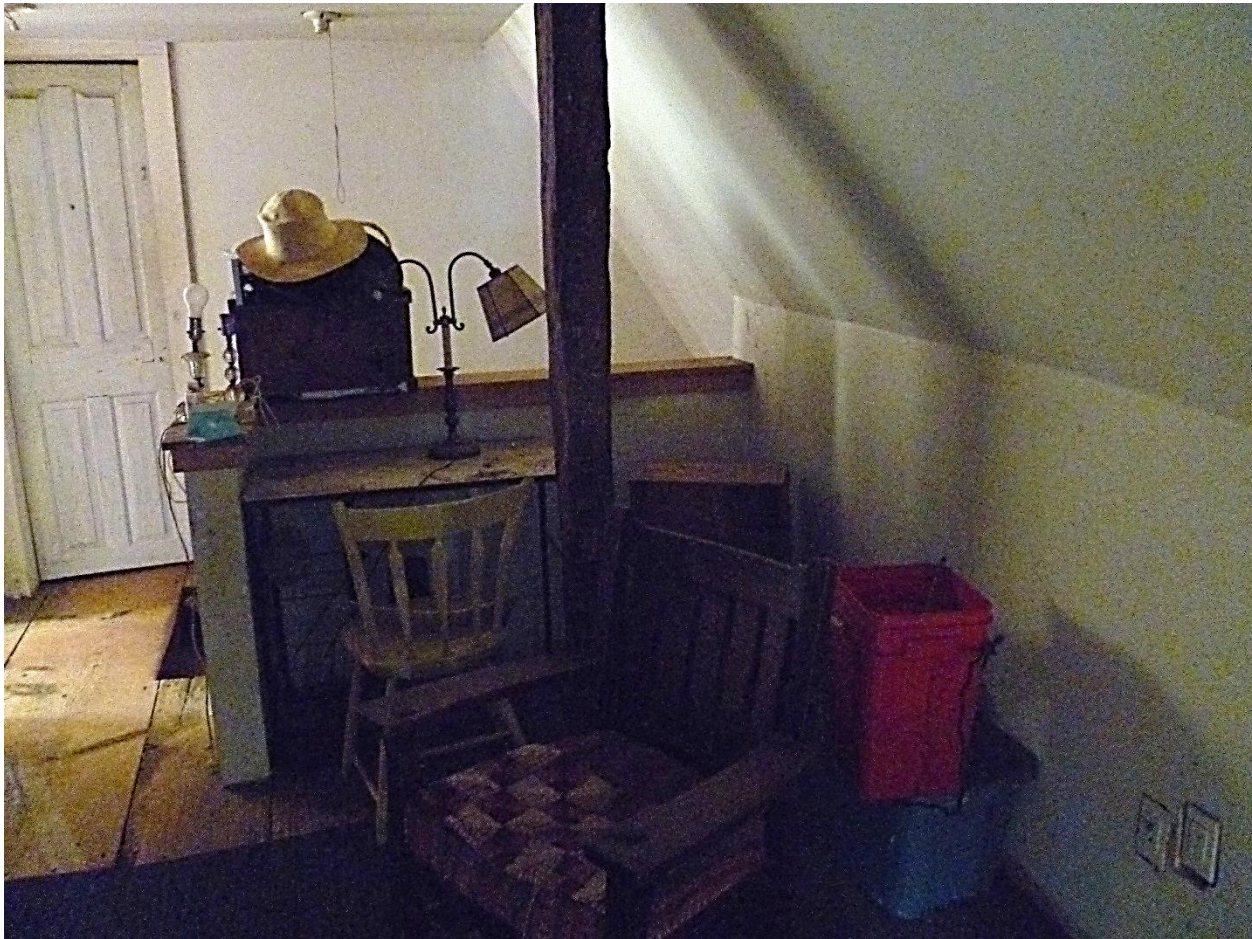
**Figure 3.54.** Interior structure is evident in unfinished landing at center of Daniel Rose House, second floor. Stairway beyond this partition leads down to the Keeping Room and this landing is also accessed from the north door of the Ballroom. Partly above the Keeping Room, this space would have been ideal for the storage of the “2 [spinning] wheels & 1 tape loom & 1 Old Chest, 3 [Bales] and  $\frac{3}{4}$  Sheeps wool” listed in Daniel Rose’s 1790 inventory. [This may have been the area in which Nelsie Harger Sheets was photographed ca. 1908 at work weaving on a large loom owned by her Aunt Eliza Harger Smith in the architecturally similar gambrel-roofed David Harger Place, once standing northwestward of the intersection of West Hartland Road and Main Road; and apparently, previously, owned by Charles Curtiss (until he moved to Ohio in 1811). David Harger boarded and lived with the Daniel Rose family during the American Revolution, as noted in his 1837 affidavit testifying to the (Castle Island) military service of Daniel’s son, Abner Rose when Abner’s widow Abigail Stebbins Rose filed for Abner’s Revolutionary War pension].

The Southwest Bedchamber is to the left. Hallway to potential ‘Docent Wing’ for a Museum caretaker’s family with second floor bath and bedroom is behind the camera. Camera facing west. Photo, September 2019.

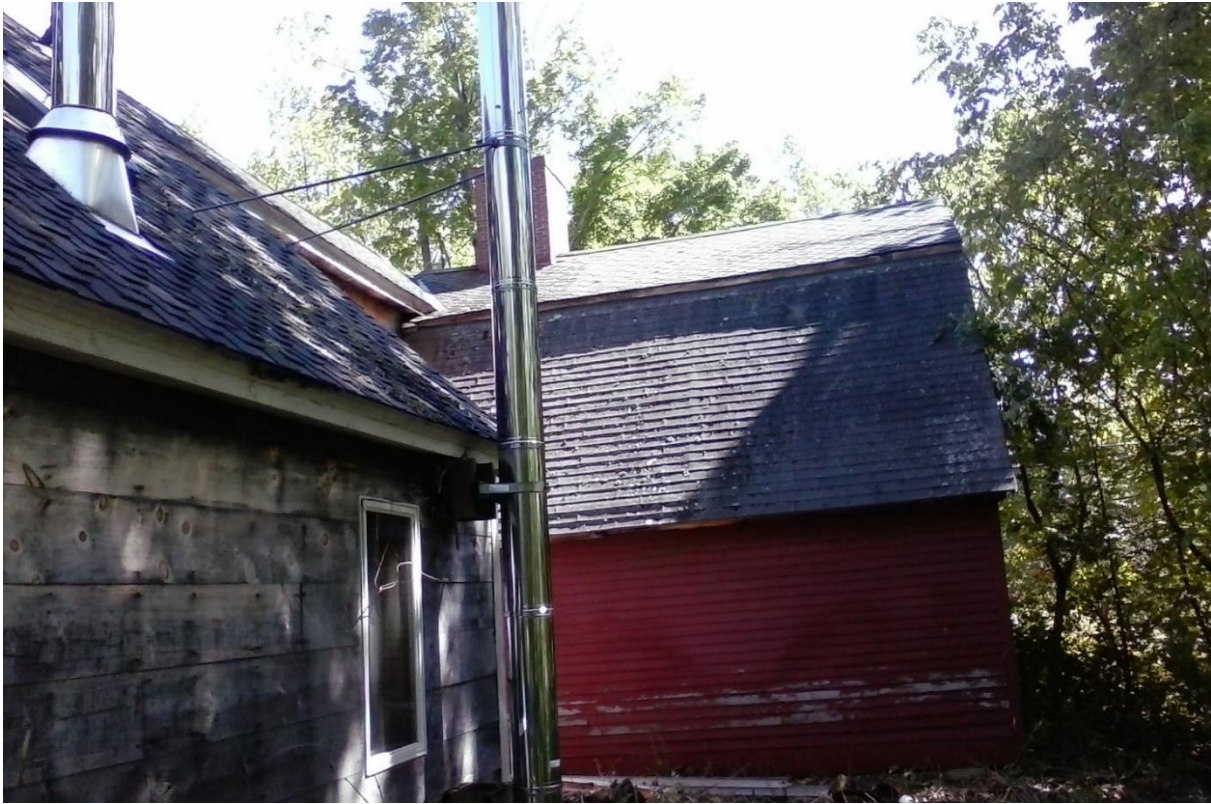
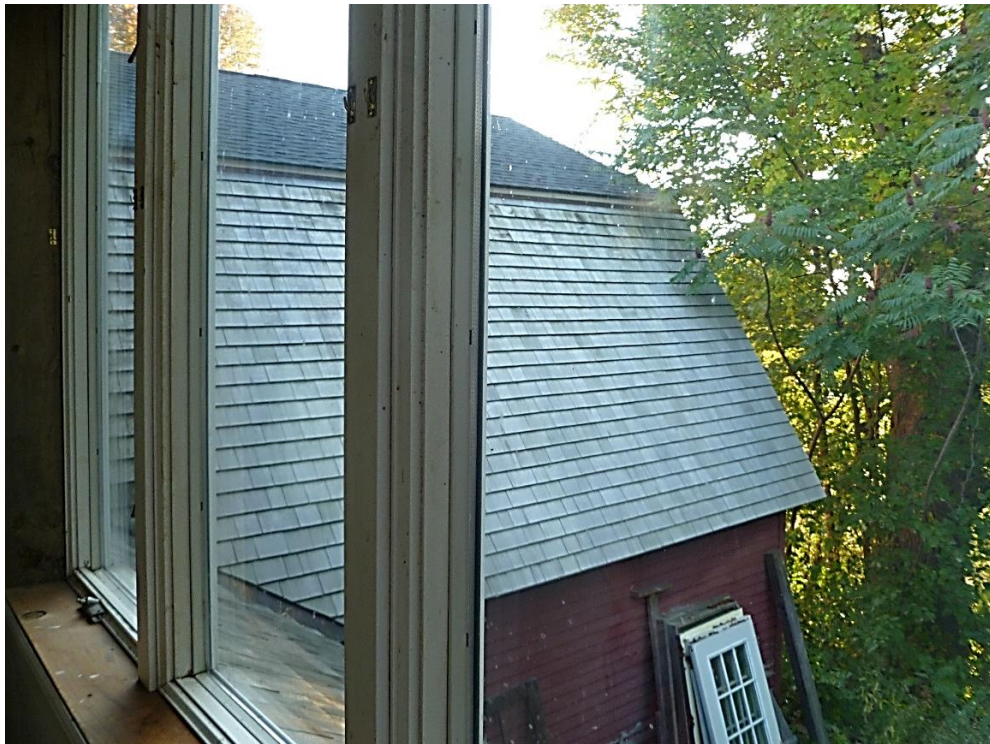
**Figure 3.55.** (Upper) Northwest façade of main block and west wall of potential ‘Docent Wing’, Daniel Rose House. Photo, 2017. (Lower) View of western elevation, gambrel roof, of main block from second floor hall c.. 1985, with updated windows of the potential ‘Docent Wing’, the two-story extension housing upstairs bath and bedroom; and downstairs kitchen and sitting room. Camera facing southwest. Photo, September 2019.

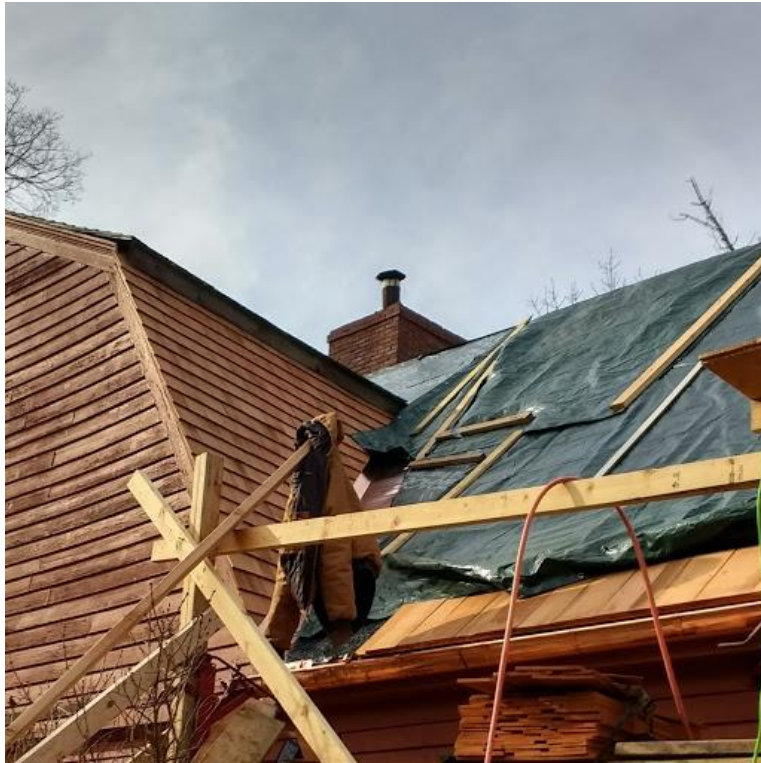
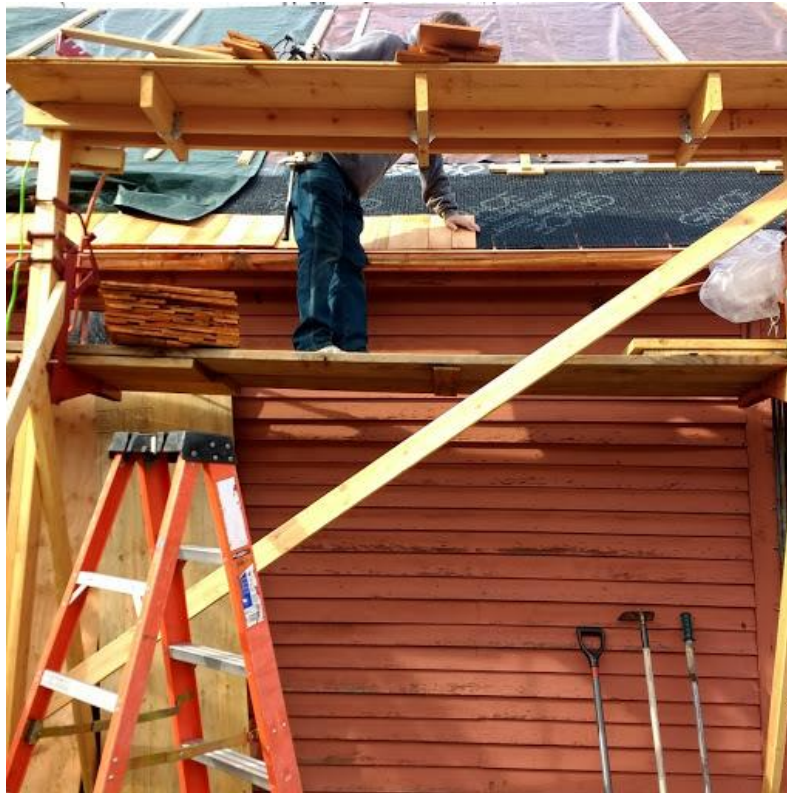
**Figure 3.56a.** In December 2017, a new roof was put on the two-story addition (ca. 1985) extending north from the keeping room, a potential ‘Docent Wing’: with Grace Ice and Water Shield underlayment, one layer of royal cedar breather and then two layers of red cedar perfection for “three sheets (of shingles) to the wind” in the old tradition with hand crafted gutters and leaders to last sixty plus years. Camera facing southwest. Photos, December 2017.

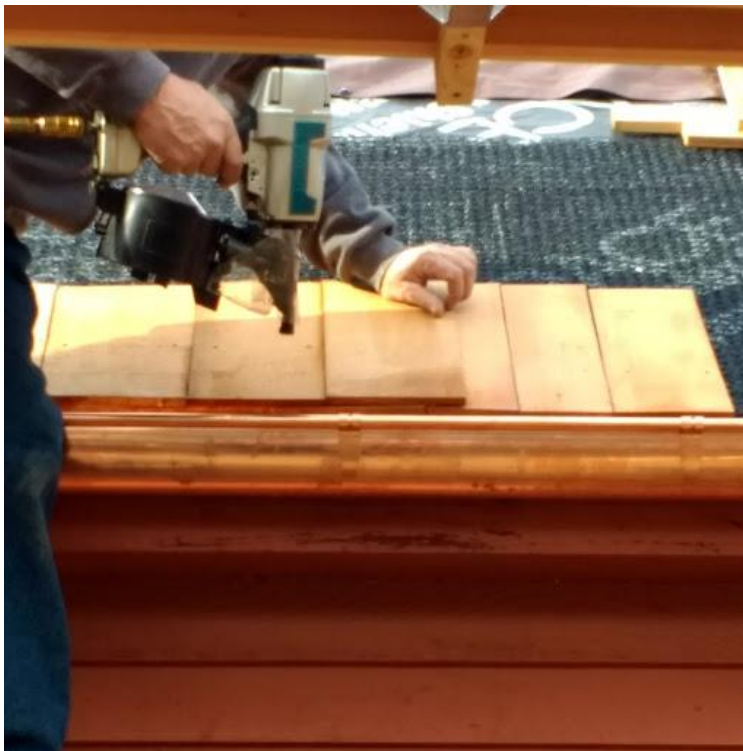
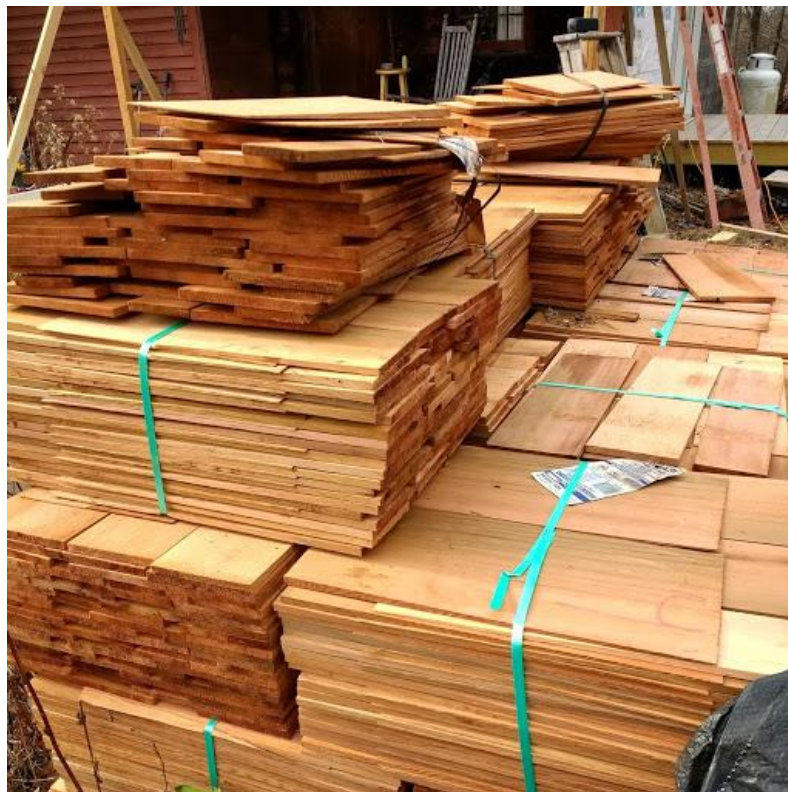
**Figure 3.56b.** In December 2017, a new roof was put on the two-story addition (ca. 1985) extending north from the keeping room, a potential ‘Docent Wing’: with Grace Ice and Water Shield underlayment, one layer of royal cedar breather and then two layers of red cedar perfection for “three sheets (of shingles) to the wind” in the old tradition. Camera facing west. Photos, December 2017.

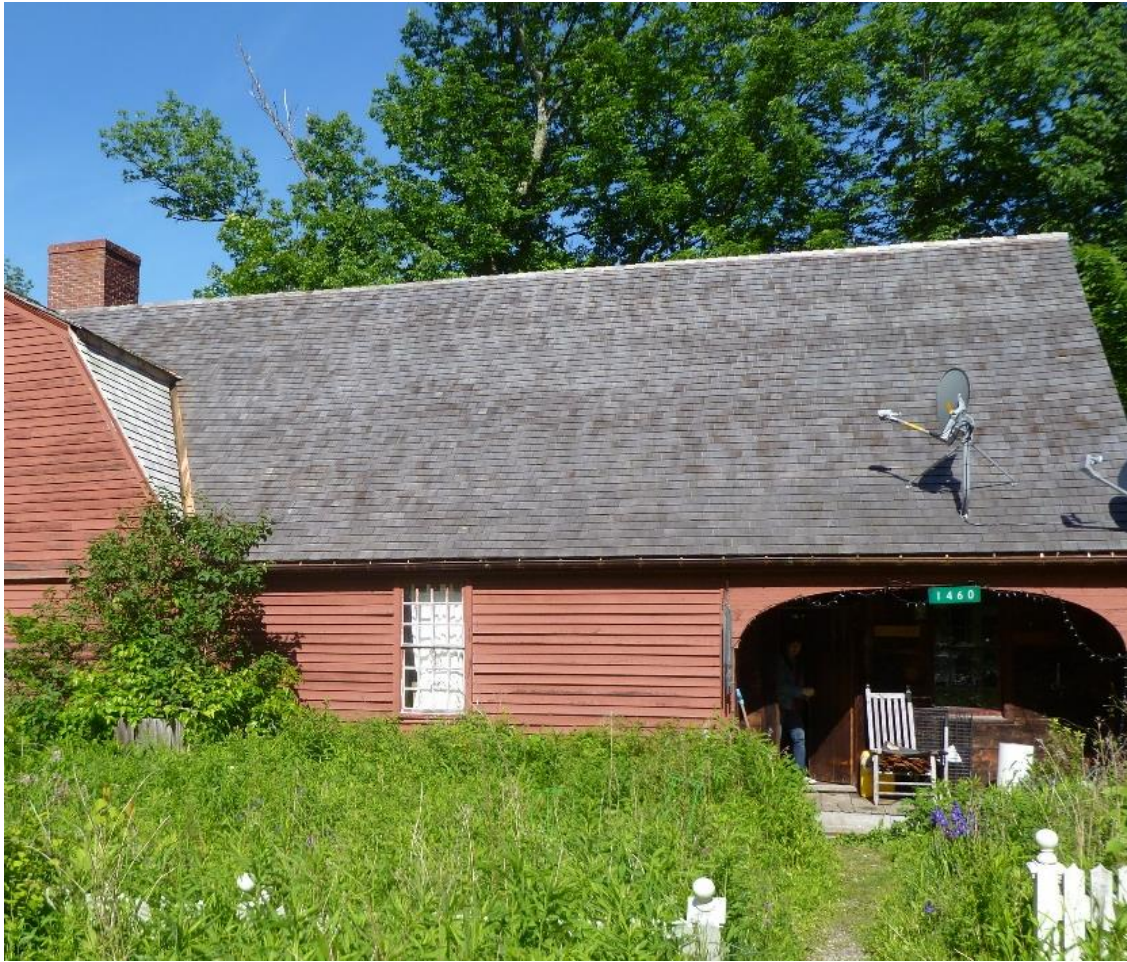
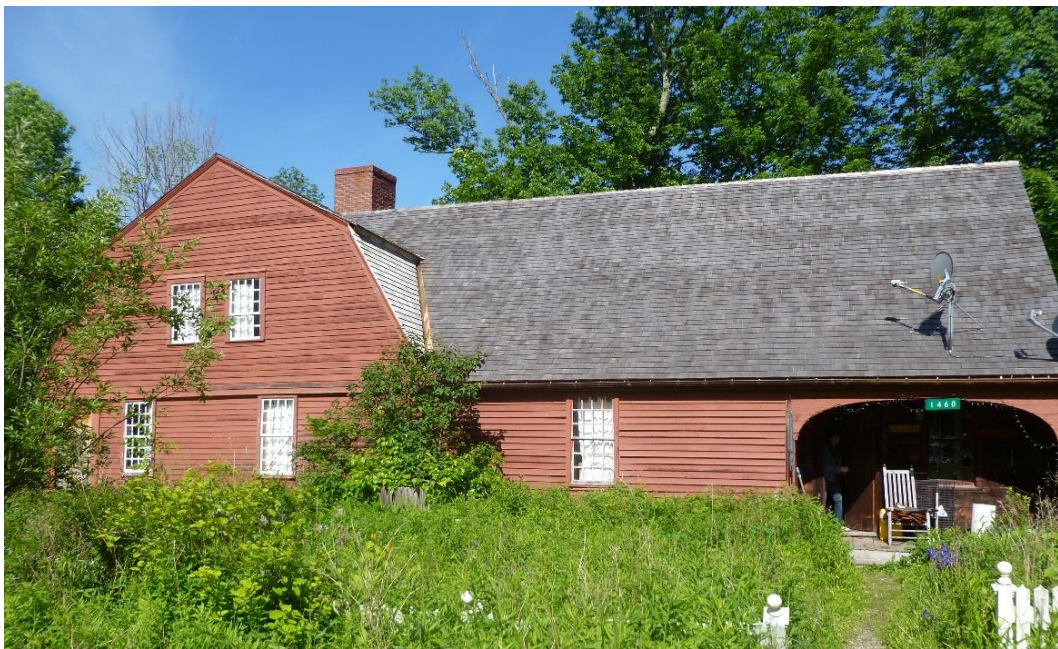
**Figure 3.57.** Daniel Rose House, 1741, east façade with new roof of three layers of cedar shingles added to the potential ‘Docent Wing’ in 2017. Photo, June 2019.

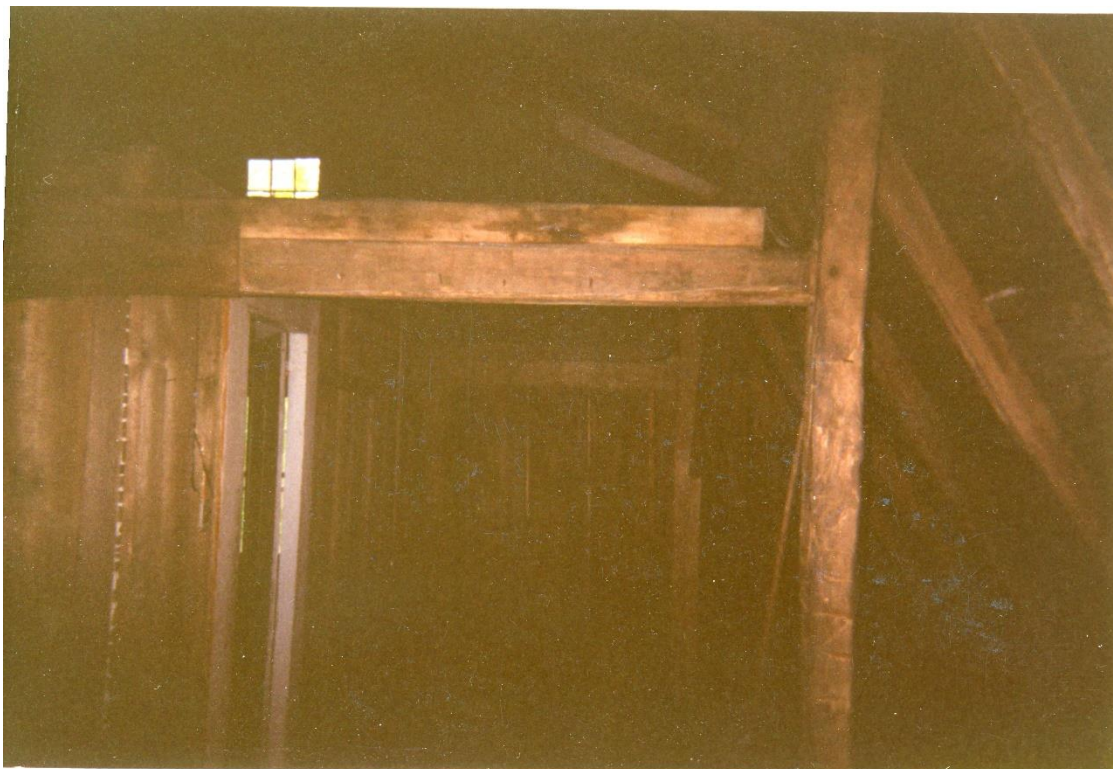
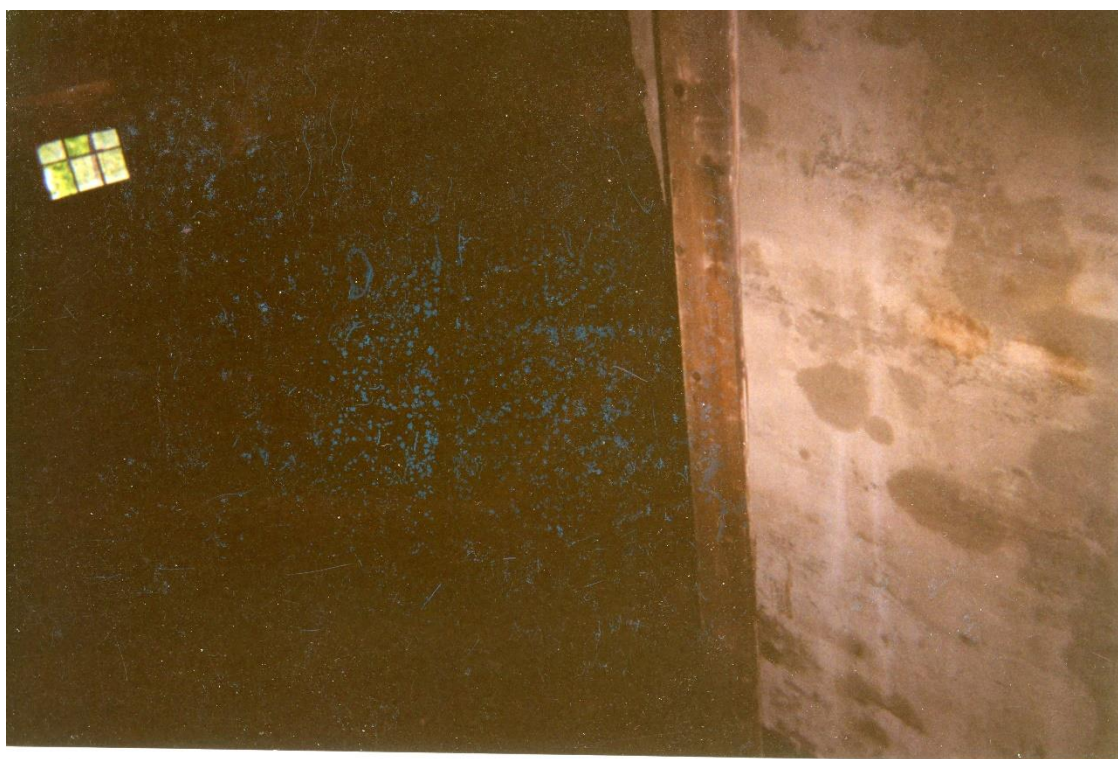
**Figure 3.58.** Attic (Upper) featuring mortise and pegged tenon construction (see peg, upper right) with (Lower) flat stone center chimney. Daniel Rose House, 1741. Camera facing six pane window, west elevation. Photos by Bill Phelon, ca. July 2004.

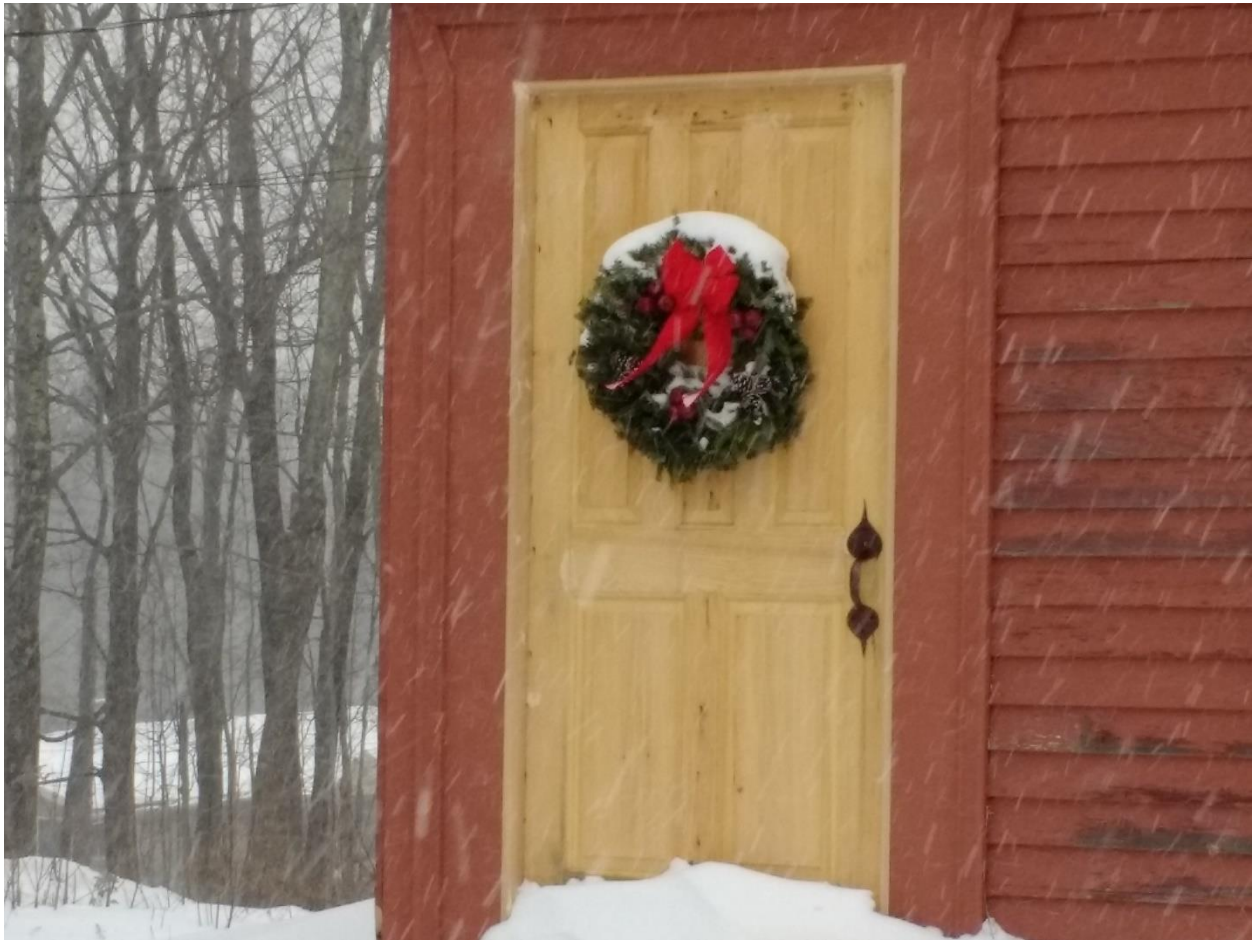
**Figure 3.60.** Daniel Rose House, 1741. ‘Bedford Settlement Door Surround’ and reconstructed east facing ‘coffin door’. Camera facing southwest. Photo, Bobbie-Jo Day, January 2018.
