LOWELL CULTURAL RESOURCES INVENTORY

ADDRESS 645 LAWRENCE STREET: SECOND STOREHOUSE, BELVIDERE MILL NO. 2

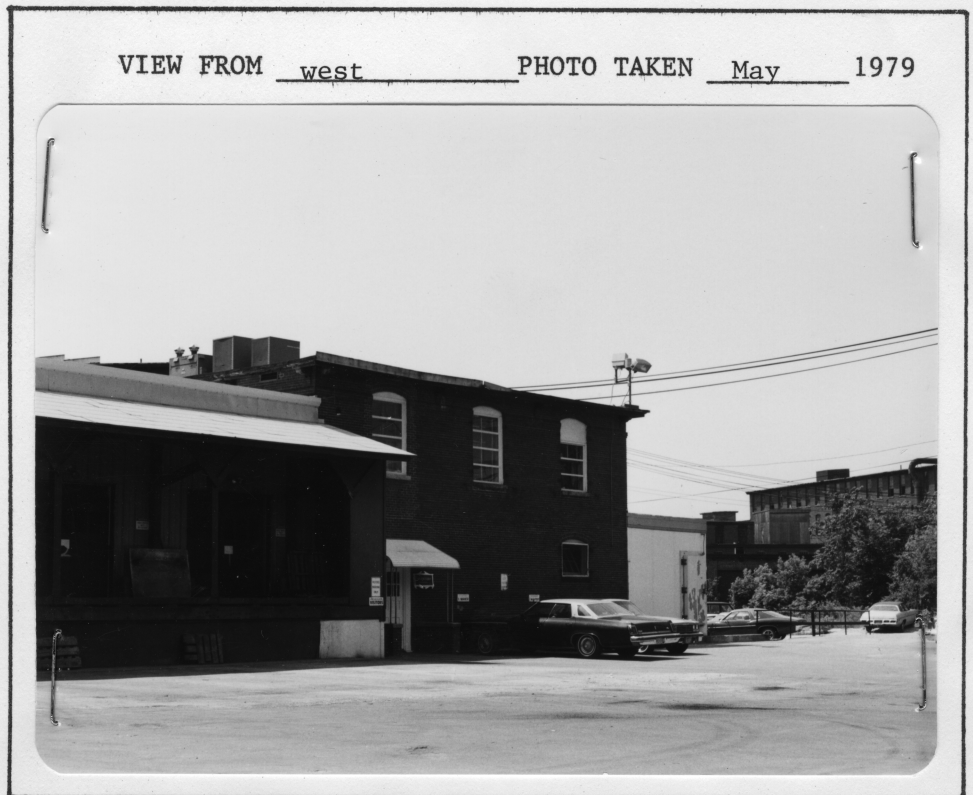
- 1) CONDITION OF BUILDING FABRIC good
- 2) IF DETERIORATED, CAUSES n/a
- 3) INTEGRITY OF HISTORIC BLDG FABRIC: GF major but reversible changes
UF intact original fabric
- 4) SURROUNDING LAND USES commercial, industrial, residential, canal frontage, river frontage
- 5) INTEGRITY OF PROP'S HIST SETTING intact with minor intrusions and/or losses
- 6) IMPORTANCE OF PROP TO HIST SETTING integral to character

The fourth of the four main historic structures of the Belvidere No. 2 complex is a two-story storehouse at the northwest side of the group. East of that simple structure is a more modern, one-story loading dock, built of concrete and sided with aluminum. The storehouse, loading dock, and other structures of various sizes and materials attached to the rear of the main mill are all outside the LHPD.
