LOWELL CULTURAL RESOURCES INVENTORY

IDENTIFICATION BOOTT MILLS--foot of JOHN STREET MAP SHEET # 8
1) CURRENT OWNER Boott Mills OWNER OCCUPIED yes
2) HISTORIC NAME Boott Mills--#1 Mill
3) CURRENT NAME Boott Mills--Building #1
4) PROPERTY TYPE mill structure 5) ZONING CLASSIFICATION B3
6) TAXES: PAYMENTS current STATUS clear
7) WITHIN BOUNDARIES OF LNHP, Locks and Canals HD, LHPD

ADDRESS BOOTT MILLS--foot of JOHN STREET: Mill #1

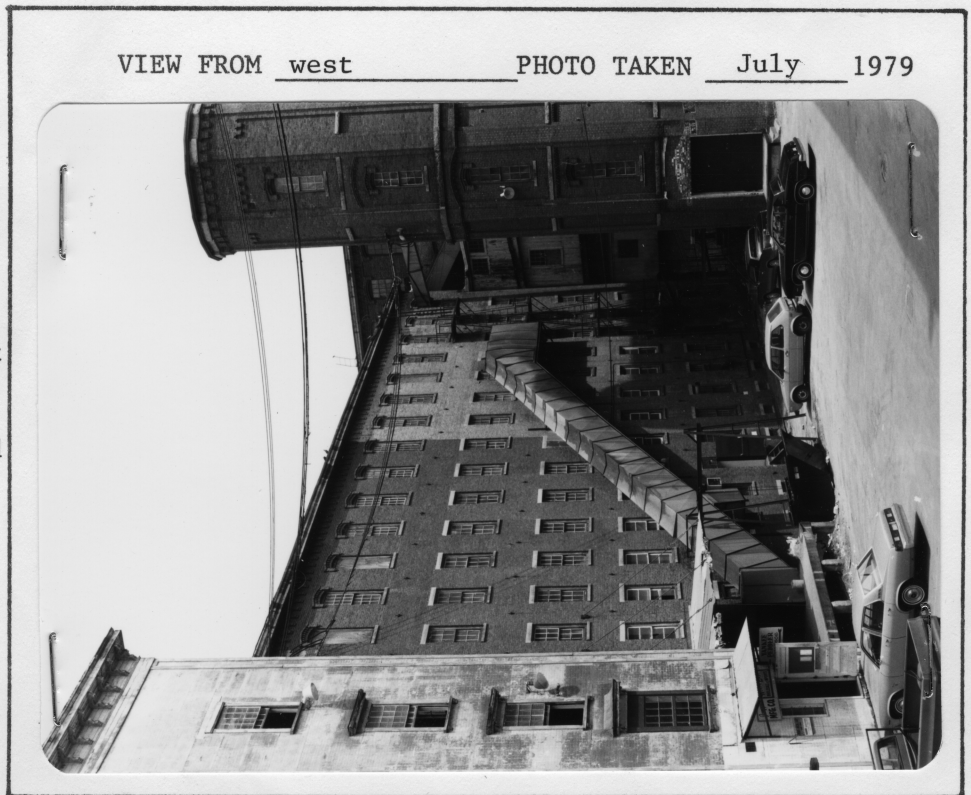
- 1) CONDITION OF BUILDING FABRIC needs minor repair
- 2) IF DETERIORATED, CAUSES n/a
- 3) INTEGRITY OF HISTORIC BLDG FABRIC: GF major but revers changes
UF intact with minor changes
- 4) SURROUNDING LAND USES commercial, industrial
- 5) INTEGRITY OF PROP'S HIST SETTING intact with minor intrusions and/or losses
- 6) IMPORTANCE OF PROP TO HIST SETTING integral to character

The #1 Mill, #2 Mill, and Connector between the #1 and 2 Mills consist of three structures which present a single, nearly symmetrical facade, 375' long. The buildings' oldest sections (#1 and 2 Mills) were originally freestanding four-story structures (150'X45', 19 bays deep); their original appearance is described in the Boott Mills--General History--Initial Development: 1835-1838 (see Figs. 4, 5 and 9). Around 1863-1865, the #1 and 2 Mills were linked by the present connector mill (75'X 94'-97'), originally four stories high with a wooden fifth story. Symmetrical except for the clock and belfry of its western stair tower, this connector mill is described in the Boott Mills--General History--Civil War Development [see Figs. 11 and 12B]. Around 1880, the roofs of all three structures were removed and an additional story added. This top story is of Italianate design with brick window hoods, a corbelled cornice, and a flat roof.

More recent alterations to the mill buildings consist mainly of the addition of one loading bay to the first story of the #1 Mill and of five loading bays to the first story of the #2 Mill, most (if not all) of which were added after 1947 (Fig. 22 of General History).
