LOWELL CULTURAL RESOURCES INVENTORY

ID	ENTIFICATION	Foot of HOWE STR	REET	MAP SHEET #12
	CURRENT OWNER			
2)	HISTORIC NAME	Site of Belvider	ce Woolen Manufacturin	g Co. Mill No. 1
3)	CURRENT NAME	same	The second secon

4)	PROPERTY TYPE	archeological	5) ZONING CLASS	IFICATION B-1
6)	TAXES: PAYMENTS	exempt	STATUS clear	
7)	WITHIN BOUNDARIES OF	LHPD (partial)		
HI	STORICAL ABSTRACT

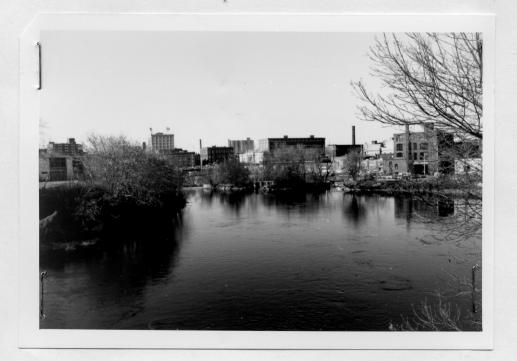
View from the southeast of the Belvidere site, from the Church Street Bridge.

Photo taken in November, 1979.

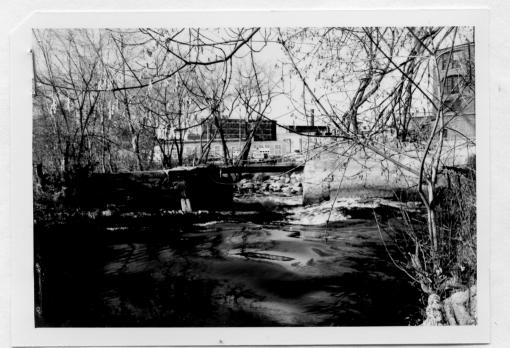
east bank. The island is separated from that shore by a narrow spillway beween concrete abutments, spanned by I-beams.

View from the southeast of the spillway separating the Belvidere site (right) from the island at the east end of the Middlesex Company dam.

Photo taken in November, 1979.

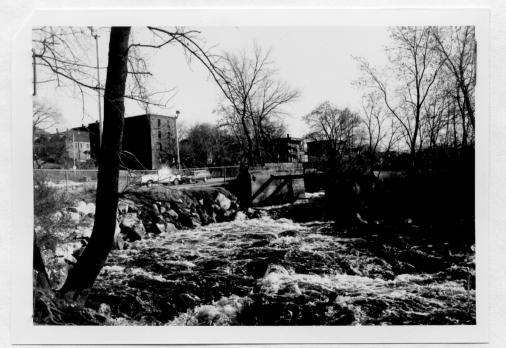
View from the northwest of the spillway. The Belvidere site is to the left, island to the right.

Photo taken in November, 1979.

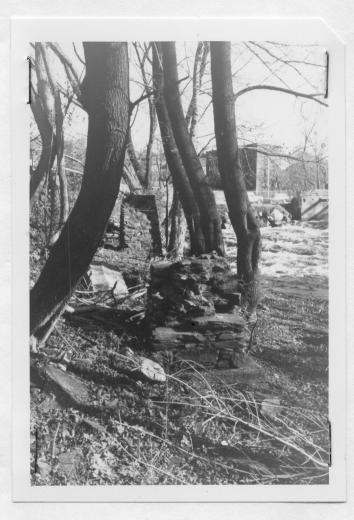
That island and the riverbank north and south of it contain numerous walls, footings, and abutments of granite, concrete, and rubble stone related to the mills which operated on this site and to their waterpower systems.

Two rubble stone abutments on the Concord riverbank at the Belvidere site.

View from the northwest.

Photo taken in November, 1979.
