LOWELL CULTURAL RESOURCES INVENTORY

ADDRESS 645 LAWRENCE STREET: STOREHOUSE, BELVIDERE WOOLEN MFG. CO. MILL NO 2

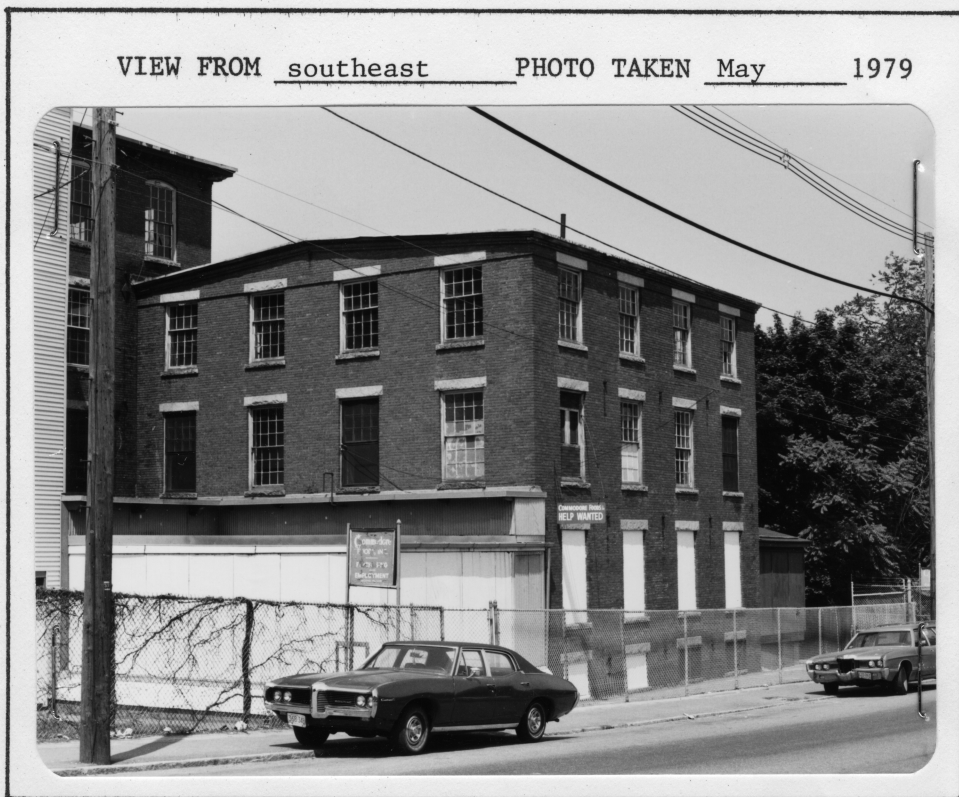
- 1) CONDITION OF BUILDING FABRIC good
- 2) IF DETERIORATED, CAUSES n/a
- 3) INTEGRITY OF HISTORIC BLDG FABRIC: GF intact with minor changes
UF intact original fabric
- 4) SURROUNDING LAND USES commercial, industrial, residential, canal frontage, river frontage
- 5) INTEGRITY OF PROP'S HIST SETTING intact with minor intrusions and/or losses
- 6) IMPORTANCE OF PROP TO HIST SETTING integral to character

This small storehouse is little changed from its original appearance except for the boarding up of lower story windows, the addition of a loading bay to its north side, and a shallow, one-story extension to its south side.
