**Barnes Hospital,
Cheadle,
Stockport,
Greater Manchester**

**Archaeological
Evaluation**

Oxford Archaeology North

September 2015

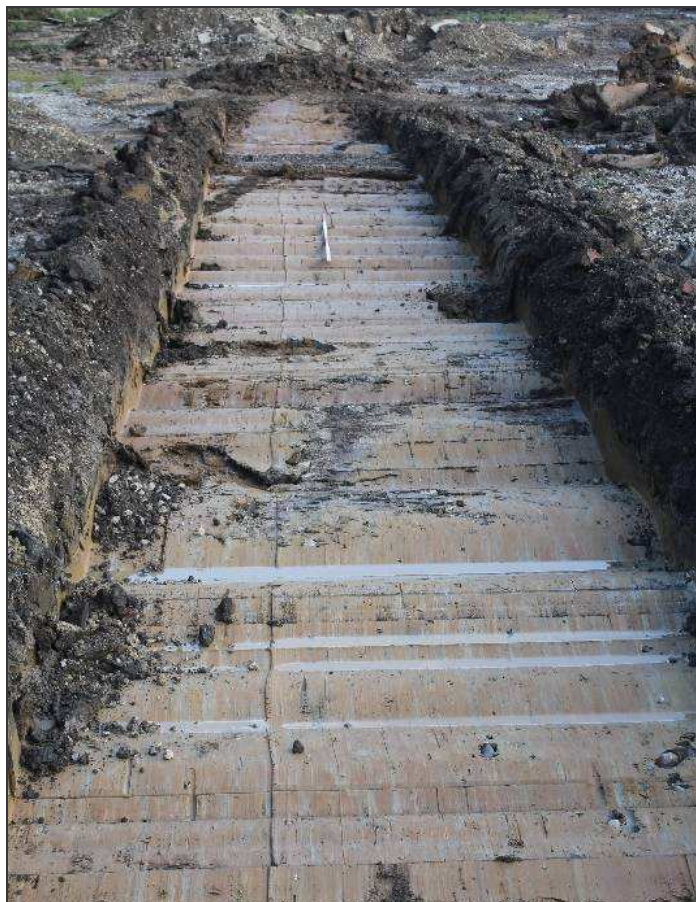
3.2.1 Trench 1 was placed on an east/west alignment, to the south of the main entrance to the site in the south-western corner of the site (Fig 2). The undisturbed natural geology was encountered at a depth of 0.4m below the present ground surface, and comprised mid-orangey-yellow heavy clay with patches of gleying.

3.2.2 The natural geology was overlain by a thin deposit of mid-yellowish-brown clay silt subsoil, up to 0.10m thick, and with rare sub-angular stones a maximum of 10mm in size (Plate 4). At the eastern end of the trench two inter-cutting ceramic field drains had been cut into the natural geology through the subsoil and above this lay a deposit of heavily disturbed loose dark grey brown silt, containing significant quantities of modern demolition rubble. This deposit covered the full length of the trench, and had itself been overlain by a modern layer of gravel and terram matting.

Plate 4: Trench 1 looking east, 2m scale

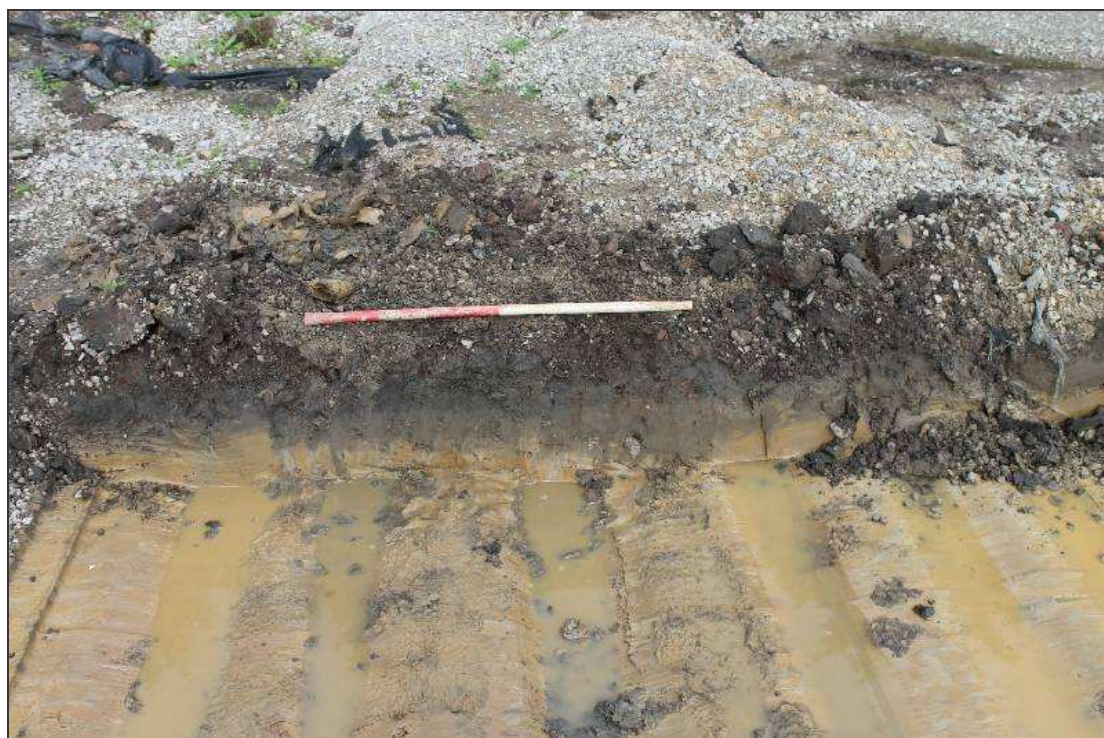
Plate 5: Trench 1, south-facing section, 1m scale

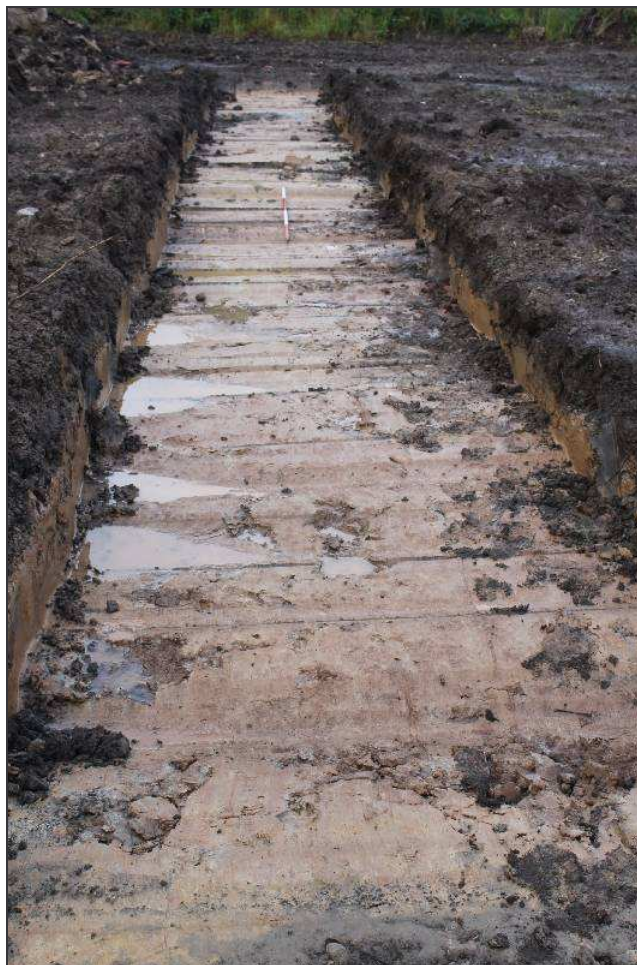
3.3.1 Trench 2 was placed to the south of Trench 1, within the south-western corner of the site, and was aligned broadly east/west (Fig 2). The natural geology was exposed at a depth of 0.30-0.40m below the present ground level, and was identical in character to that described in Trench 1.

3.3.2 Towards the western end of the trench a modern drain, backfilled with gravel, crossed the width of the trench. A small sub-circular depression or pit was recorded to the west of the drain, measuring 0.37m in diameter. Excavation revealed it to be only 0.04m in depth, and filled with dark greyish-brown silt containing modern demolition rubble. The pit and natural geology were sealed by the same loose dark grey brown silt deposit identified in Trench 1 but, despite the proximity of the two trenches, there was no evidence for a subsoil in this location.

Plate 6: Trench 2, facing west, 2m scale

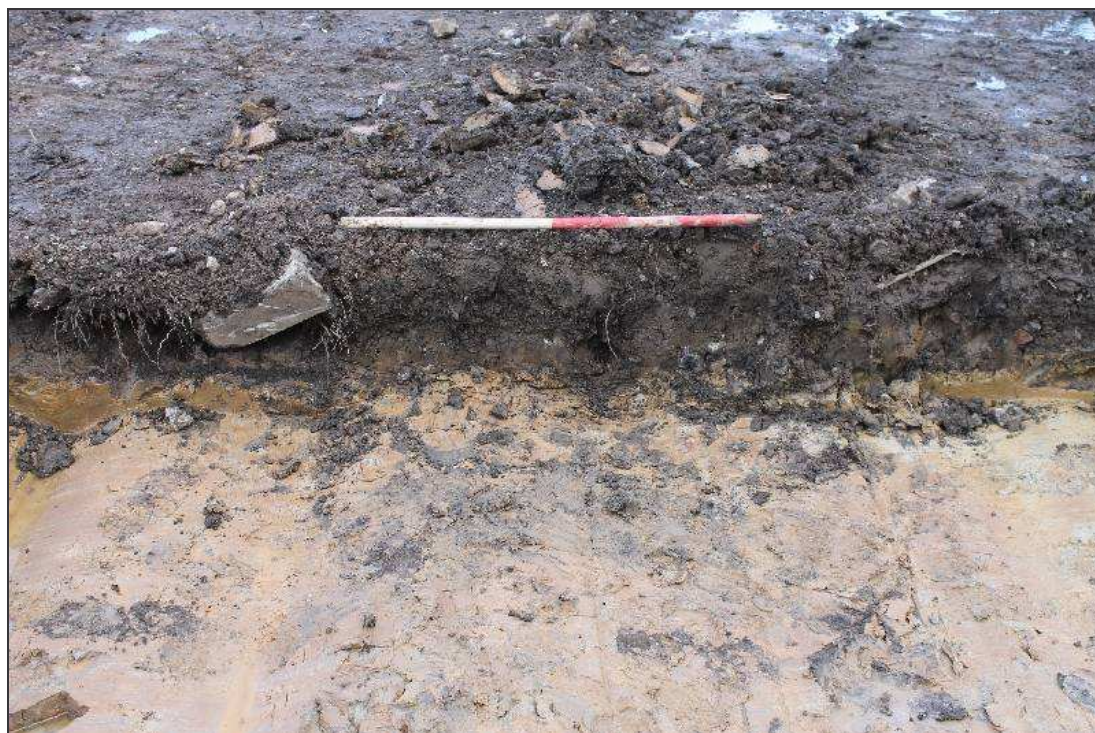
Plate 7: Trench 2, south-facing section, 1m scale

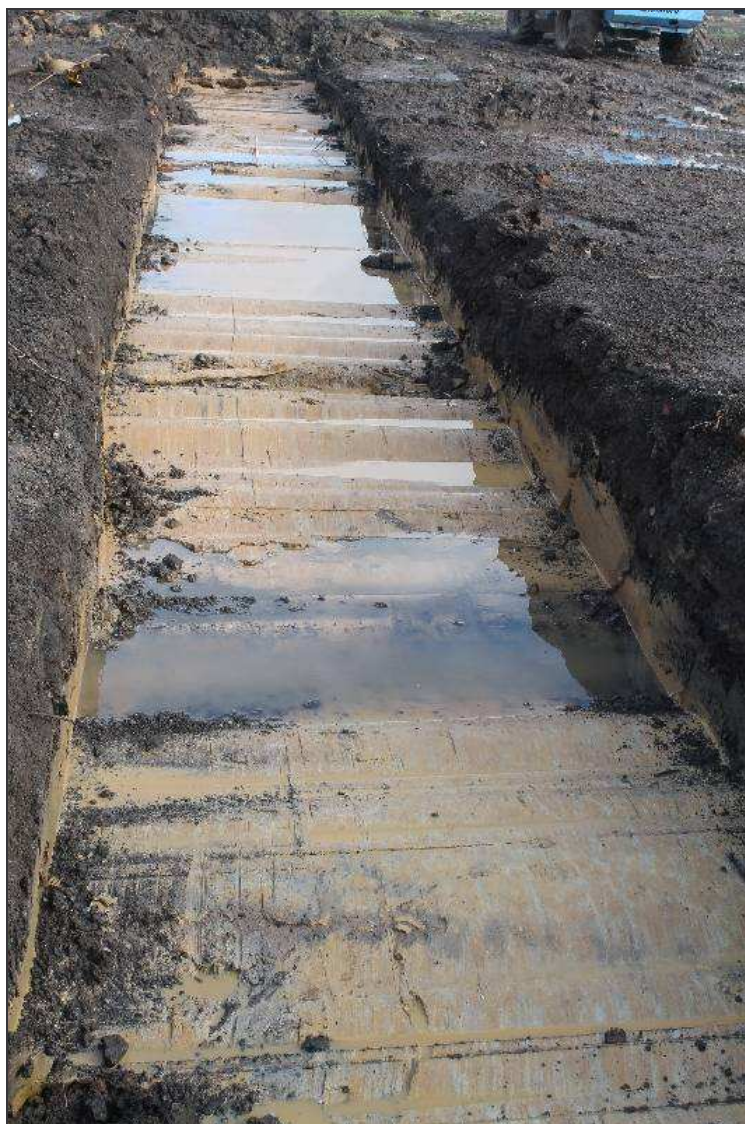
- 3.3.1 Trench 3 was aligned broadly north/south, and lay a short distance to the west of trenches 1 and 2 (Fig 2). Its position was adjusted slightly further to the south than originally intended to avoid the line of a gas main, which once supplied the hospital.

- 3.3.2 Deposits of mid-orangey-yellow heavy clays with patches of grey gleying were again encountered just 0.30m below the present ground surface, and a ceramic field drain had been cut into the natural, crossing the northern end of the trench. Both the drain and natural clay were covered by the same loose dark greyish-brown silt that had been recorded in both trenches 1 and 2 and contained significant quantities of modern demolition waste. The soil increased in thickness to the south up to a maximum of 0.60m, reflecting a slight rise in the ground surface in this direction and in places this demolition waste had been pressed into the top of the underlying natural clays.

Plate 8: Trench 3, looking north

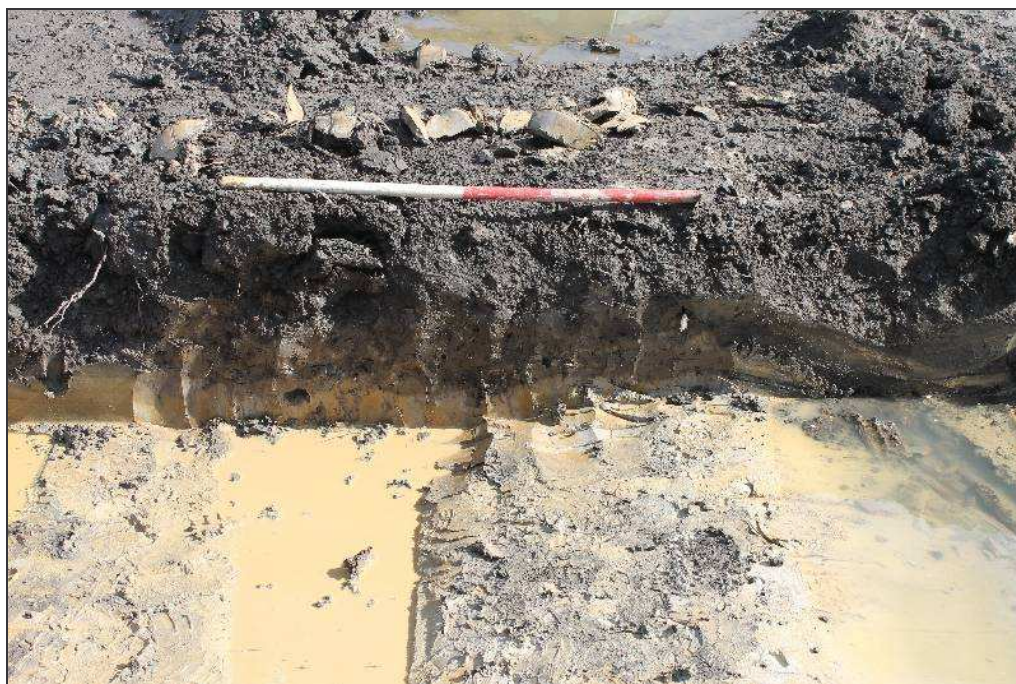
Plate 9: Trench 3, west-facing section, 1m scale

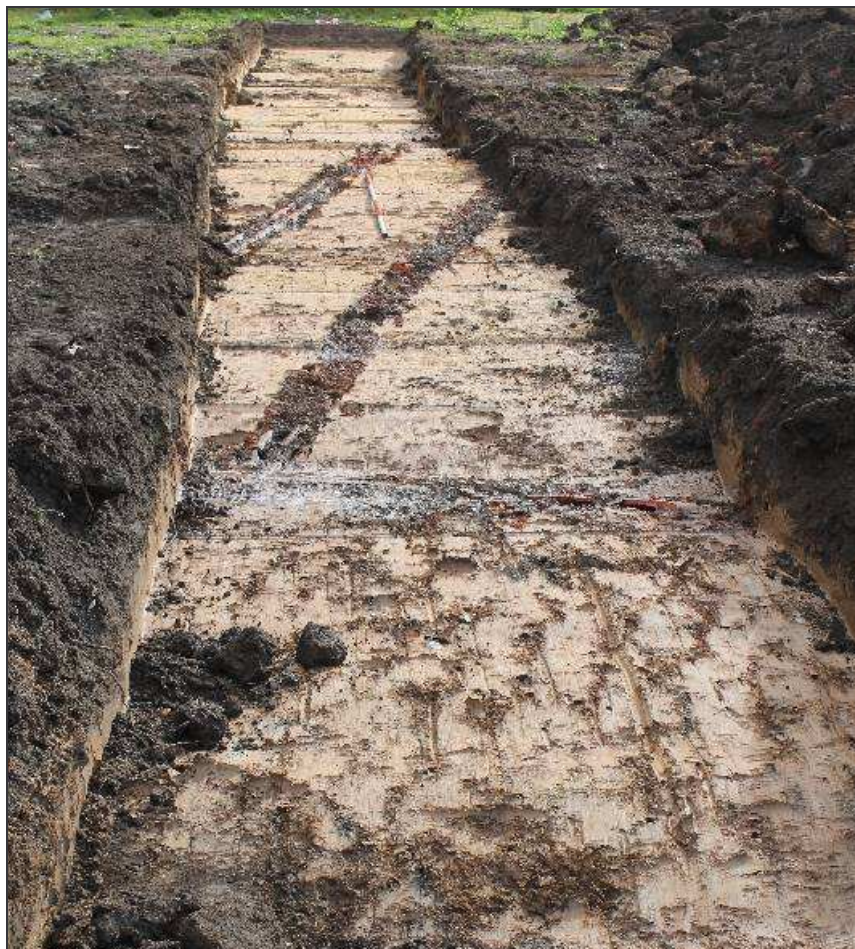
3.4.1 Trench 4 was located in the south-eastern corner of the site, on an area of grass land to the east of the original hospital building, and lay upon a broadly east/west alignment (Fig 2). Natural clays were encountered at a depth of 0.30m beneath the present ground surface, and three ceramic field drains were recorded cutting the natural across the centre of the trench. Two of the drains were aligned approximately east/west and, unusually, each cut contained two parallel drains. The third was aligned north/south, and contained just a single drain. All three drains and the natural clays were sealed beneath a layer of mid-yellowish-brown clay silt, containing fragments of modern demolition waste and rare sub-angular stones up to 10mm in size.

Plate 10: Trench 4, facing east, 2m scale

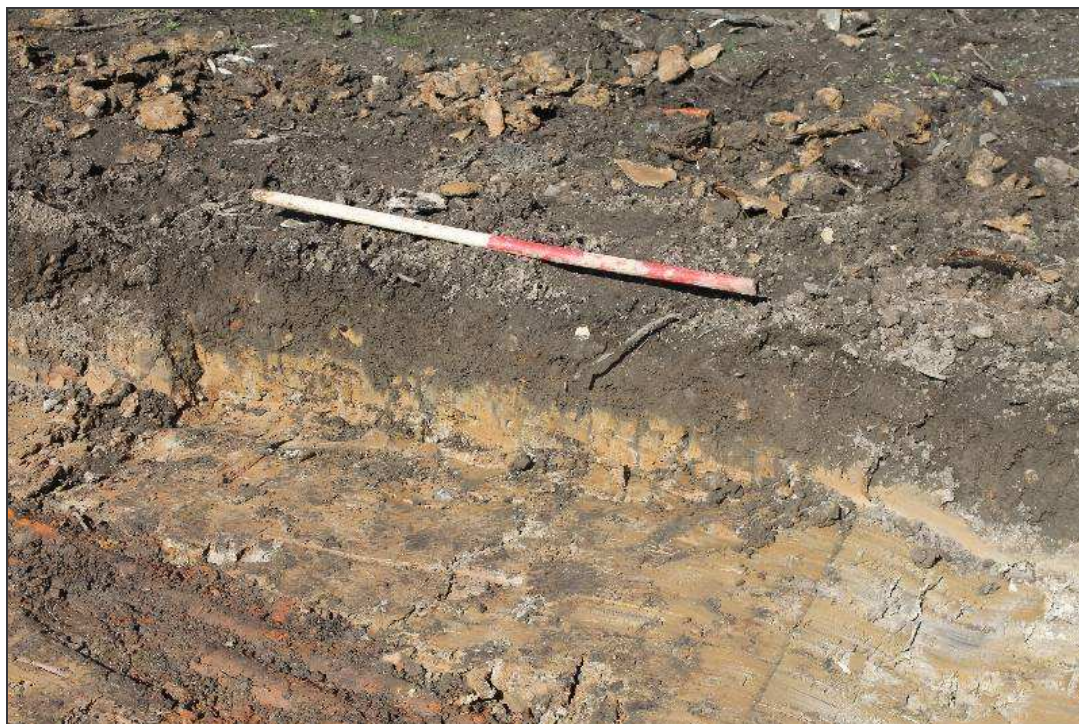
Plate 11: Trench 4, south-facing section, 1m scale

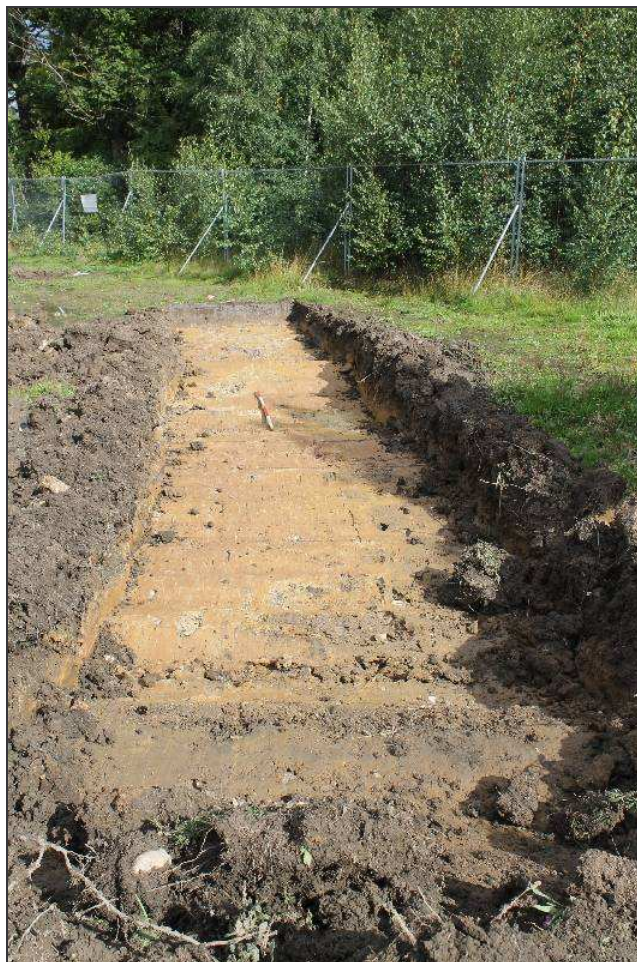
3.5.1 Trench 5 was placed in the south-eastern corner of the site, just a short distance to the south of Trench 4, and west of the footbridge crossing the slip road for the west-bound carriageway of the M60 motorway. It was aligned broadly north/south, and was the only trench with a length of 10m.

3.5.2 Natural clay was identified at a depth of only 0.40m below the modern ground surface, and was covered by a deposit of mid-yellowish-brown clay silt, identical to that described within Trench 4.

Plate 12: Trench 5, facing north, 2m scale

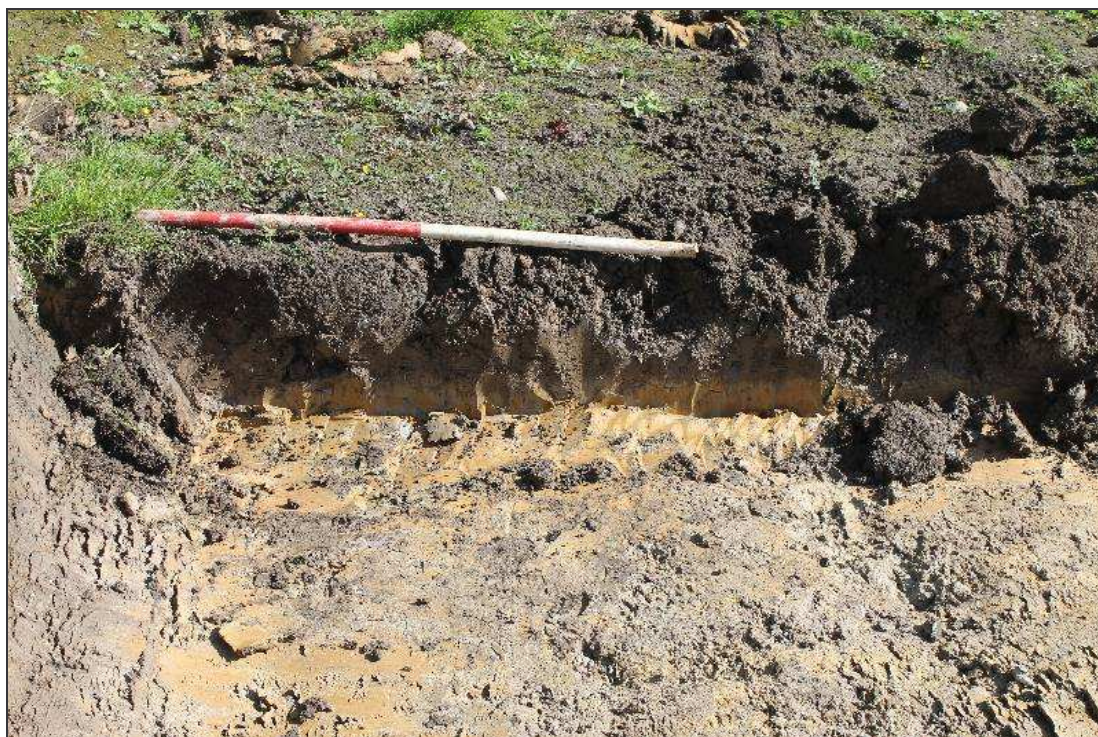
Plate 13: Trench 5, west-facing section, 1m scale

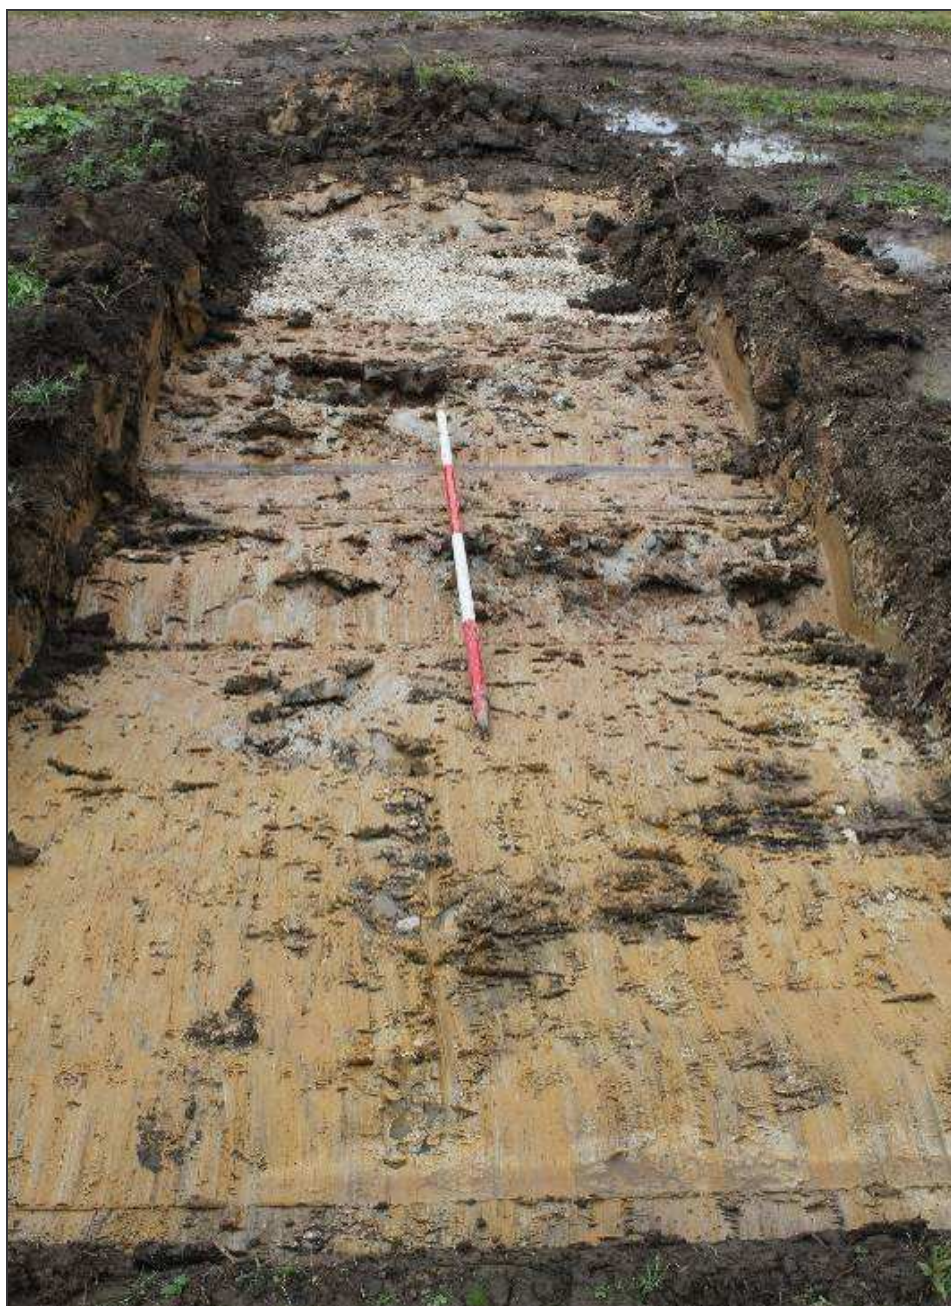
- 3.6.1 Trench 6 lay within the south-eastern corner of the site to the south-west of trenches 4 and 5, and was located upon a broadly east/west alignment (Fig 2). It was the only trench with a length of 5m, allowing it to be placed in the southern portion of the grassed area, and its excavation revealed natural clays at a depth of 0.36m. The cut of a modern drain was identified at the western end of the trench, backfilled with gravel, and both the drain and natural clay was covered to the present ground surface by a layer of mid-yellowish-brown clay silt, containing fragments of modern demolition waste and rare sub-angular stones up to 10mm in size.
- 3.6.2 No archaeological features were identified within the trench.

Plate 14: Trench 6, facing west, 2m scale

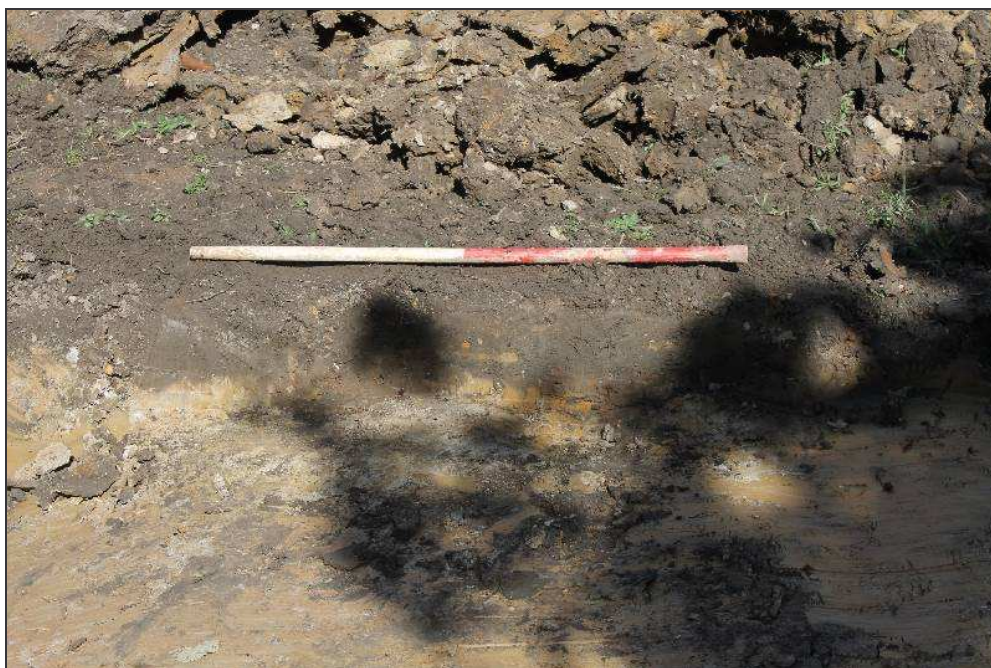
Plate 15: Trench 6, south-facing section, 1m scale

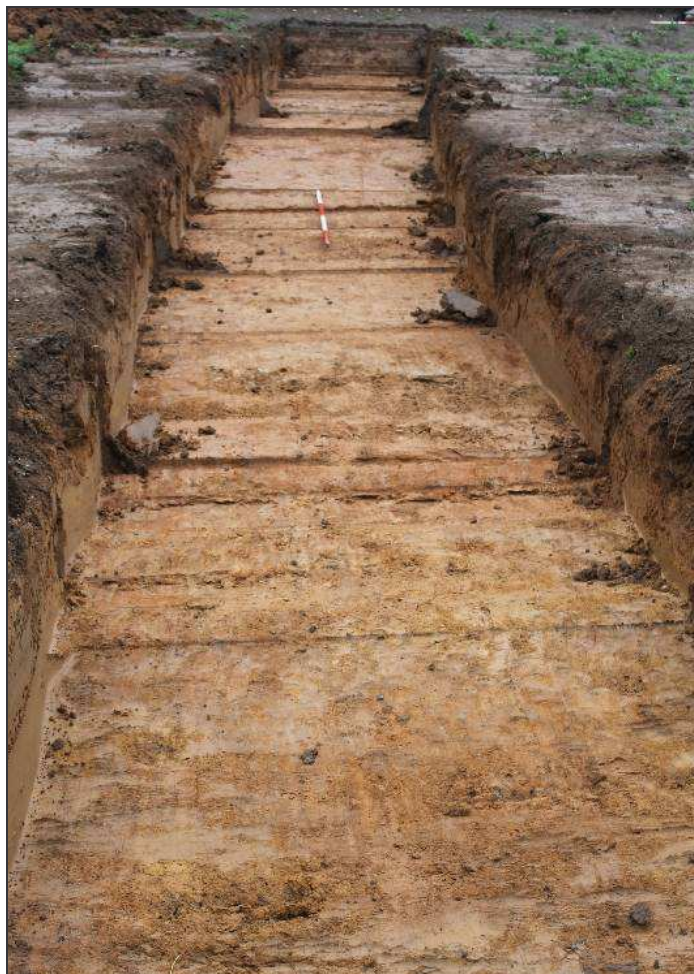
- 3.7.2 Trench 7 was aligned east/west, and its location was moved slightly further to the north than originally designed to avoid an area of rubble spoil, which covered the southern end of the site. Its excavation revealed mid-orangey-yellow coarse sandy clay, with occasional patches of grey gleying and alluvial gravels at a depth of 0.65m.

- 3.7.3 The natural geology was sealed beneath a deposit of mid-brownish-yellow clay silt subsoil with very rare sub-angular and sub rounded stone up to 10mm in size. The subsoil reached a maximum thickness of 0.4m, and was overlain by mid-yellowish-brown topsoil to a maximum depth of 0.25m. The topsoil contained occasional sub angular to sub-rounded stones up to 0.20m in size and included fragments of nineteenth century and later pottery and ceramic building material throughout.

Plate 16: Trench 7, facing east, 2m scale

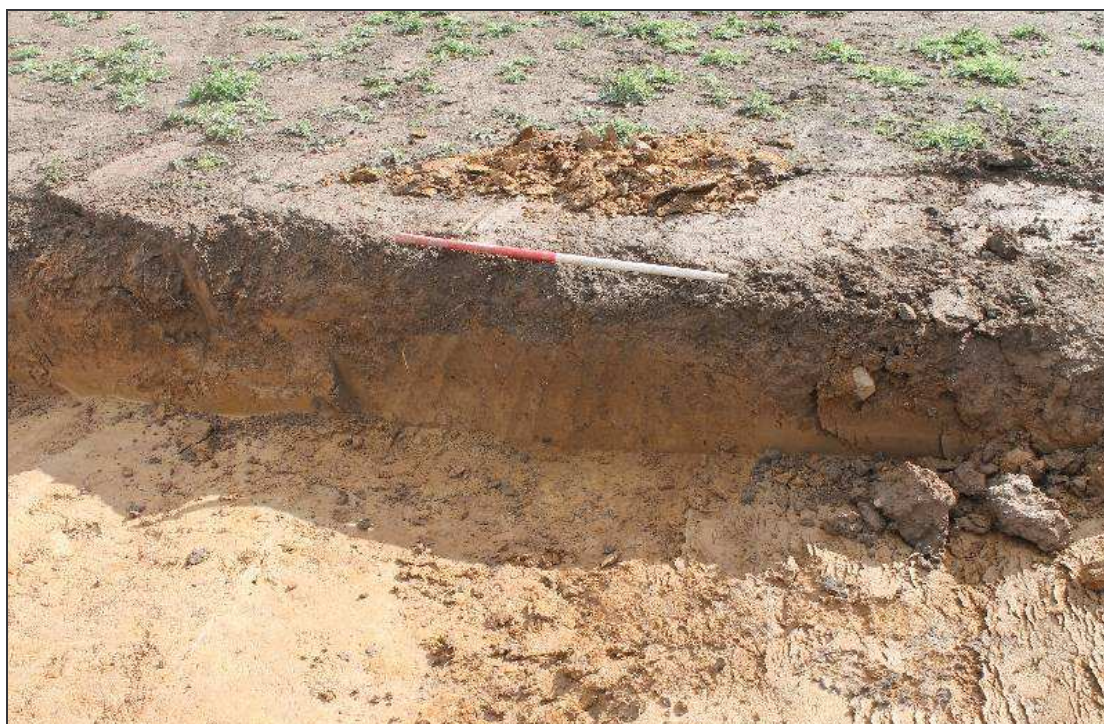
Plate 17: Trench 7 north-east-facing section, 1m scale

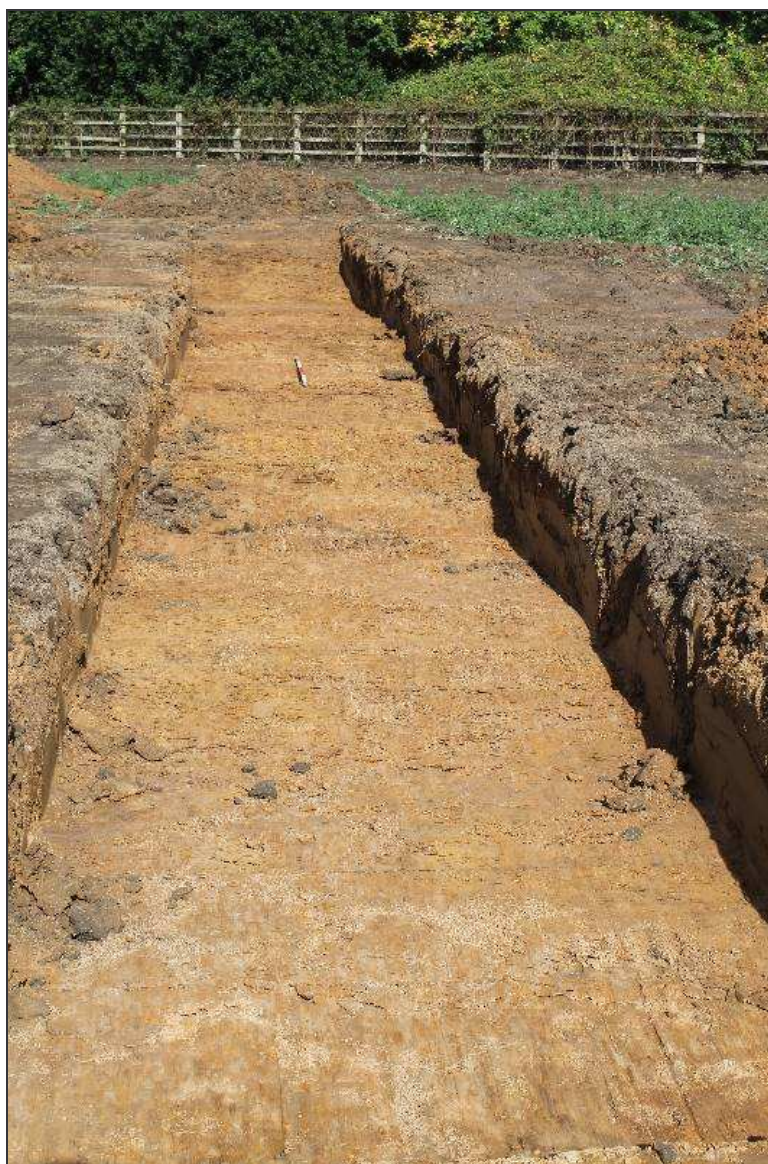
- 3.8.1 Trench 8 was placed a short distance to the north west of Trench 7, and placed on a north-east/south-west alignment (Fig 2). It was located slightly further to the north-east than originally designed to avoid an area of flooding and also to incorporate a linear feature which had been noted during the walk-over survey.

- 3.8.2 The excavation of the trench revealed natural clays sands and gravels identical to that recorded in Trench 7 at a depth of 0.68m. The natural was covered by a layer of mid-brownish-yellow clay silt subsoil, identical to that described in Trench 7, to a maximum thickness of 0.5m. A ceramic field drain had been cut into the subsoil on a north-east/south-west alignment, and the cut backfilled with a mixture of subsoil and topsoil. The field drain and subsoil was overlain by the surviving lower portions of the mid-yellowish-brown topsoil to a thickness of up to 0.15m.

Plate 18: Trench 8, facing north-east, 2m scale

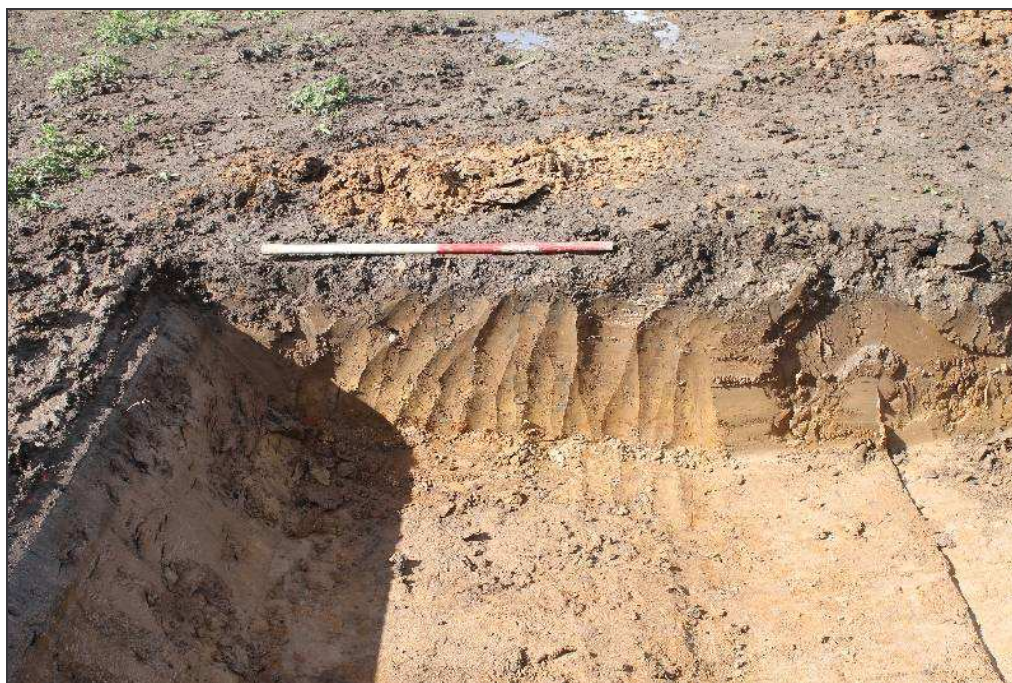
Plate 19: Trench 8, south-east-facing section, 1m scale

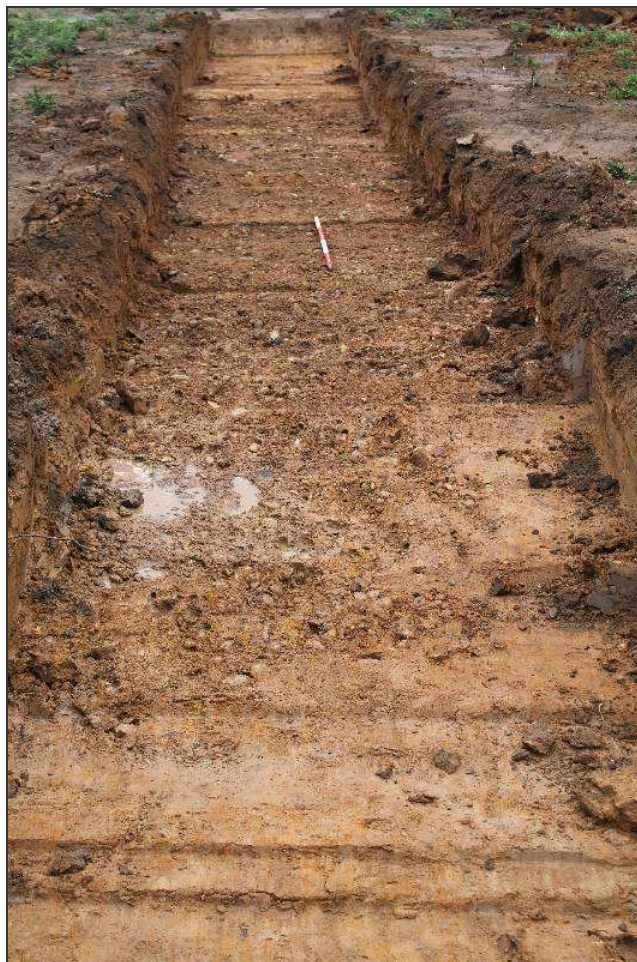
3.9.1 Trench 9 was placed to the north of Trench 8, along the north-eastern boundary of site (Fig 2). It was aligned broadly north/south, and was excavated to a maximum depth of 0.65m, where undisturbed natural soils were encountered. The natural was similar to that described in Trench 7, with mid-orangey-yellow coarse sandy clays, but in this case included a band of alluvial gravels across the centre of the trench. A sondage excavated into the gravel band showed it to have irregular edges and be entirely sterile of archaeological material, confirming it to be of natural origin. A layer of mid-yellowish-brown clay silt overlay the natural to a depth of 0.45m, which in turn was covered by 0.20m of mid yellow brown clay silt topsoil.

Plate 20: Trench 9, facing north, 1m scale

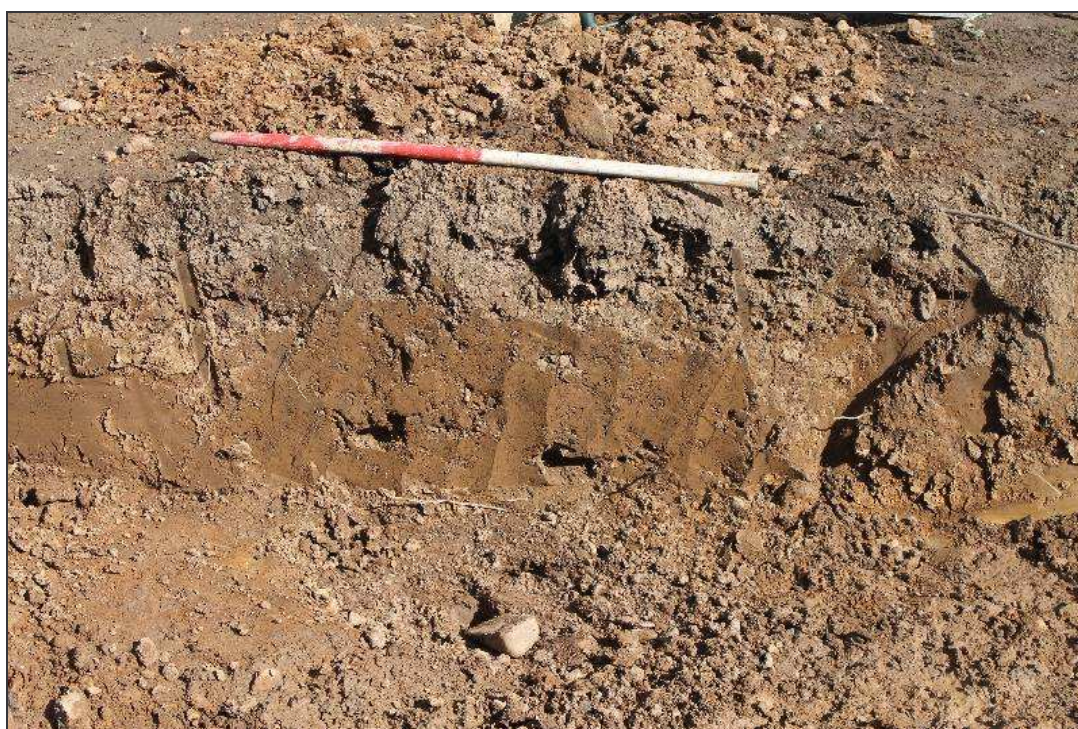
Plate 21: Trench 9, west-facing section, 1m scale

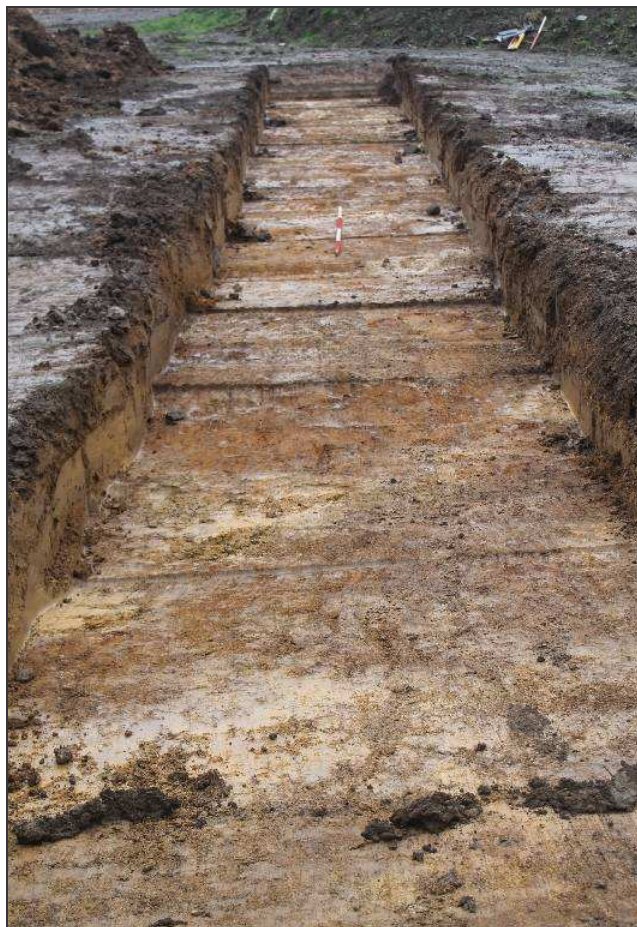
3.10.1 Trench 10 lay to the west of Trench 8, and was aligned approximately north/south. Its final location was adjusted further to the east to avoid a large spoil heap and area of flooding. Excavation revealed natural coarse sands and gravels at a depth of 0.6m, overlain by a layer of mid-yellowish-brown clay silt subsoil 0.4m thick. A mid-yellowish-brown clay silt topsoil, 0.20m thick covered the trench to the present ground surface.

Plate 22: Trench 10, facing south, 2m scale

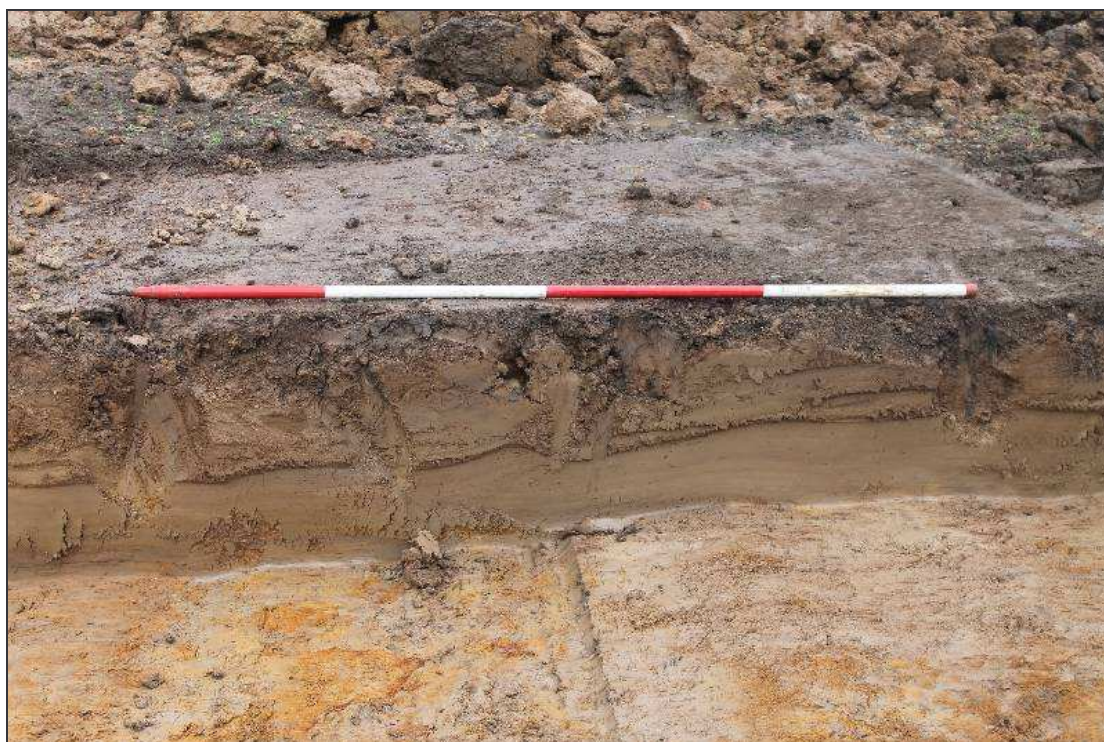
Plate 23: Trench 10, west-facing section, 2m scale

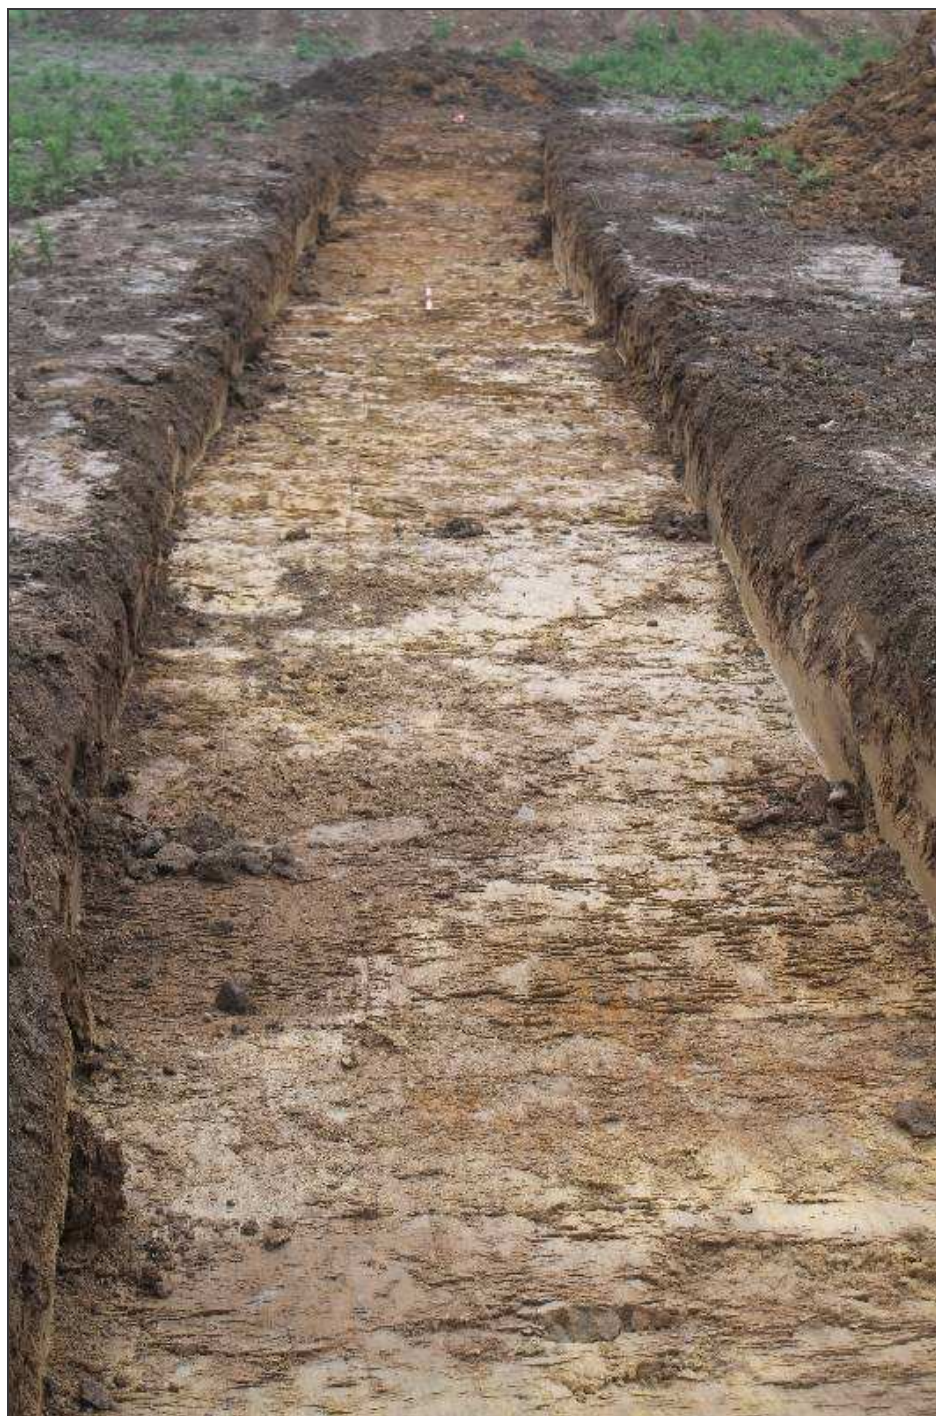
3.11.1 Trench 11 lay in the north-eastern corner of the study area, and was aligned north-east/south-west (Fig 2). Coarse natural clays were revealed at a depth of between 0.65m and 0.70m below the present ground surface, and were covered by mid-brownish-yellow clay silt subsoil up to 0.50m thick. Mid-yellowish-brown clay silt topsoil, 0.20m thick, overlay the subsoil to the top of the trench.

Plate 24: Trench 11, facing north-east, 2m scale

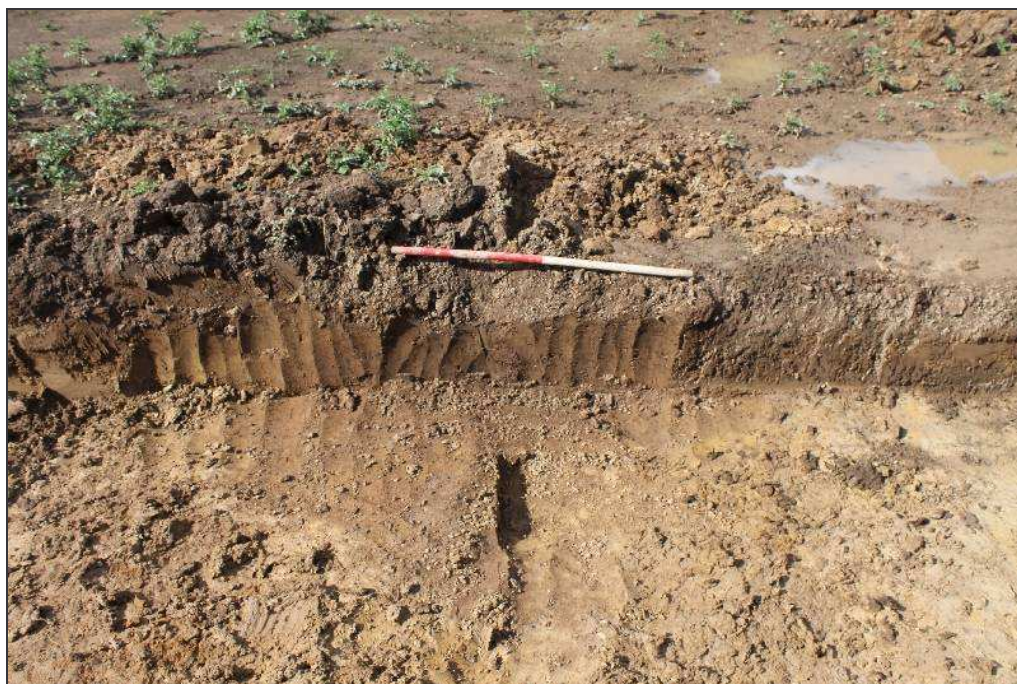
Plate 25: Trench 11, south-east-facing section, 1m scale

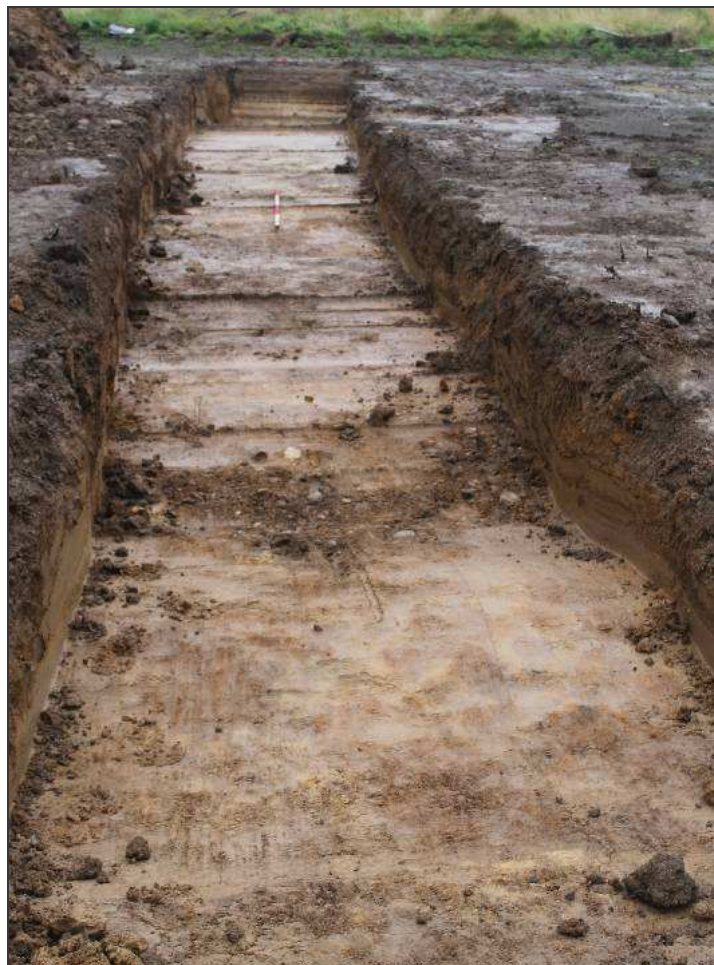
3.12.1 Trench 12 lay a short distance to the north-west of Trench 11, and was moved slightly further to the east of its intended location to avoid an existing spoil heap. It was placed on an east/west alignment, and was excavated to a depth of 0.6m, where undisturbed natural clay was encountered. A sondage, excavated at the western end of the trench, established the continuation of the clays, along with thin bands of fine orange sands and gravels to a depth in excess of 1.1m. The natural geology was overlain by a deposit of mid-brownish-yellow subsoil, 0.50m thick, which in turn was covered by a mid-yellowish-brown clay silt topsoil of between 0.05 and 0.10m thick.

Plate 26: Trench 12, facing west, 2m scale

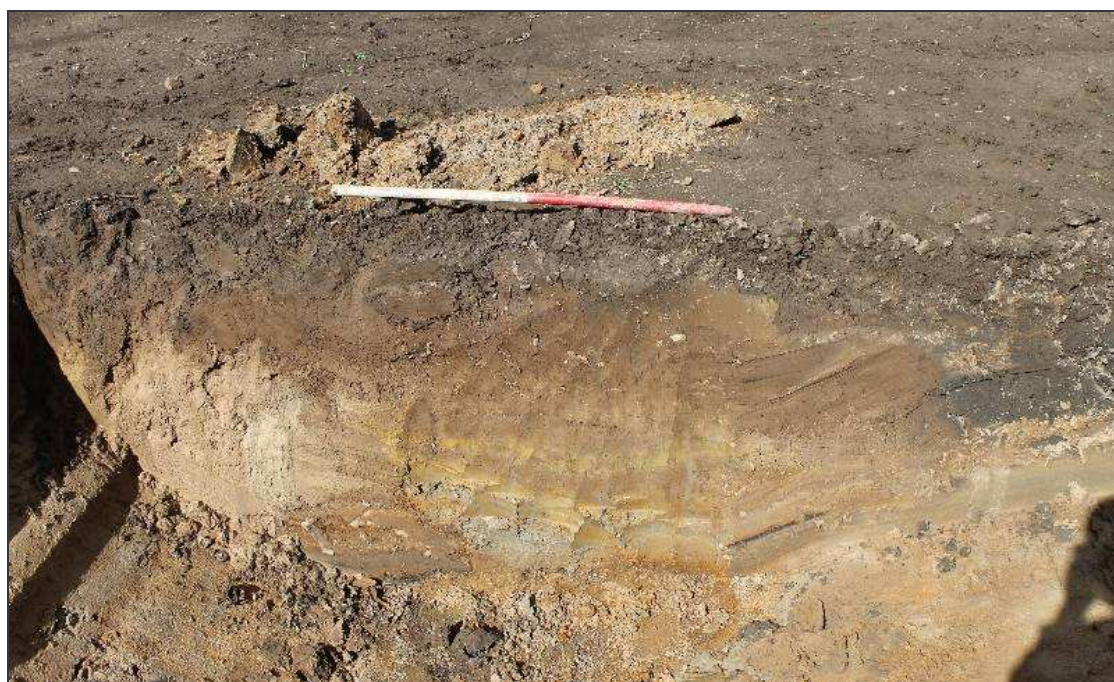
Plate 27: Trench 12, south-west-facing section, 1m scale
