**Barnes Hospital,
Cheadle,
Stockport,
Greater Manchester**

**Archaeological
Evaluation**

Oxford Archaeology North

September 2015

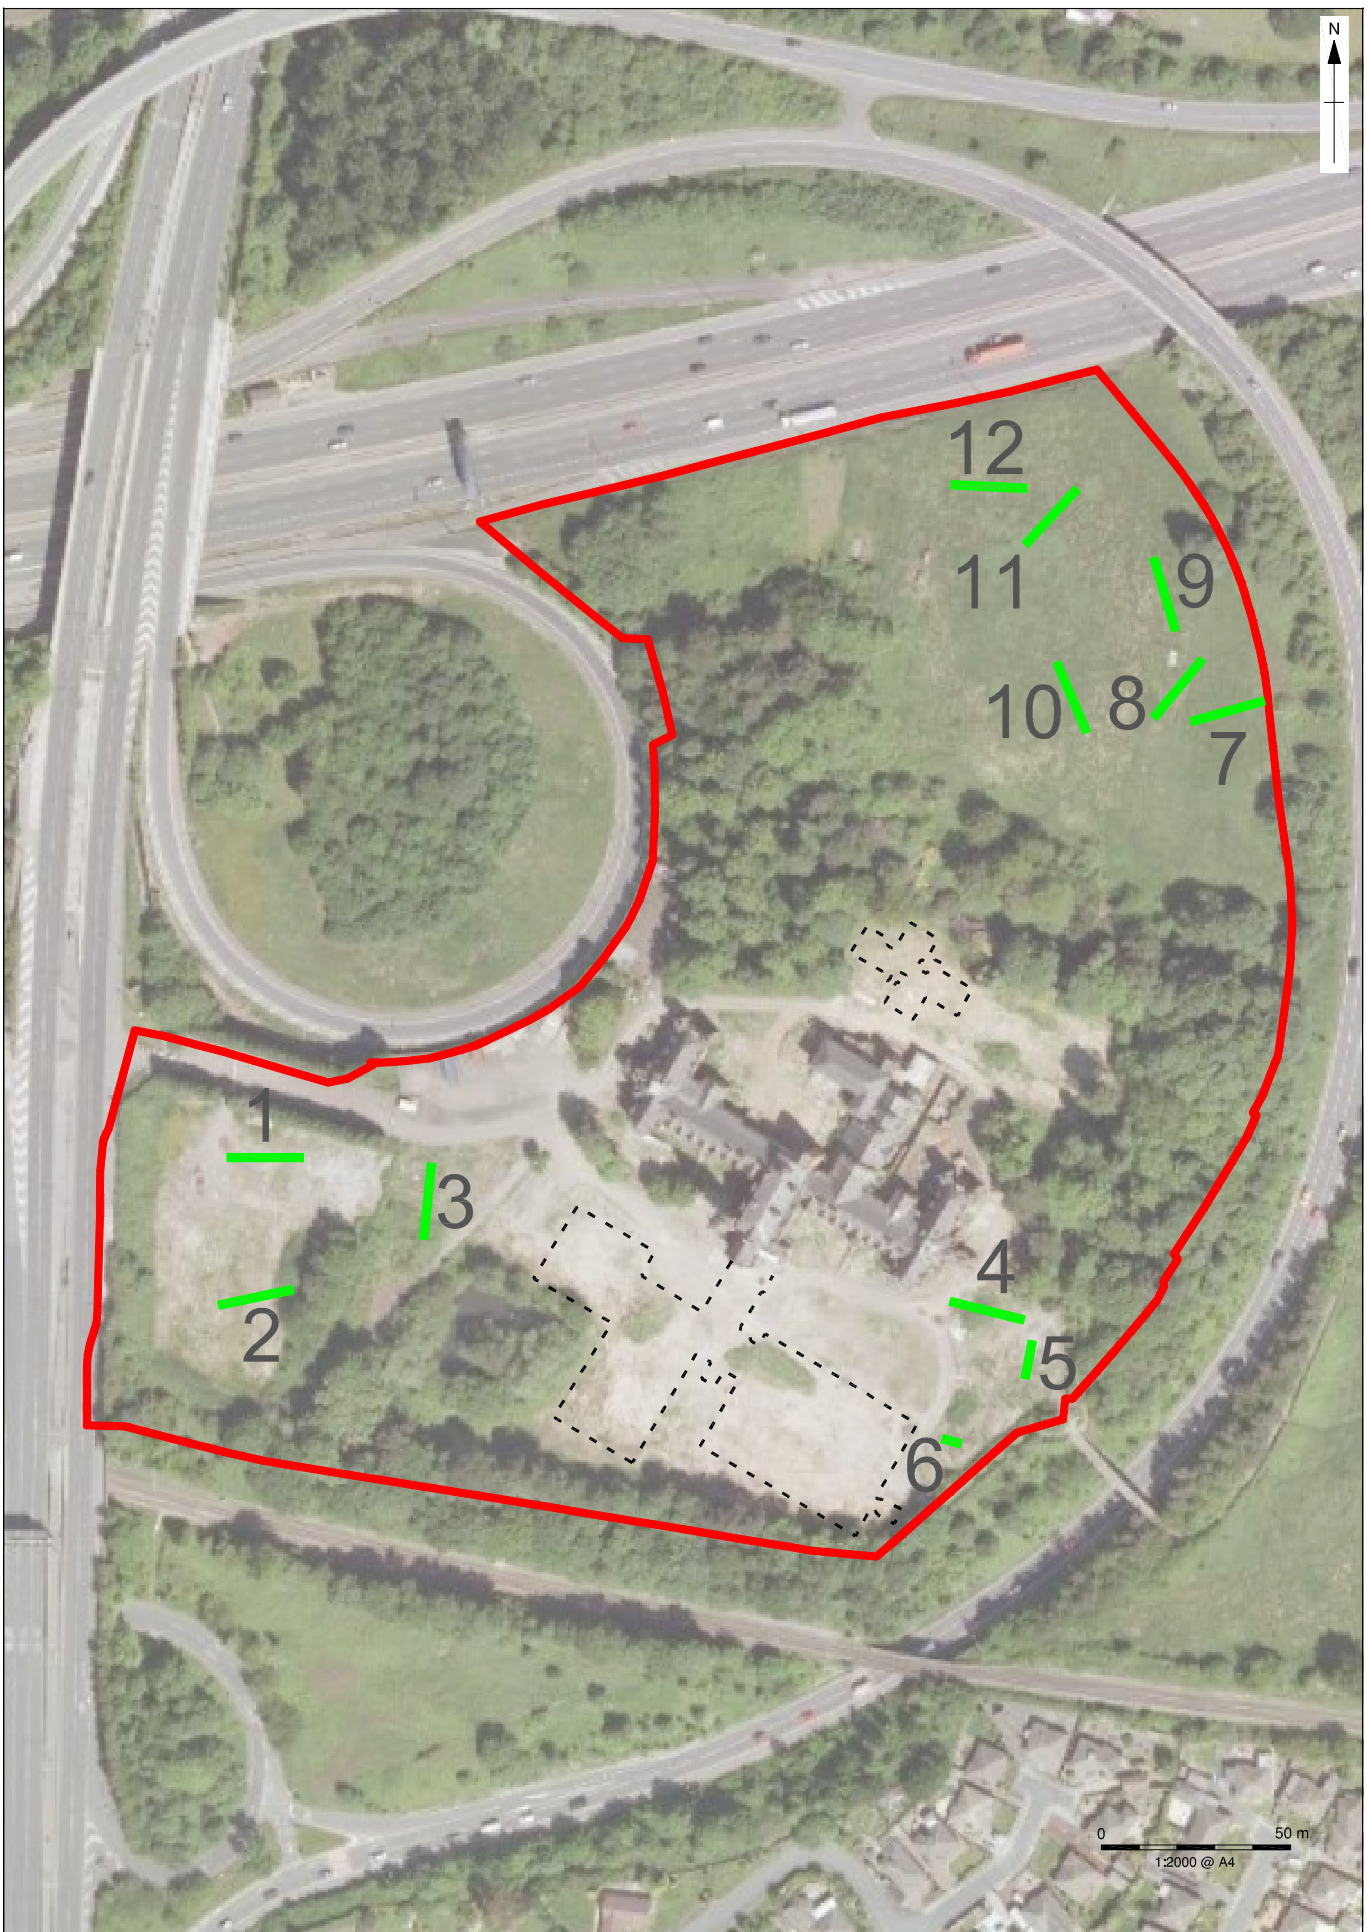
Figure 2: Plan showing position of evaluation trenches

3.1.1 A total of 12 trenches were excavated during the course of the evaluation (Fig 2), in accordance with the approved Written Scheme of Investigation (*Appendix 1*). Each trench had a length of 20m and a width of 2m, except trenches 5 and 6, which measured 10m and 5m long respectively. A summary of the results obtained from each trench is presented below
