Archaeological Evaluation

Abney Court,
Manchester Road,
Cheadle, Stockport.

Technical Report:
Andrew McGuire

Report No: 26/2013

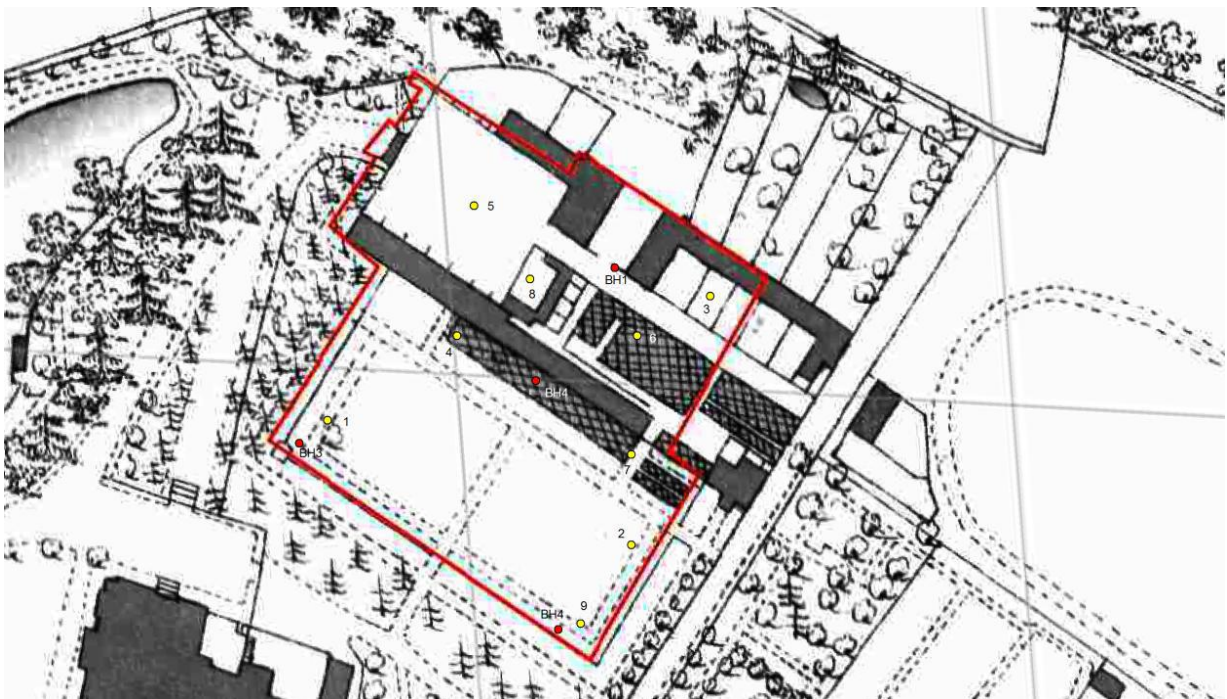
Figure 2. Locations of boreholes and watching brief geotechnical pits (Wellicome, 2013).

The results of the watching brief showed that one trial pit (2) and one bore hole (BH4) produced evidence for archaeological remains (**Fig.3**). These were interpreted as being partial foundations for the structures seen on the 1872 OS map (Ibid). It was also noted that undulations in the ground level, across certain areas of the car park, may also fit the alignment of these same structures.

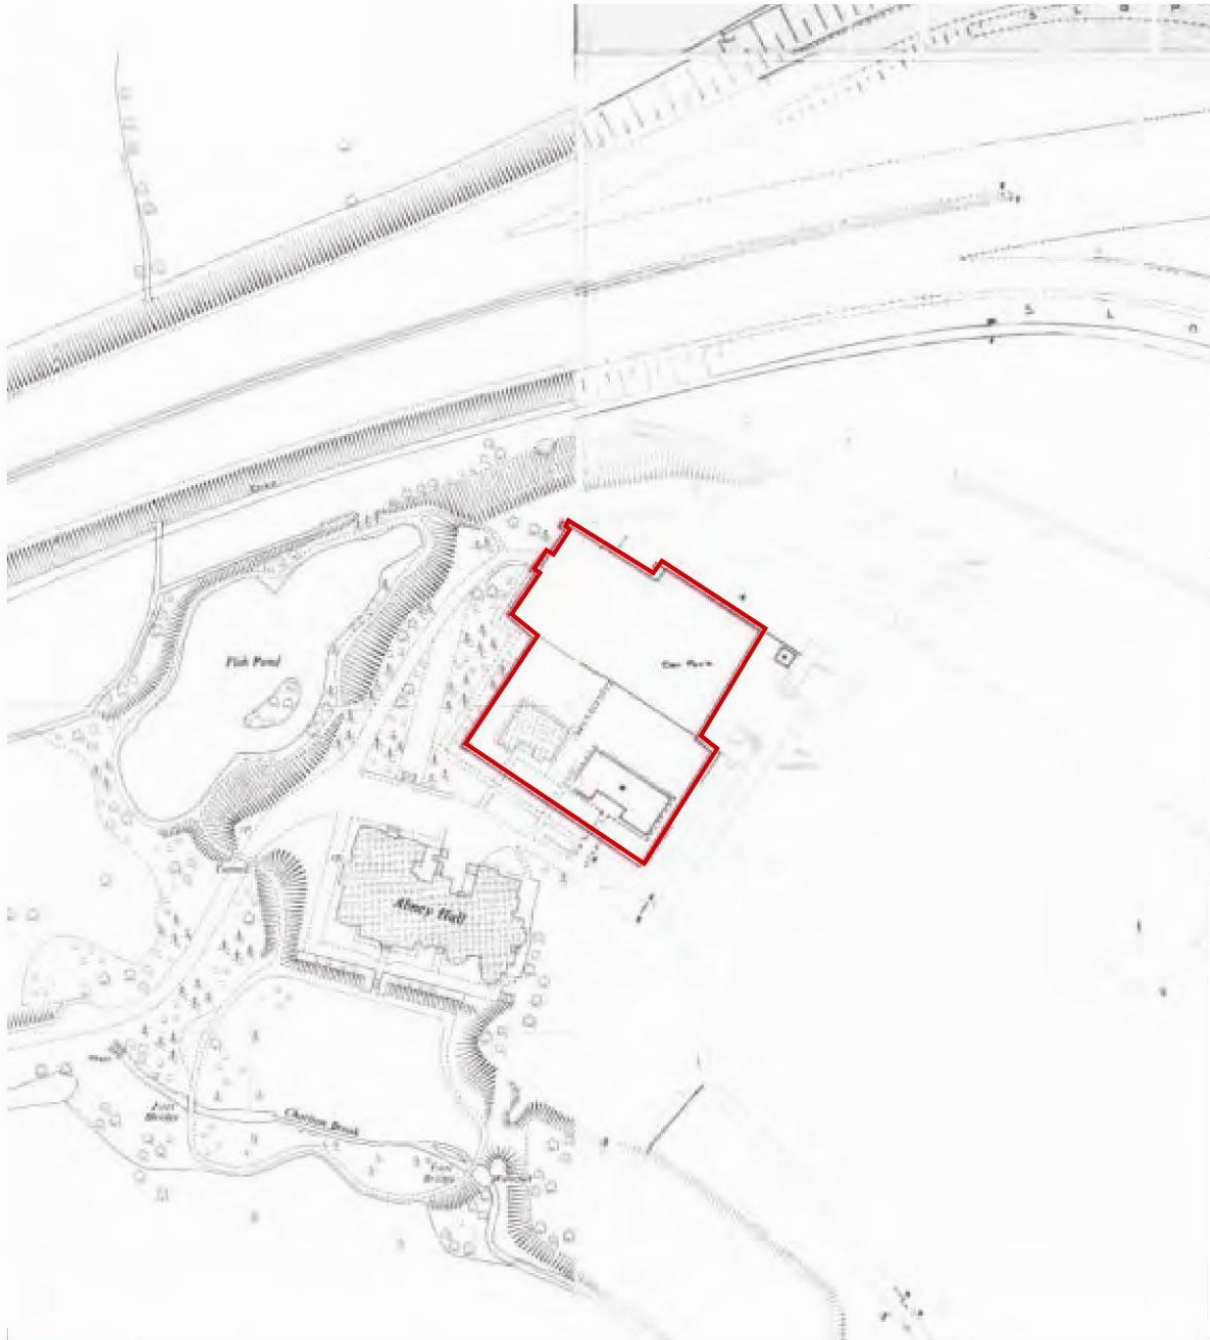
Figure 7. 1977 OS map

By 1977 several major changes have taken place (**Fig.7**). In the southern half of the study area the symmetrical pathways and garden structures have been replaced by two fairly large U-shaped buildings. In the middle of the study area, part of the original garden wall can be seen. This was presumably the wall from which the south facing glasshouse, seen in earlier maps, was attached. Finally the 1977 map shows that the whole of the northern half of the study area has been cleared and is marked 'car park'

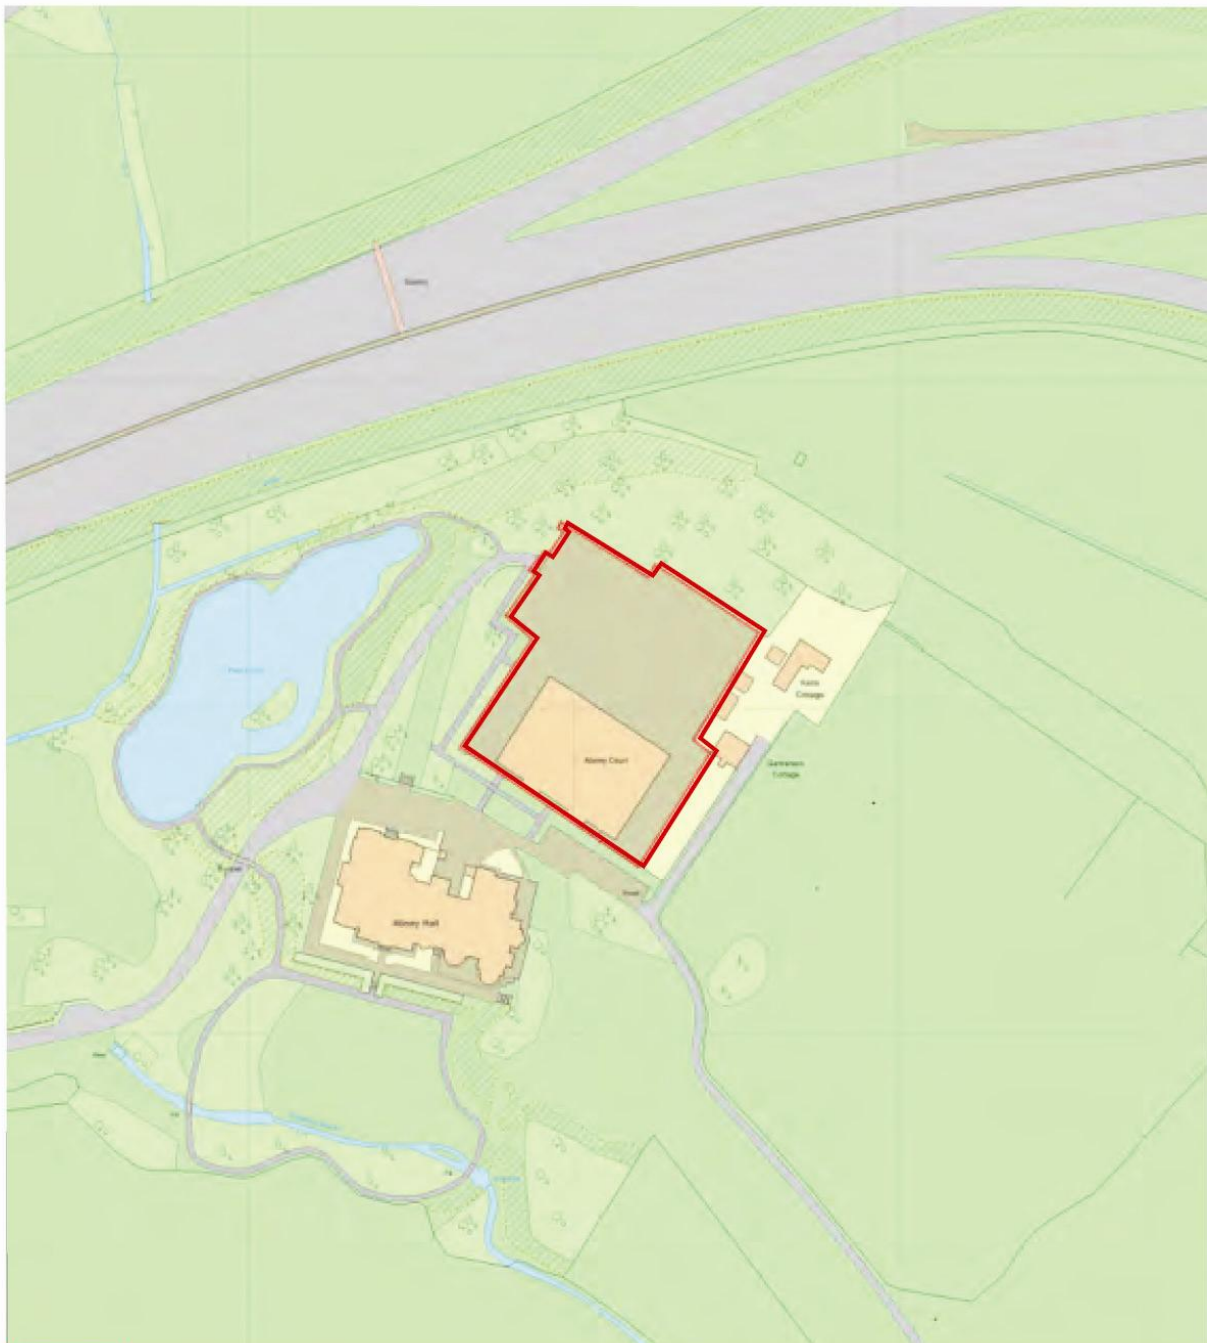
Figure 8. 2011 modern map

The 2011 map (**Fig.8**) shows the study area as it is today. The buildings seen on the 1977 map, within the southern half of the study area, have been replaced by the Abney Court offices. The northern half of the study area is unchanged.

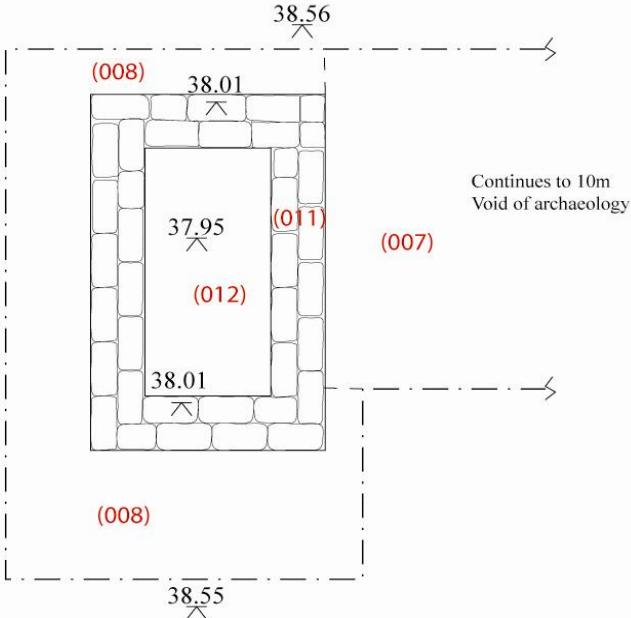
Figure 10. Plan of Trench 1.

Investigations revealed archaeological deposits underlying (008). This took the form of a 1.63x1.03m, enclosed, rectilinear wall (011) orientated north-east south-west. The structure consisted of two horizontal courses of handmade bricks measuring 0.23m x 0.11m x 0.07m. Three vertical courses were also observed but seen to continue to an unknown depth. No foundation cut was observed. A compact, mid-brown/white clay sand, containing frequent <0.05m sub-angular inclusions (012), of unknown depth, was observed within the area that (011) enclosed (**Fig.16**).

Trench 1 was largely barren of archaeology. However, a single feature (010) was observed at the north-western end of the trench. (010) was observed to be more C20th in terms of construction and material composition and differed greatly from the features observed in trenches 5 and 6. It may also be noted that it doesn't tie in with any of the structures seen within historic mapping (**Figs.4-6**) or those in the trench results overlay (**Fig.12**). Due to the compact nature of the fill (012), it may be summarised that (010) may have been a 'filled-in' man-hole or similar structure of C20th origin.

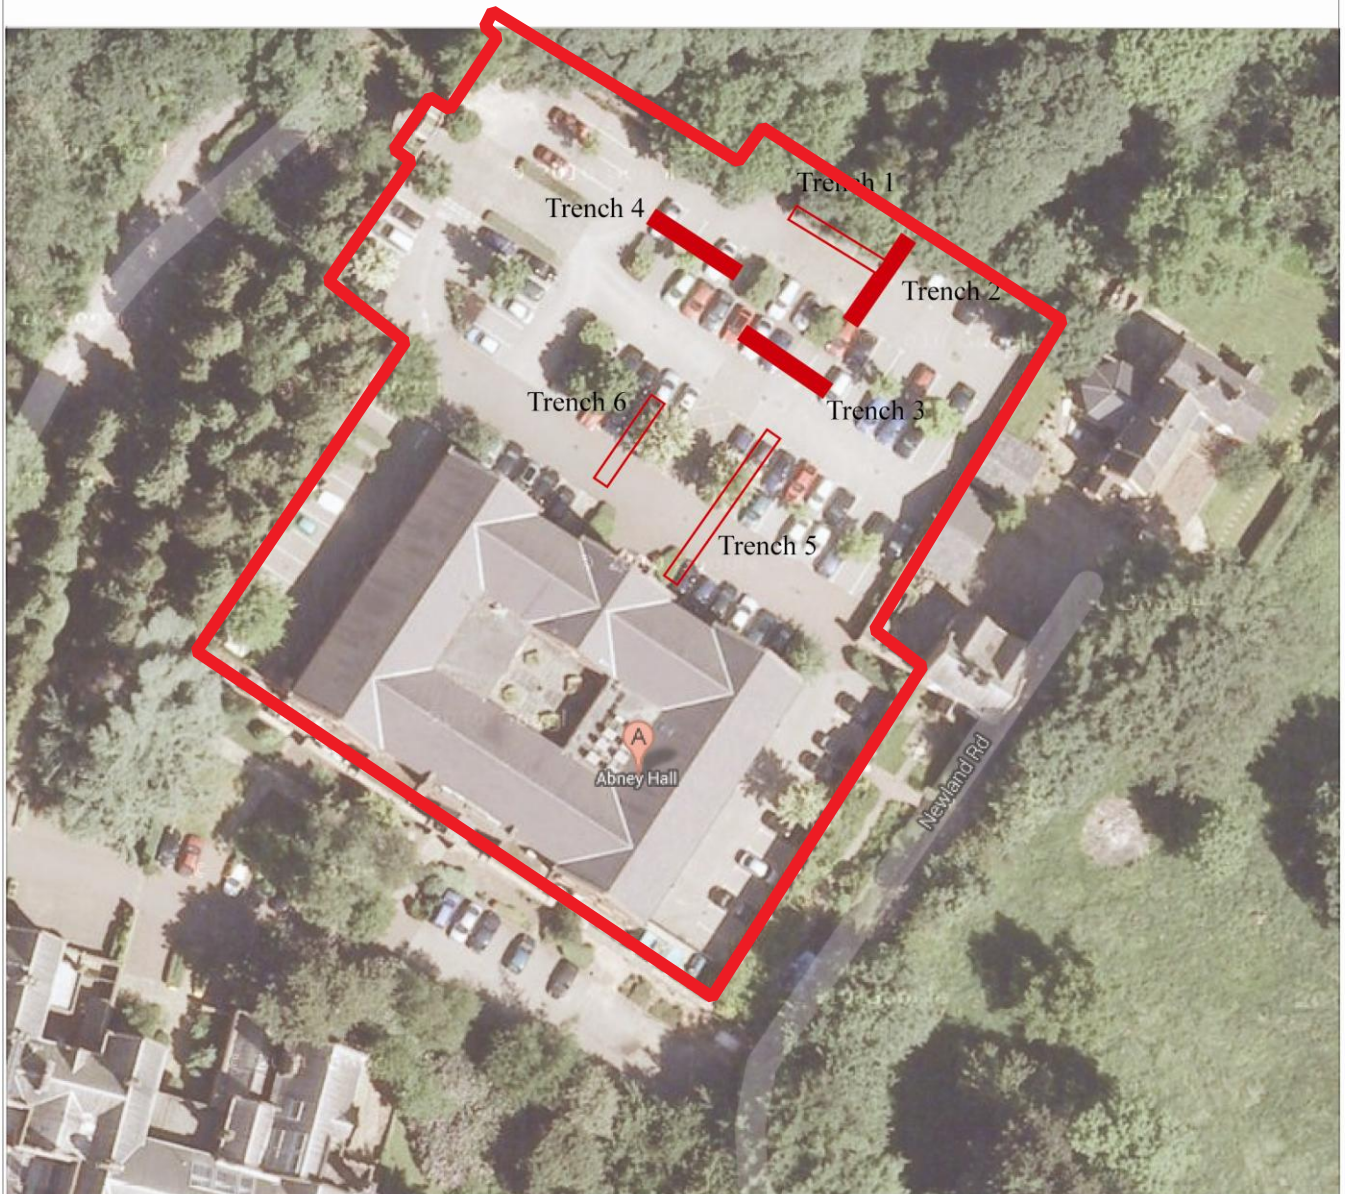
Figure 13. Study area and Trench locations overlain onto Google Maps

The work comprised of six evaluation trenches across the study area (**Fig.13**). The work was carried out in order to determine the presence, extent, depth, state of preservation and significance of the archaeological resource enabling informed recommendations to be made for the future treatment of any surviving remains. The significance of the archaeological resource has been assessed using NPPF (National Planning Policy Framework, March 2012).

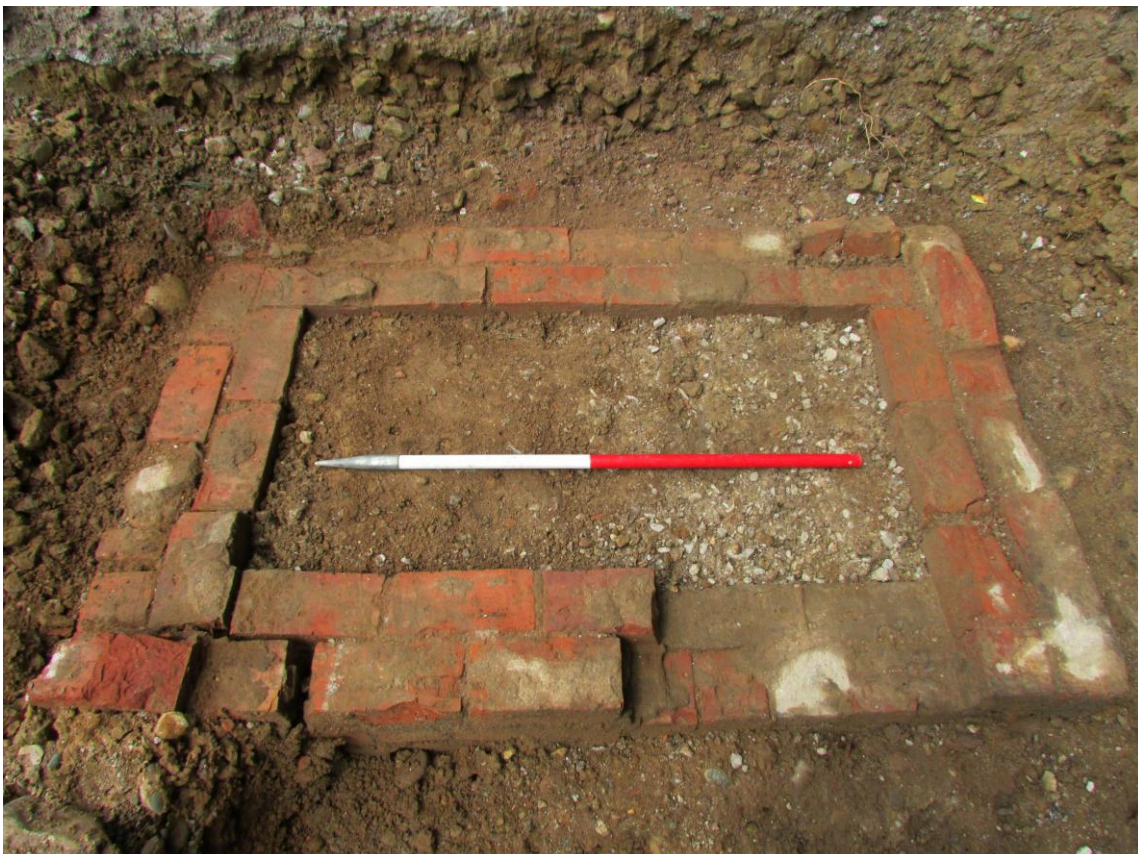
Figure 16. Shot of rectangular wall (011) and central fill (012), looking north-west.

Excavations of trenches 1, 2, 3 and 4 identified that no archaeological remains, relating to the gardens, have survived in the northern part of the study area. Trench 1 did contain a walled, rectangular structure with a very compact, mixed deposit within its center. This feature was not present in the historic mapping. It has therefore, been summarised to be a C20th feature as it clearly differs from the C19th remains found in trenches 5 and 6. It has been suggested that this object may have been a 'filled-in' man-hole.

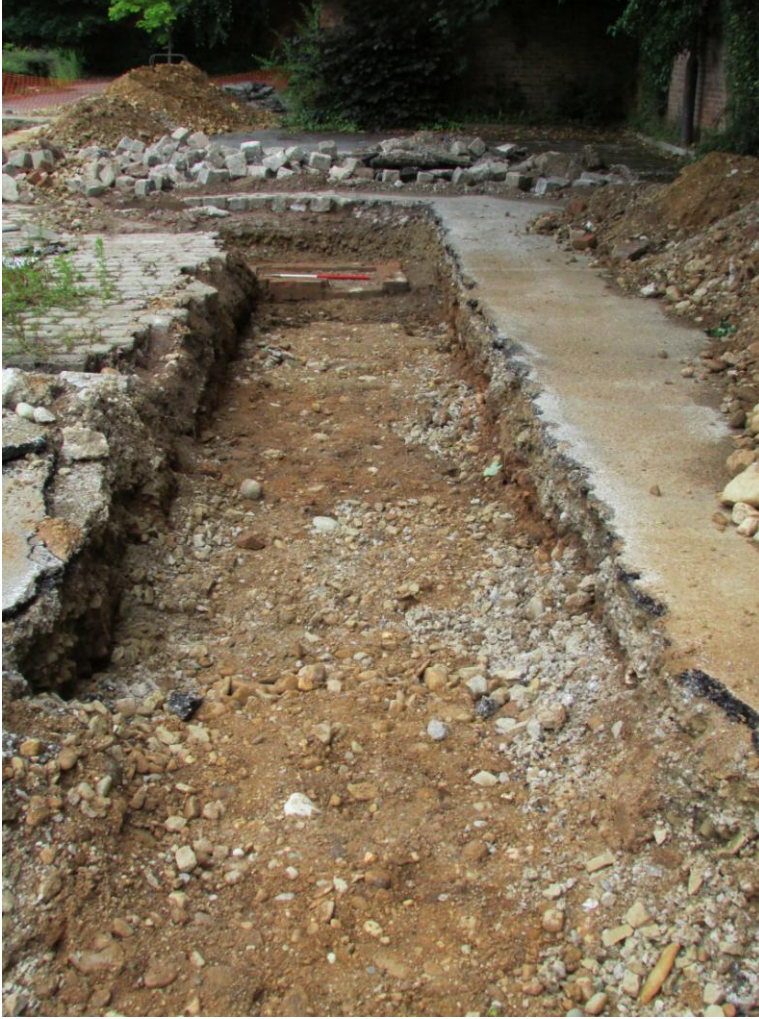
The general composition of the trench consisted of a 0.20m layer of a loosely compacted, light-brown sandy silt, containing abundant <0.05m, sub-angular inclusions (006), which overlay (007). Overlying (006) was a 0.10m thick layer of loosely compacted, light-grey/white <0.03m sub-angular stone inclusions (004), covered by a sealing layer of tarmac (001) (see **Fig.15**). At the North-western extent of trench 1 (006) was replaced by (008), a loosely compacted, mid-brown silty sand, containing frequent <0.10m sub-angular inclusions. (004) and (001) were replaced by (005) and (002) respectively. These layers formed a concrete foundation (005) with cobbled sets (002) above (**Fig.17**).

left **Figure 17.** General shot of Trench 1 after extension, looking north-west.

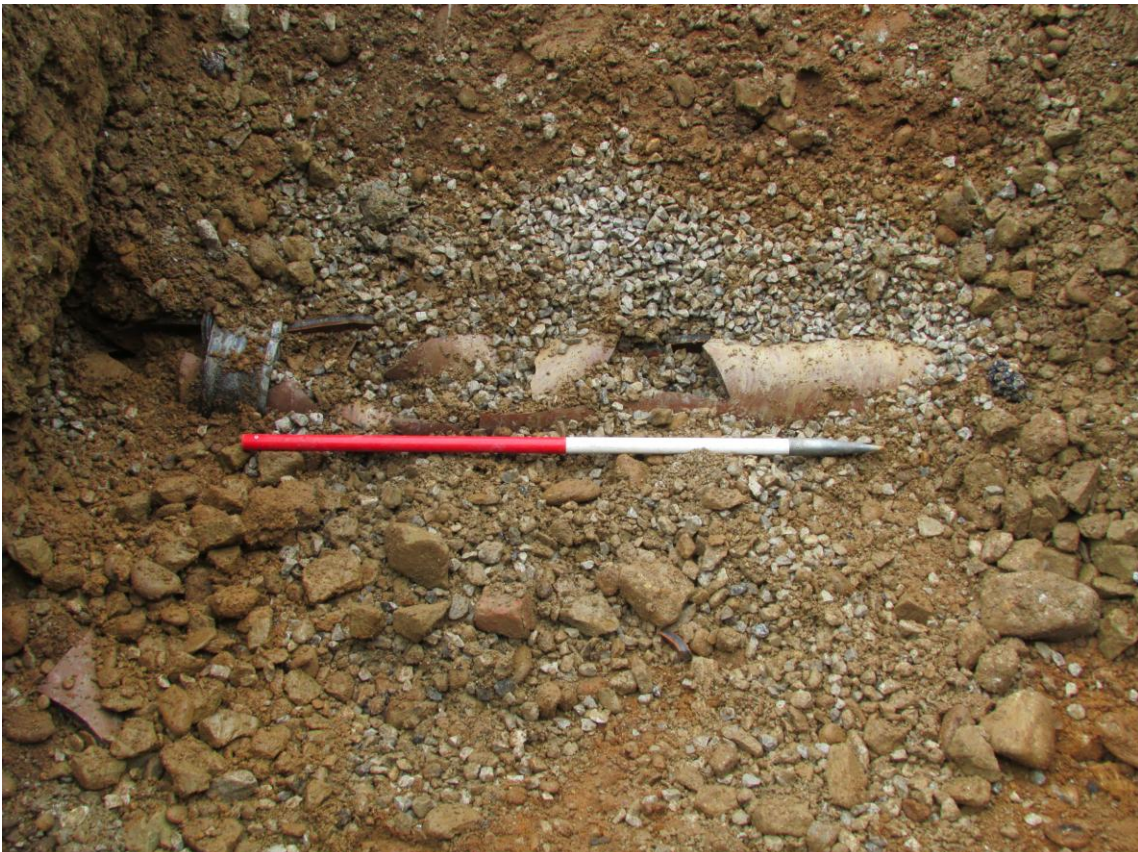
At the terminal ends of Trench 2 modern services were encountered running north-west south-east. The north eastern service was observed to be wiring contained within plastic piping and occurred at roughly 0.20m below the surface. The south-western service was a ceramic drain (**Fig.18**) which was packed by a loosely compacted light-grey/white layer of <0.03m sub-angular gravel (009). The drain and (009) were contained within (008). This

below **Figure 18.** Shot showing modern service in trench 2. Looking south-west.

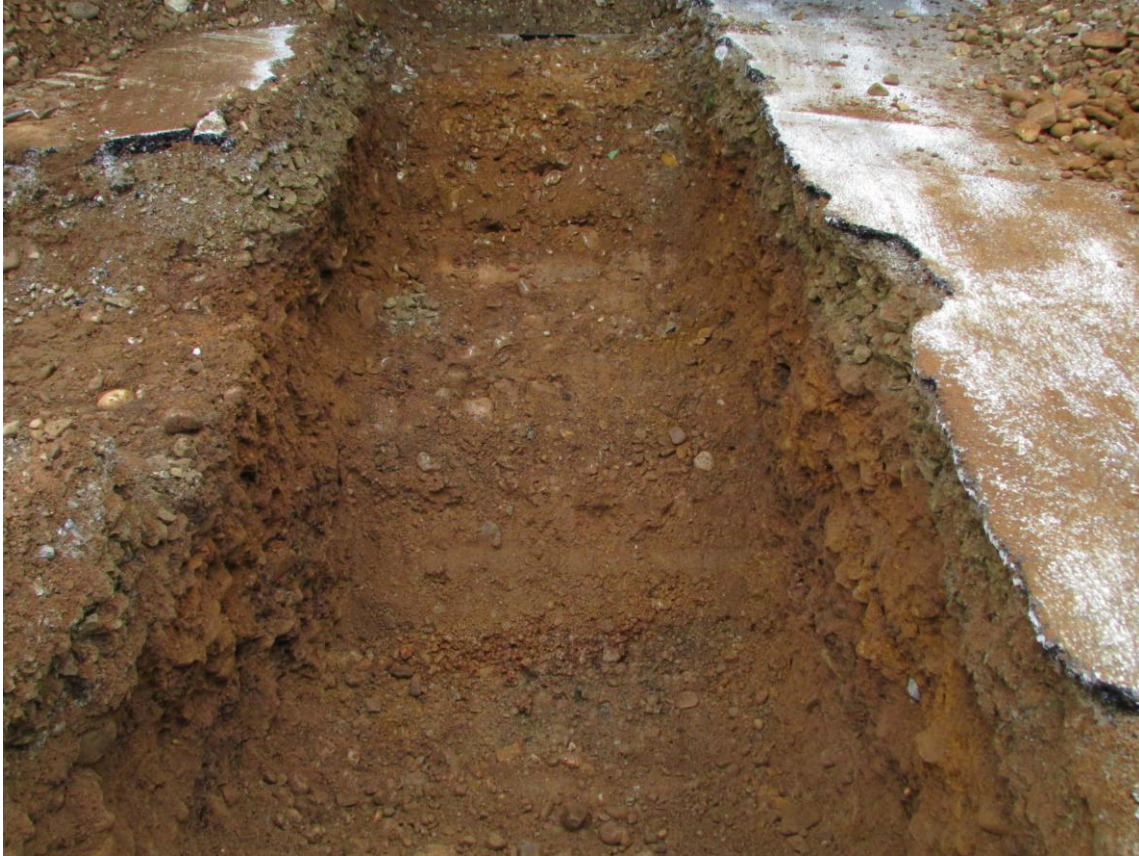
Figure 19. General shot of trench 2. Looking north-east.

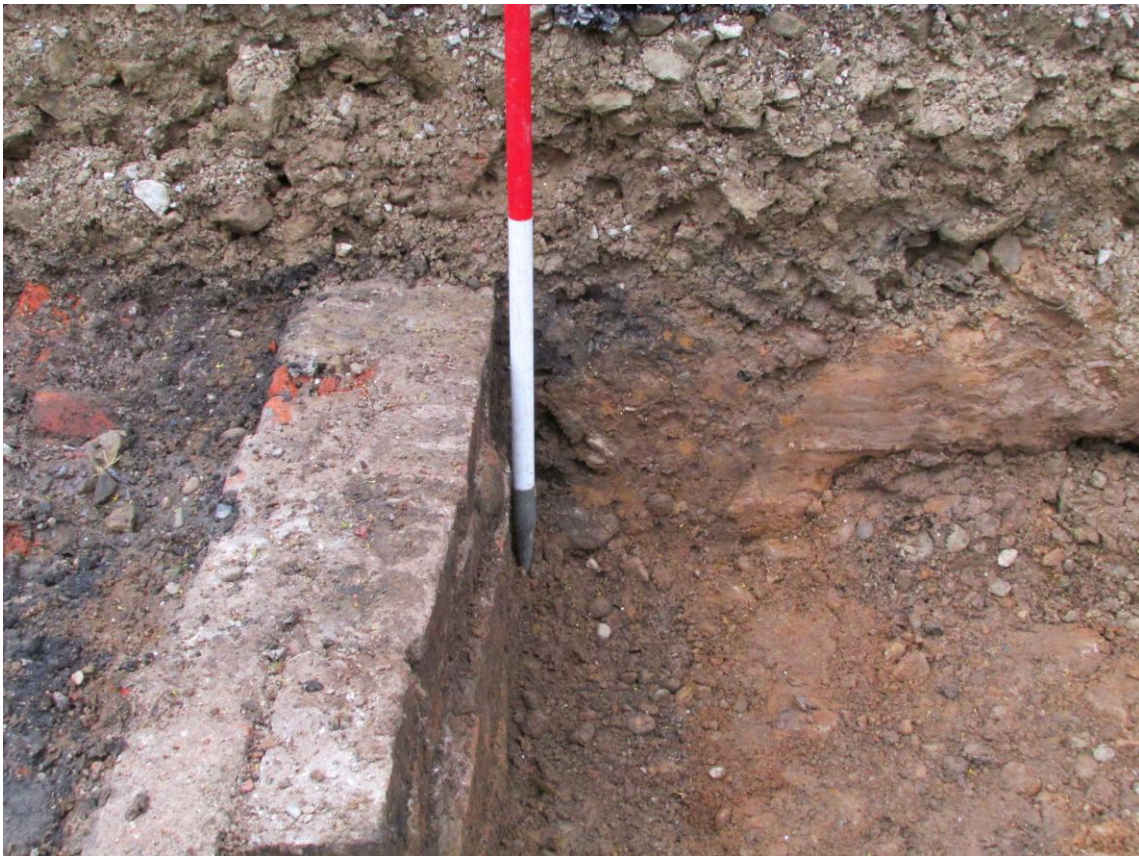
Figure 20. Shot of trench 5 south-east facing section showing [015]/(016). Looking north-west.

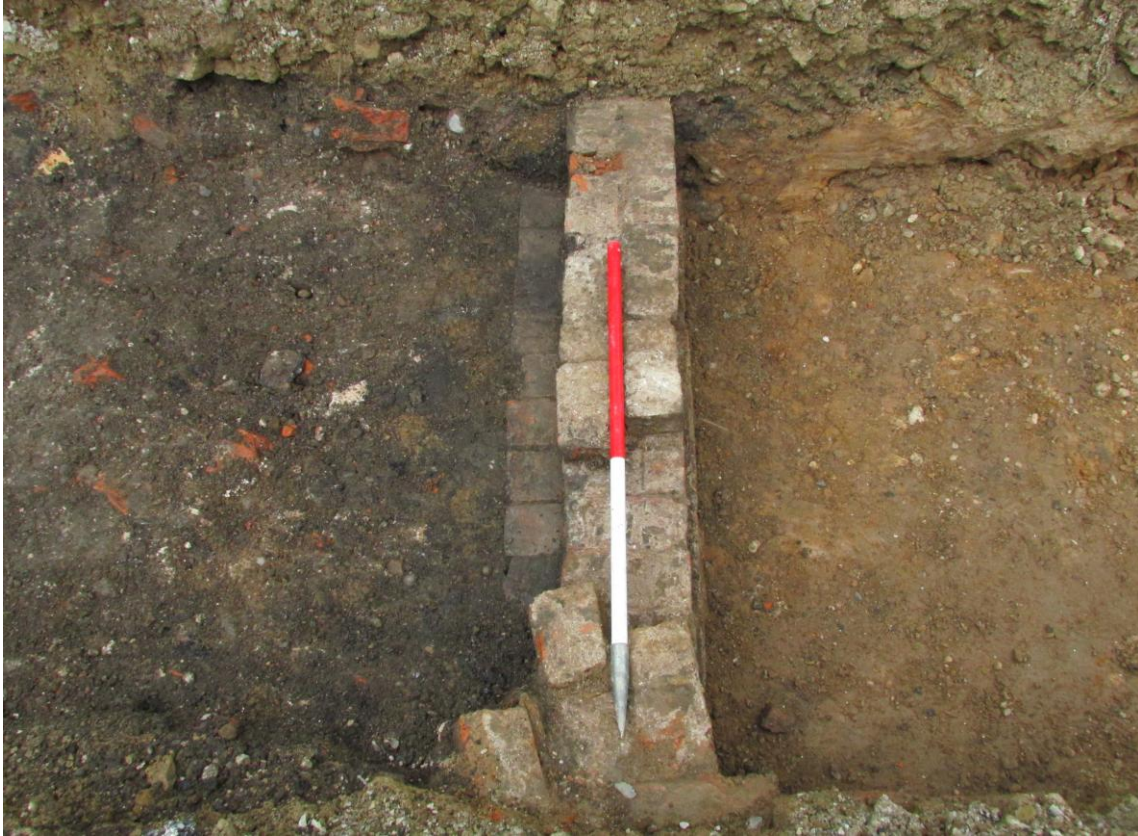
(014)	T5	Hand-made brick wall, located in middle of T5 and running NW-SE. Seen for 1.6m, continues NW into baulk. As it enters SE baulk, turns 90 degrees and runs along NE facing section for 0.50m. 5 courses deep, 2 wide at top seen at 3 wide. EGW bond with grey/brown mortar. Average brick size: 0.23mx0.11mx0.07m
[015]	T5	Foundation cut for (014). Seen in both sections. NW facing section suggests (014) heads SW into Baulk.

Figure 21. Trench 5: shot of wall (014) with natural (007) *right* and demolition layer (017) *left*. Looking north-west.

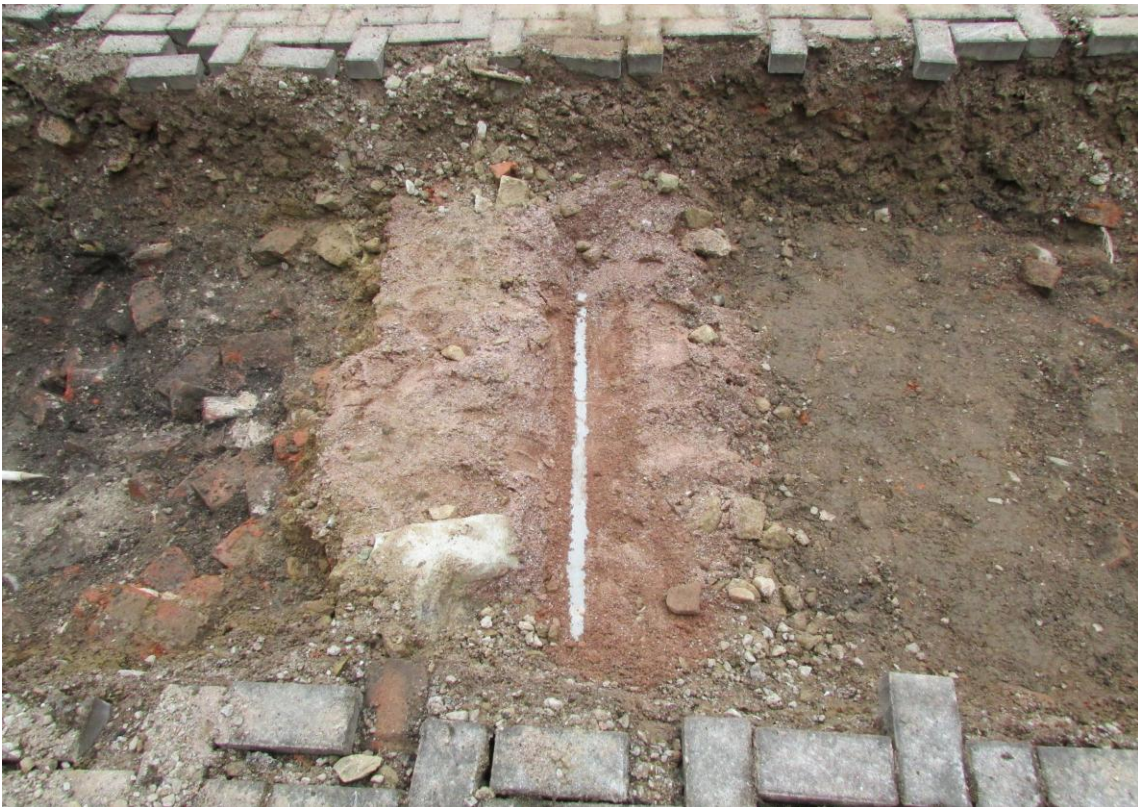
Figure 22. Modern BT service in trench 5. *To left* (017). *To right* (019)

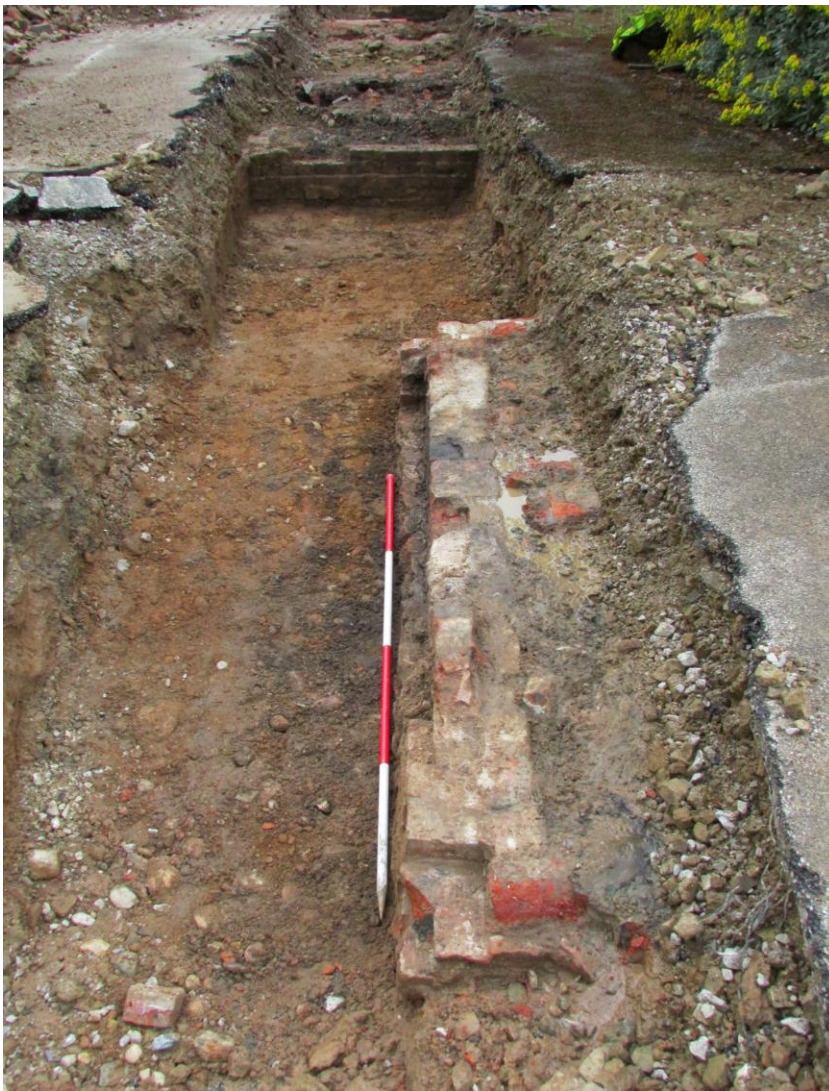
Finally the map over-layer shows that (013) ties directly into the south-eastern wall of the small glasshouse, orientated north-east south-west. The construction of (013) suggests that this building may have been partitioned. However, this is not observed in the mapping evidence.

left **Figure 23.** Shot of wall (013) in trench 5. Looking south-west

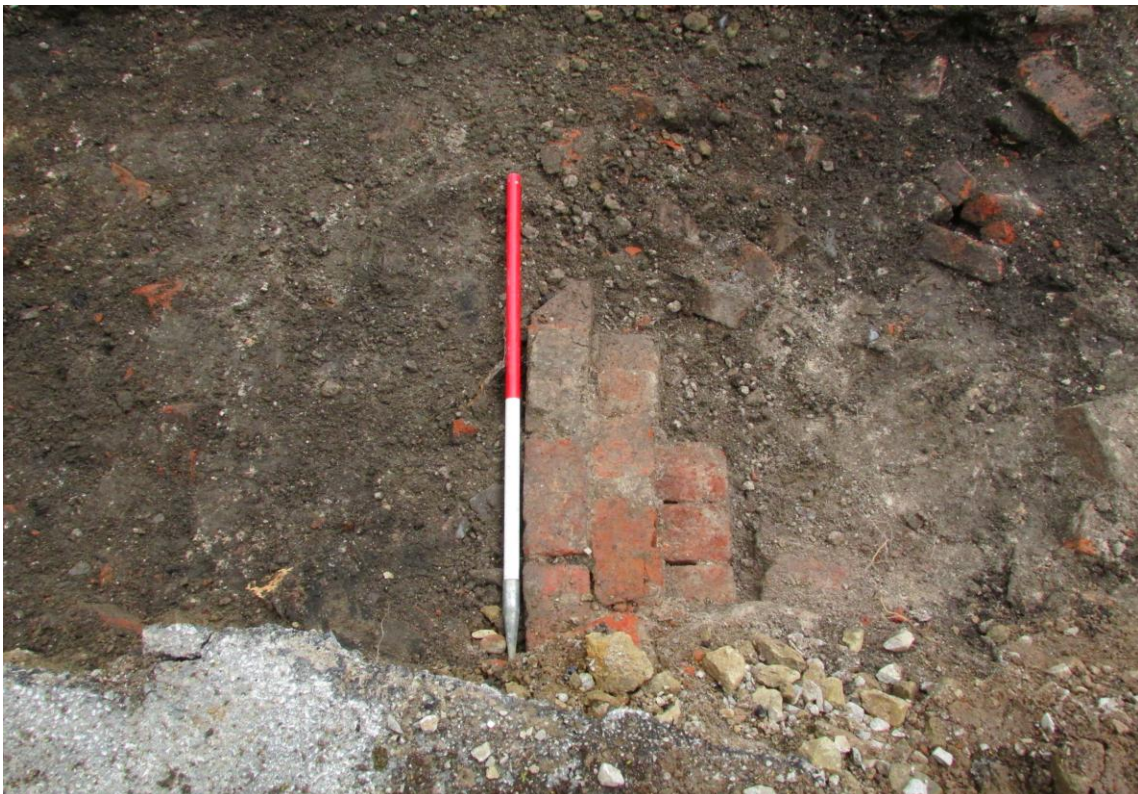
Three more walls were observed in the north-eastern half of trench 5. Two of these, (018) and (014), were again orientated along the same alignment. However, (018) terminated towards the middle of the trench with a deliberate trapezoidal facing. Observations made in trench 6 may suggest that this wall formed part of a gateway. The only wall that didn't match trench 5's general north-west south-east orientation was (013). The construction of this wall was similar to the others in trench 5 but areas of excessive lime mortar made it look fairly crude in places.

below **Figure 24.** shot of trapezoidal wall (018) in trench 5. Looking south-east.

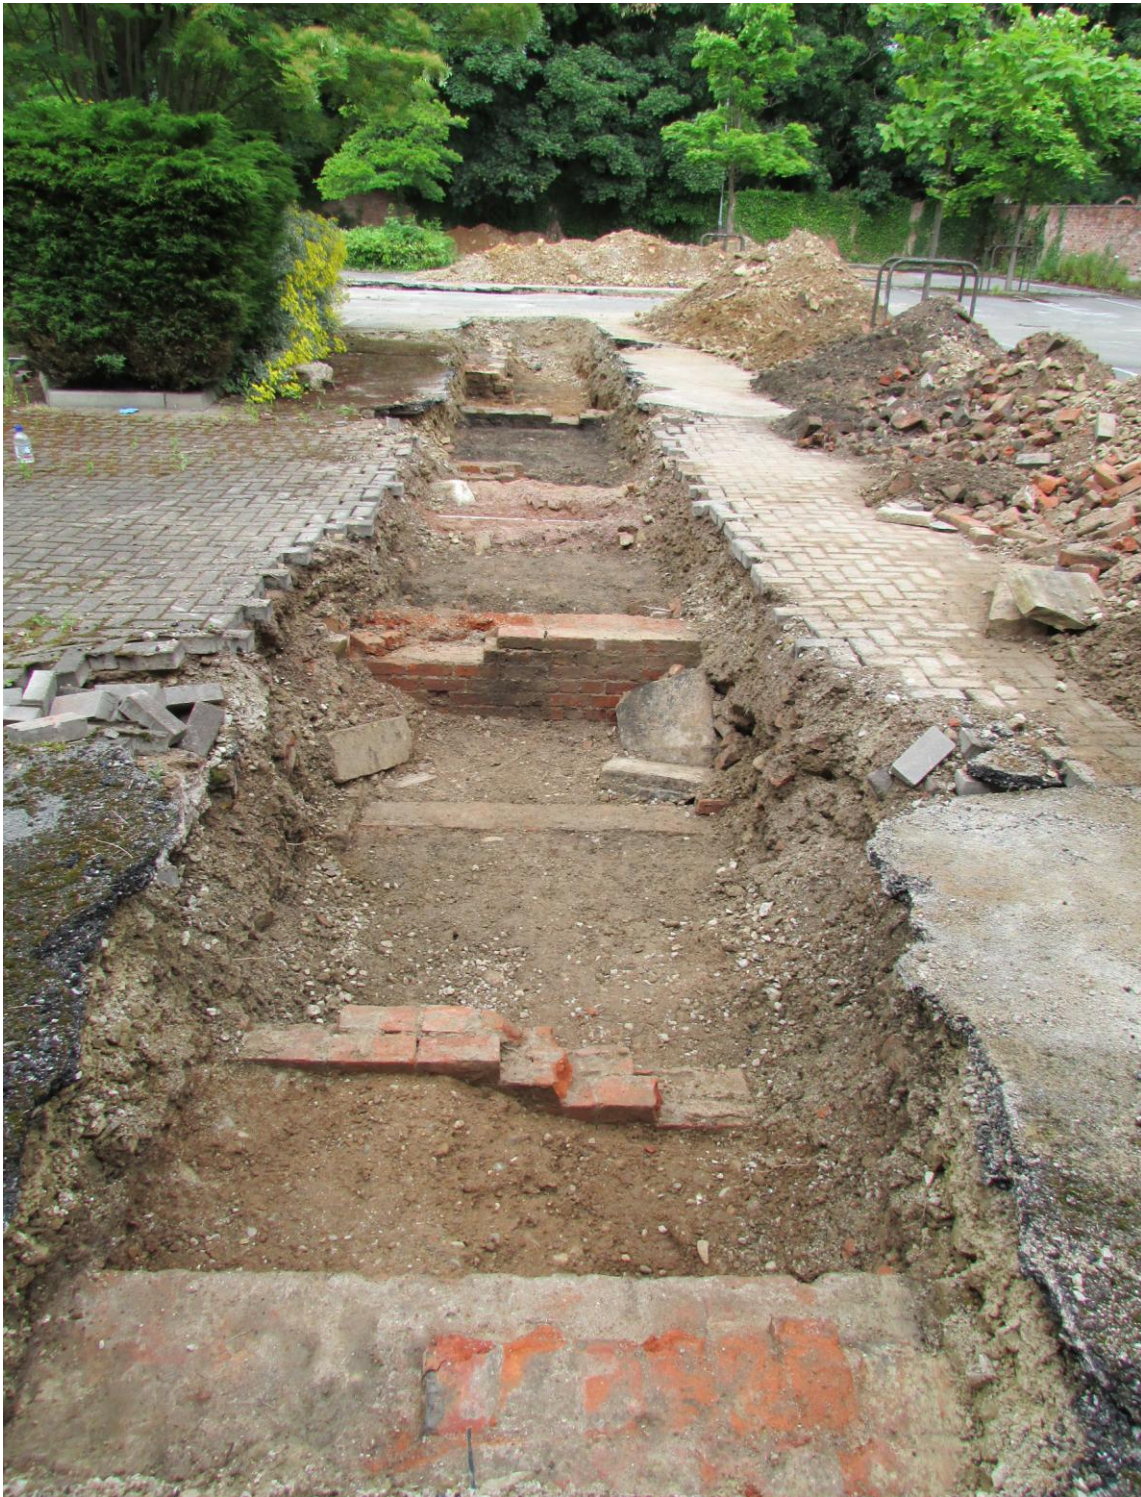
Figure 25. General shot of trench 5 looking north-east.

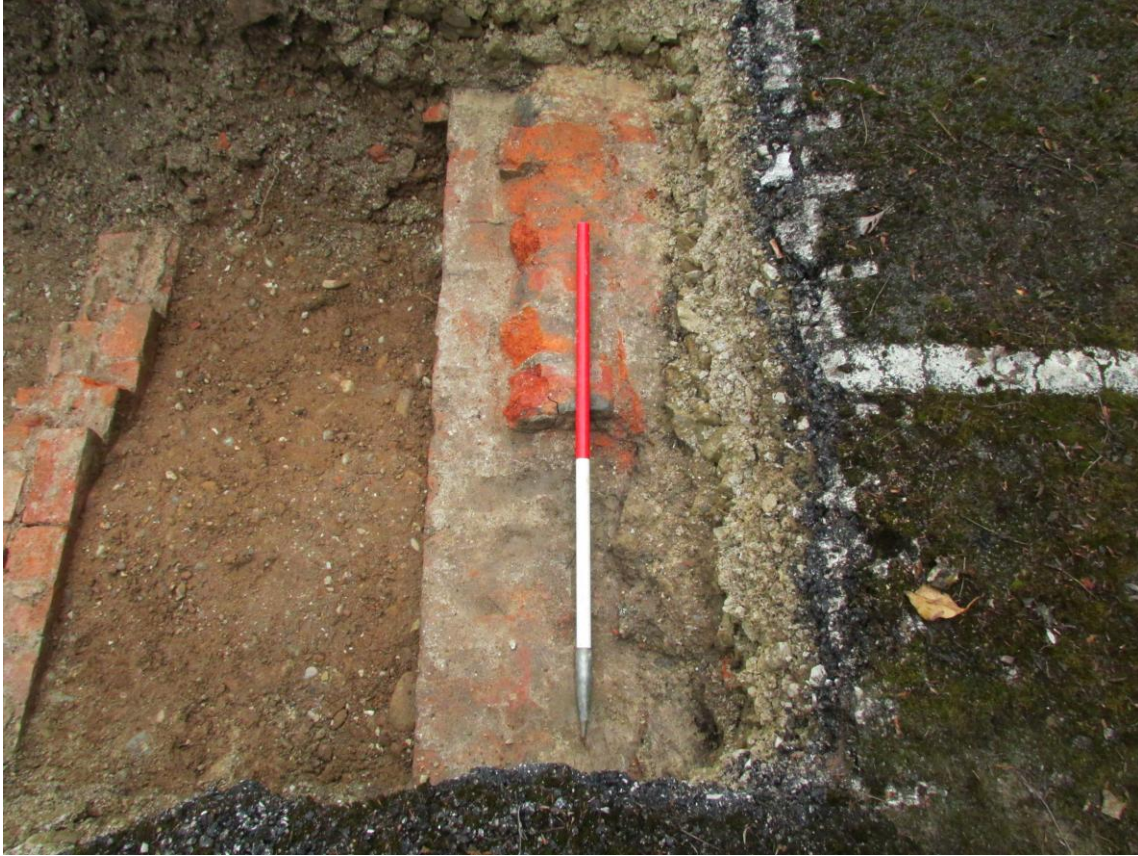
At the south west terminal of trench 5 two walls were encountered. The first (024), was a manmade brick wall, roughly 0.30m from the surface, orientated north-west south-east and constructed using an English Garden Wall bond (**Fig.26**). It visibly consisted of six vertical courses, four horizontal courses and was seen for 1.60m. Average brick size was 0.23m x 0.11m x 0.07m. No foundation cut was seen. Natural deposit (007) was observed, running for 0.80m from the north-eastern face of (024) at a depth of 0.50m. At the north-eastern interface of (007), with no obvious foundation cut and at 0.60m from the surface was handmade brick wall (023) (**Fig.27**). This wall was orientated north-west south-east and observed for 1.60m, continuing into both sections. It was constructed using an English

Figure 26. Wall (024) in trench 5. Looking south-east.

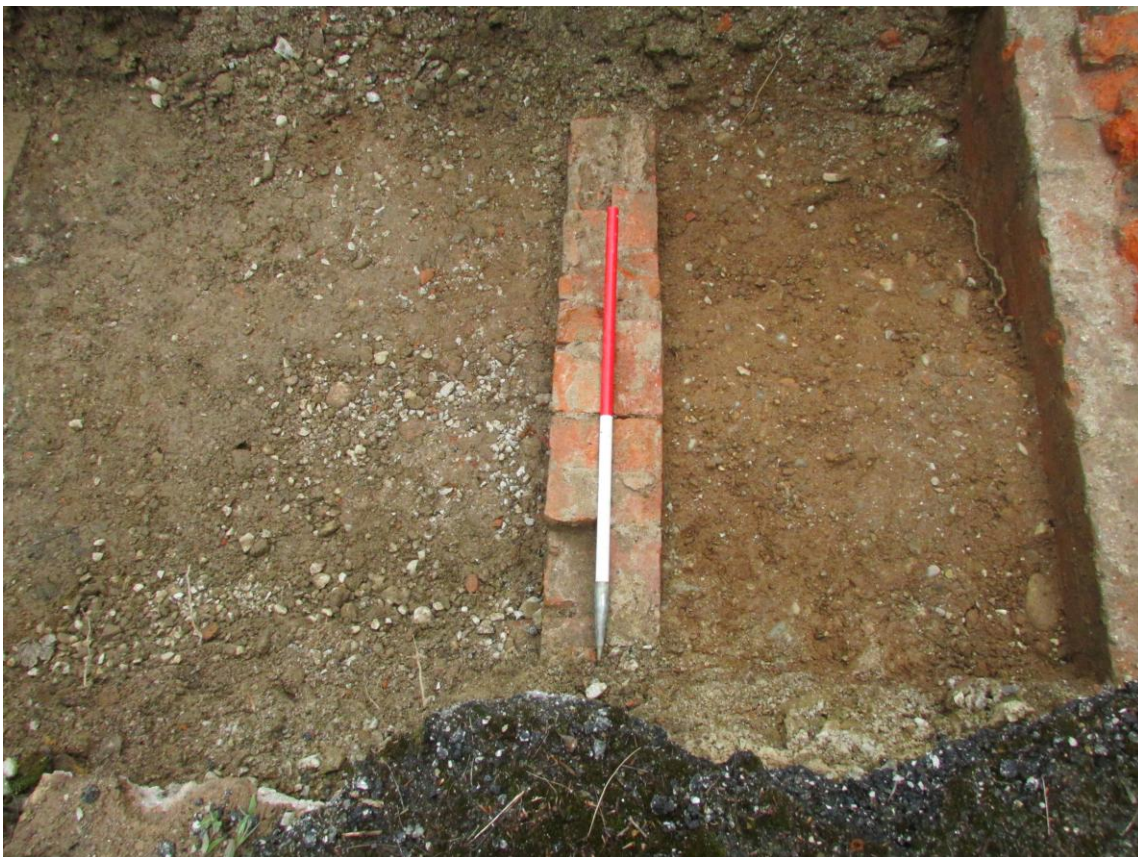
From the north-eastern face of (023), a compact, mid-brown sandy silt with frequent brick and mortar inclusions (021), was observed to run north-east for 1.60m, depth unknown. Due to the instability of the sections it was unclear at what depth this layer began. Handmade brick wall (022) was observed within (021) at around 3.44m from the south-western terminus of trench 5 (**Fig.28**). This wall was seen to run for 1.60m before continuing into both sections. Two horizontal courses were observed but only the upper vertical course was seen which was roughly 1.00m from the surface. Due to the depth it was not possible to observe the walls construction. Average brick size was 0.23m x 0.11m x 0.07m.

Figure 27. Shot of wall (023) looking south-east.

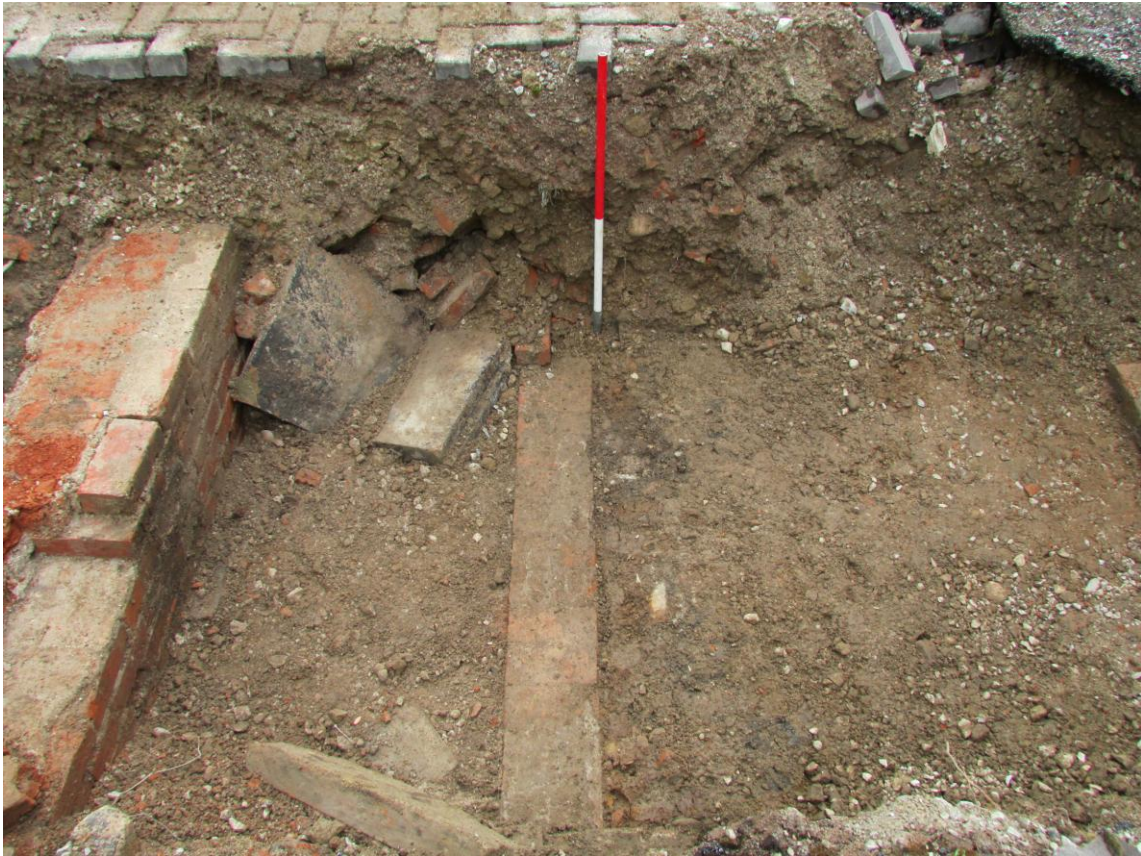
(021) continued north-east over (022) for a further 1.06m. Large blocks of cut stone were observed within measuring 0.50m x 0.52m x 0.12m. At 1.06m (4.50m from south-west terminus) this layer bordered the south-western face of handmade brick wall (020) (**Fig.29**). This wall was orientated north-west south-east and observed for 1.60m before continuing into both sections. It was constructed with an English Garden Wall bond with four, visible, horizontal courses and six vertical courses. Average brick size was 0.23m x 0.11m x 0.07m. Beyond (020) was a compact dark-brown/black sandy silt with frequent brick and mortar inclusions (019). This was very similar in make-up to (017) and ran for 1.40m between (020) and (010) (*see Fig.22*). Due to the instability of the sections (*see Fig.30*), it was unclear at what depth this layer began. A maximum depth was not determined.

above **Figure 28.** Shot of wall (022) and demolition layer (021). Looking south-east.

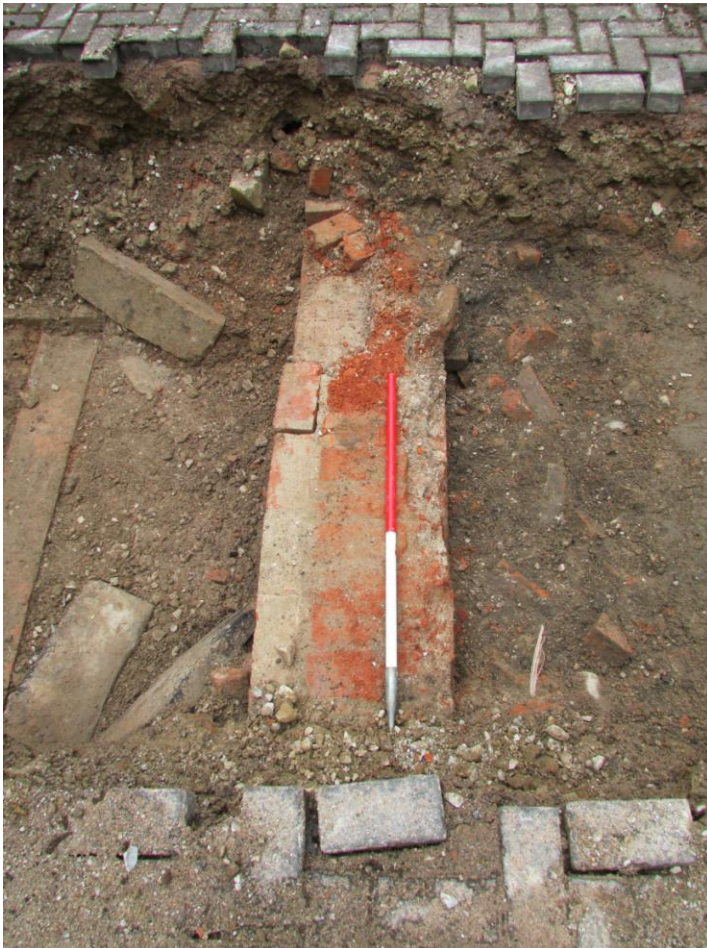
Figure 12 shows that (020) was an extension of the Grade II listed wall that forms the boundary of the study area (noted on site by Mr Norman Redhead *pers. com*). This extension ran north-west south-east and

left **Figure 29.** Shot of wall (020) looking north-west. Demolition layer (019) can be seen to the right of (022).
