Archaeological Evaluation

Abney Court,
Manchester Road,
Cheadle, Stockport.

Technical Report:
Andrew McGuire

Report No: 26/2013

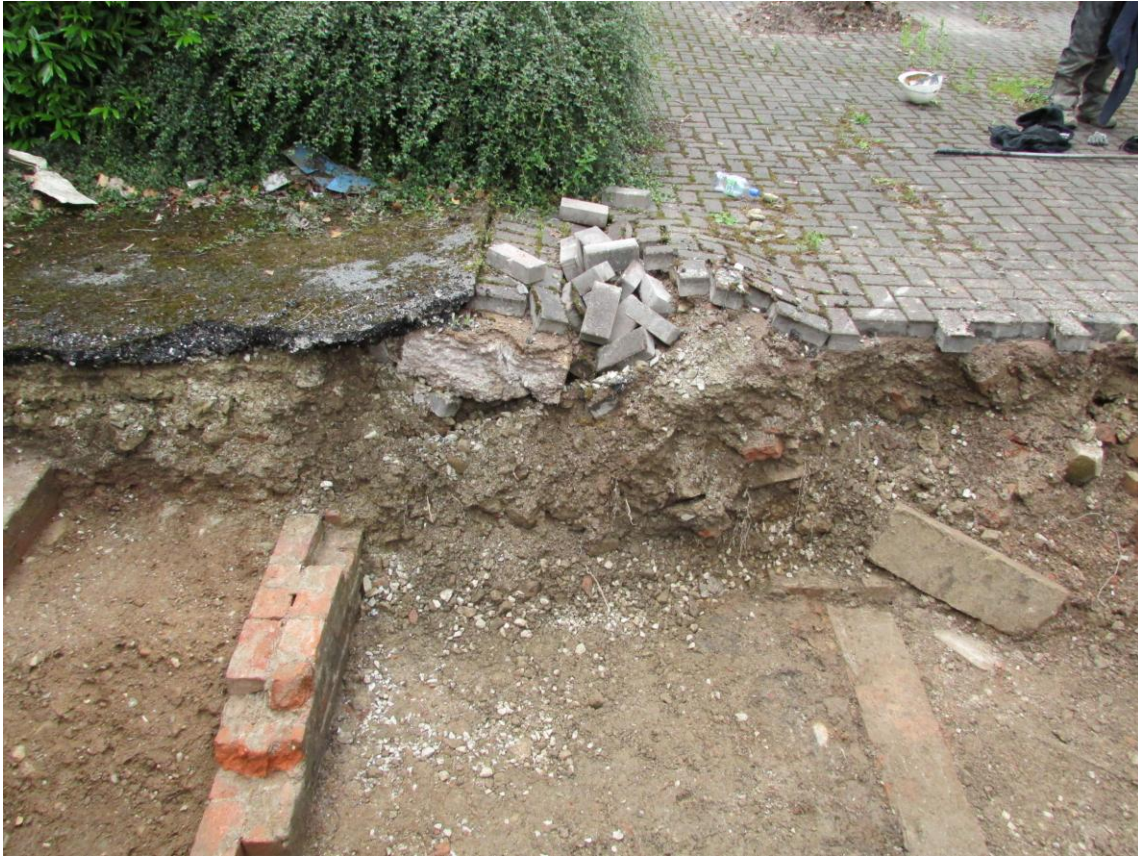
Due to the nature of the deposits in trench 5, it was not possible to fully observe any foundation cuts for these features. This makes it difficult to accurately phase the structures found there. However, when the plans for this trench were over-lain onto historic mapping (Figure 12) it was observed that they are aligned with structures that were resident within the walled garden from 1872-1957 (*see* Figs 4-6). The 1910 OS map was chosen for the over-lay because it sits in the middle of the date range and the structural definition is very clear

above **Figure 30.** An example of the unstable sections seen across site

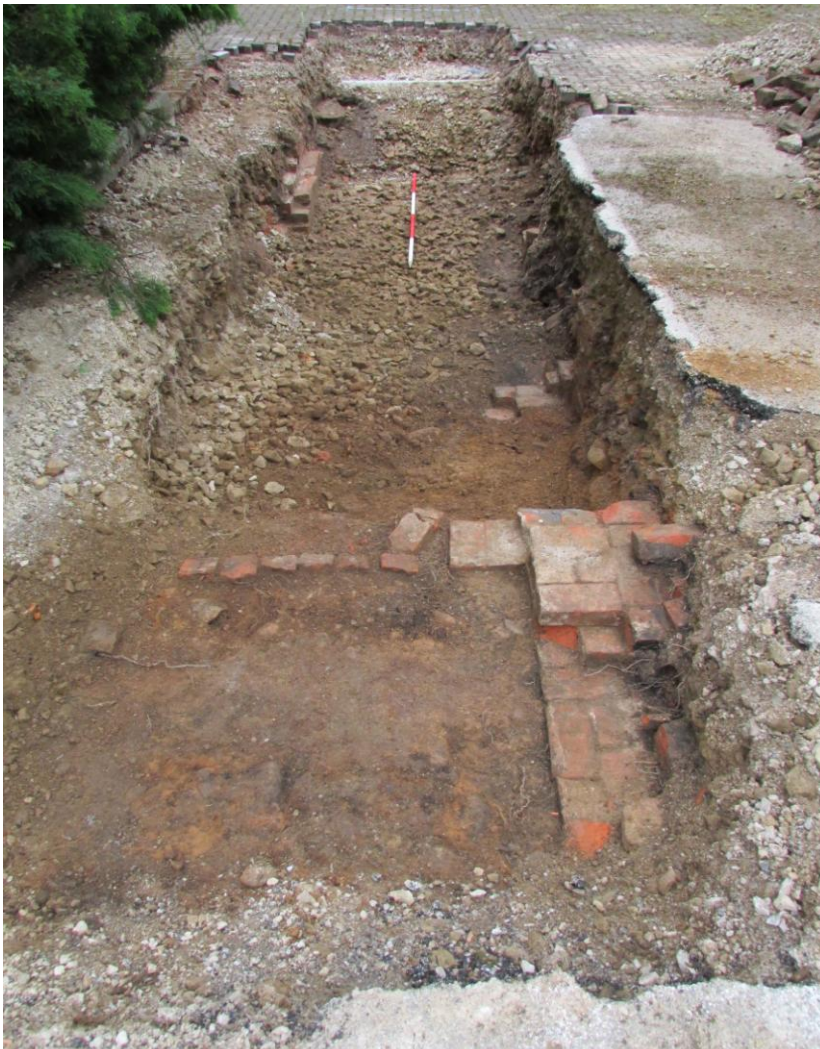
left **Figure 31.**
General shot of
trench 6 looking
south-west.

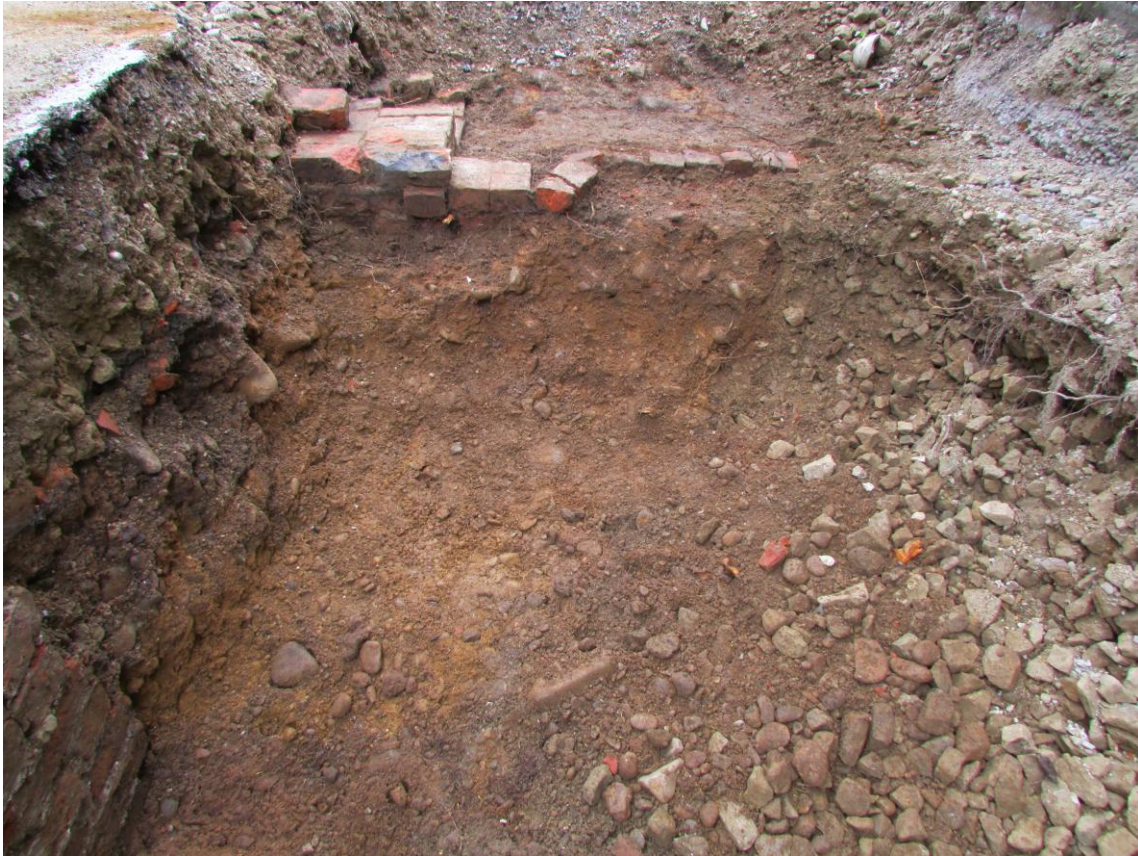
Figure 33. Shot of trench 6 showing the cut [030] of a modern service running diagonally across the trench. (008) can be seen to the right of the cut line.

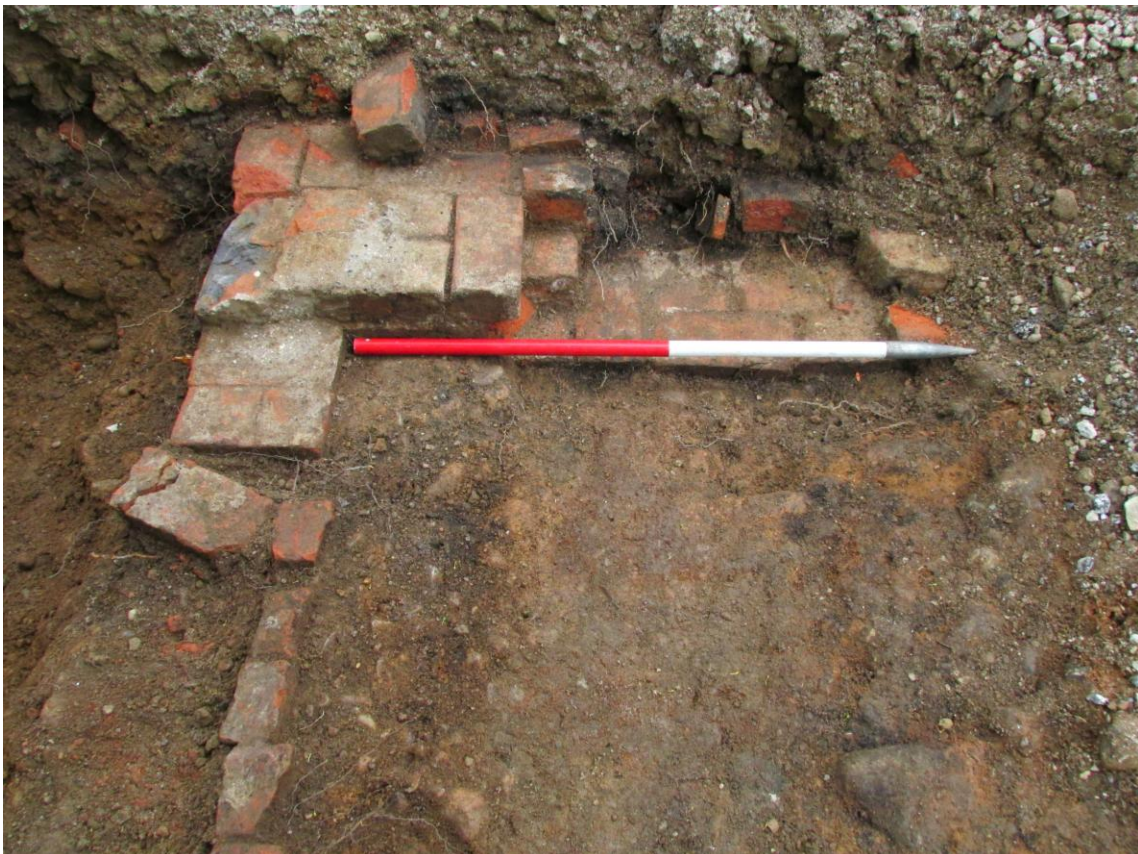
(029)	T6	Hand-made, brick wall, orientated NE-SW. Seen for 1.25m before continuing into NE section. Seen at 4 courses wide and 3 courses deep. Possible continuation of wall ran SE however this is heavily truncated. Single course of brick and slate seen during machining, running NW-SE, 0.70m from SW edge of (029). Gap in (029) at same distance NE contained ceramic pipe fragments & black staining, suggesting possible heating system.
[030]	T6	Cut for service running roughly W-E across most of T6.

Figure 34. Shot of wall (029) within trench 6 looking north-west.

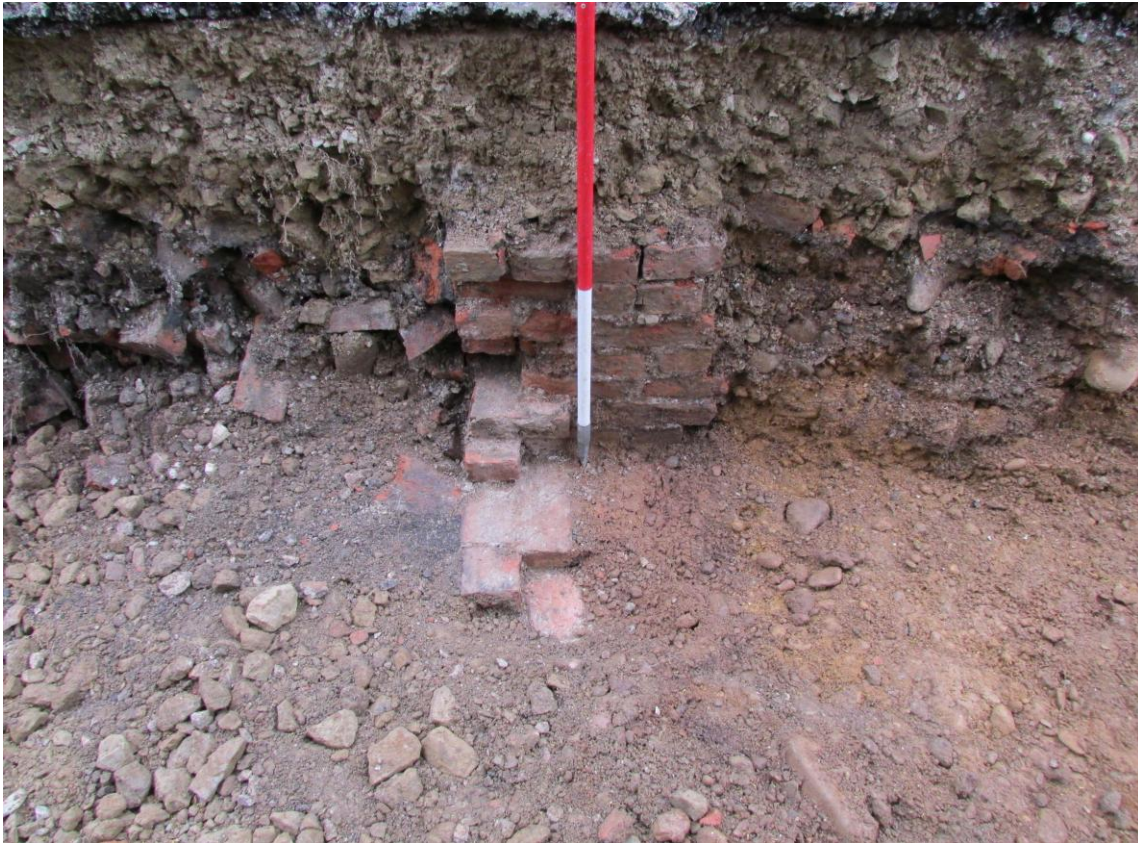
At around 1.50m south-west of (029), another handmade brick wall **(028)** was observed. This wall was orientated north-west south-east at a depth of 0.90m and ran for roughly 0.40m from the north-west section where it was truncated by [030] (**Fig.35**). In the north-west section (028) was observed to turn roughly ninety degrees and continue north-east for 0.30m, forming a 'dog-leg'. (028) was constructed using an English Garden Wall bond with two horizontal courses (seen on the south-east orientation) and eight, visible, vertical courses. Average brick size was 0.23m x 0.11m x 0.07m. (028) was bordered by natural (007) to the north-east and a fairly compact dark-brown/black sandy silt, with frequent brick and mortar inclusions **(026)**, to the south-west (*see Fig.35*). (026) was seen for 3.7m between the northern cut of [030] and wall (028). It was also observed for 0.40m from the south-eastern section, where trench 6 had been extended, at an estimated distance of 1.70m. Deposits (008) and (026) had mixed in this area (*see Fig.36*), forming an interface which was difficult to accurately define and which subsequently obscured the southern cut of [030].

Figure 35. Shot of wall (028) in trench 6 looking north-west. Cut [030] can be seen running diagonally from left to right. Demolition layer (026) can be seen in section to the left.

Figure 12 shows that wall (014), in trench 5, continues north-west. Wall (028), is aligned along this continuation. The ‘dog-leg’ seen to continue along in section is probably the linking wall to the cell-like structures and the associated outbuilding, orientated north-east south-west. The south-west corner of this outbuilding seems to align with (029), suggesting that the observed north-west south-east continuation was very probable. Observations made while machining this area and the blackened, ceramic

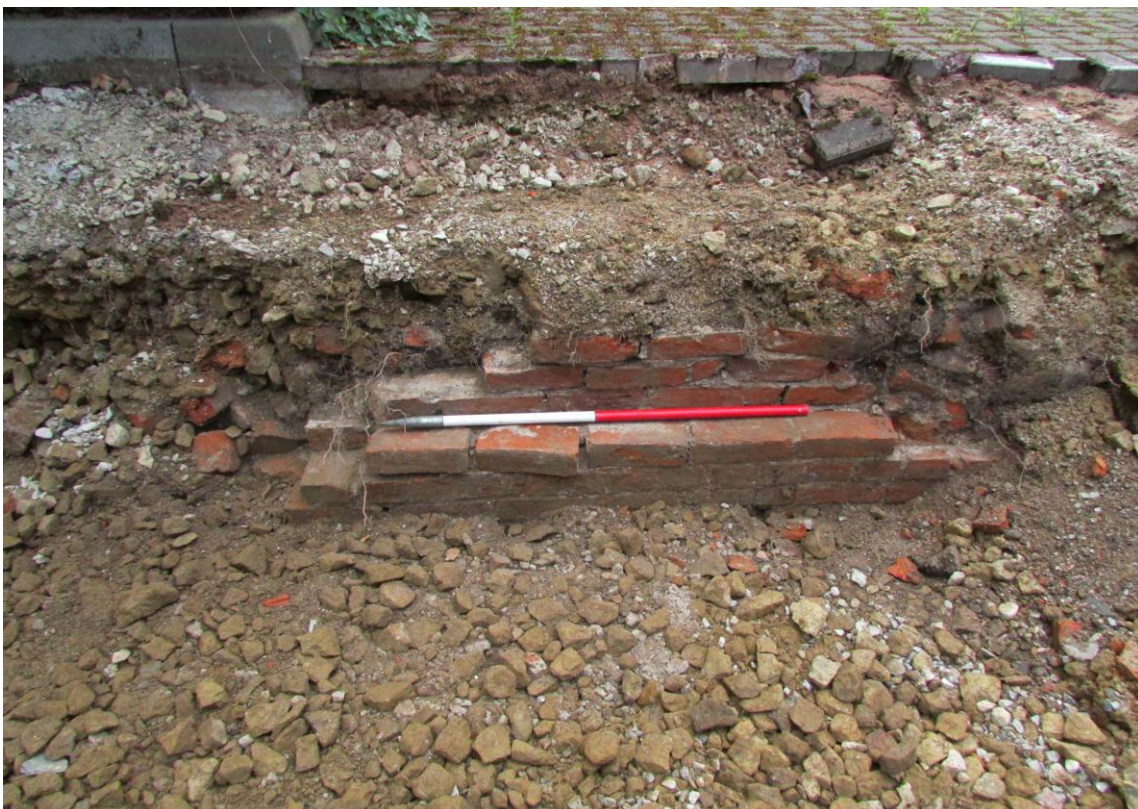
Hand made brick wall **(025)** was observed within the extension of trench 6, at around 2.10m from the south-west terminus (**Fig.36**). This wall appeared at a depth of around 1.00m and was orientated north-east south-west along the section edge. (025) had been heavily truncated at its north-eastern extent by [030]. From this point it was observed to run south-west for 1.70m before continuing into the trench edge. Wall (025) was constructed using an English Garden Wall bond with two, visible, horizontal courses and seven, visible, vertical courses. It was observed that beyond the point of (025)'s truncation, hardcore layer (008) was intermixed with handmade brick rubble within the section. The north-west face of (025) sat within demolition layer (026). No foundation cut was observed.

Figure 36. Shot of wall (025) in trench 6 looking south-east. Context (026) can be seen to the middle-right in frame. The fragility of the section edge is displayed here.

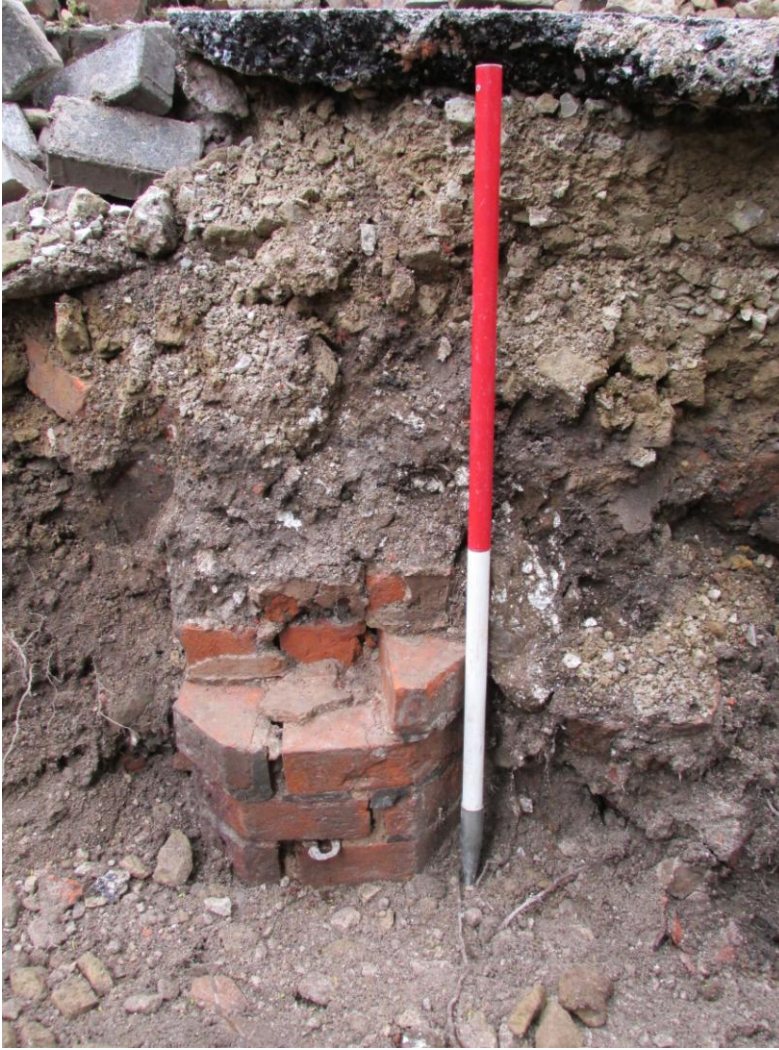
The final archaeological feature in trench 6 was located at around 4.00m from the south-western terminus. Contained within (026), at a depth of 0.80m was a handmade brick wall **(027)** (**Fig.37**). This wall emerged from section, orientated north-west south-east and ran for 0.20m before terminating with a trapezoidal face. (027) was constructed using three, visible, horizontal courses and four, visible, vertical courses. 'Squint headers' were used at the terminus to form the trapezoidal face. A U-shaped iron fitting was observed to be protruding from the south east face of (027) and an iron, sliding bolt was found in close proximity, within layer (026). Voids within this layer allowed a further three vertical courses to be seen. No foundation cut was observed.

left **Figure 37.** Shot of 'trapezoidal' wall (o27) in trench 6. Looking north-west.

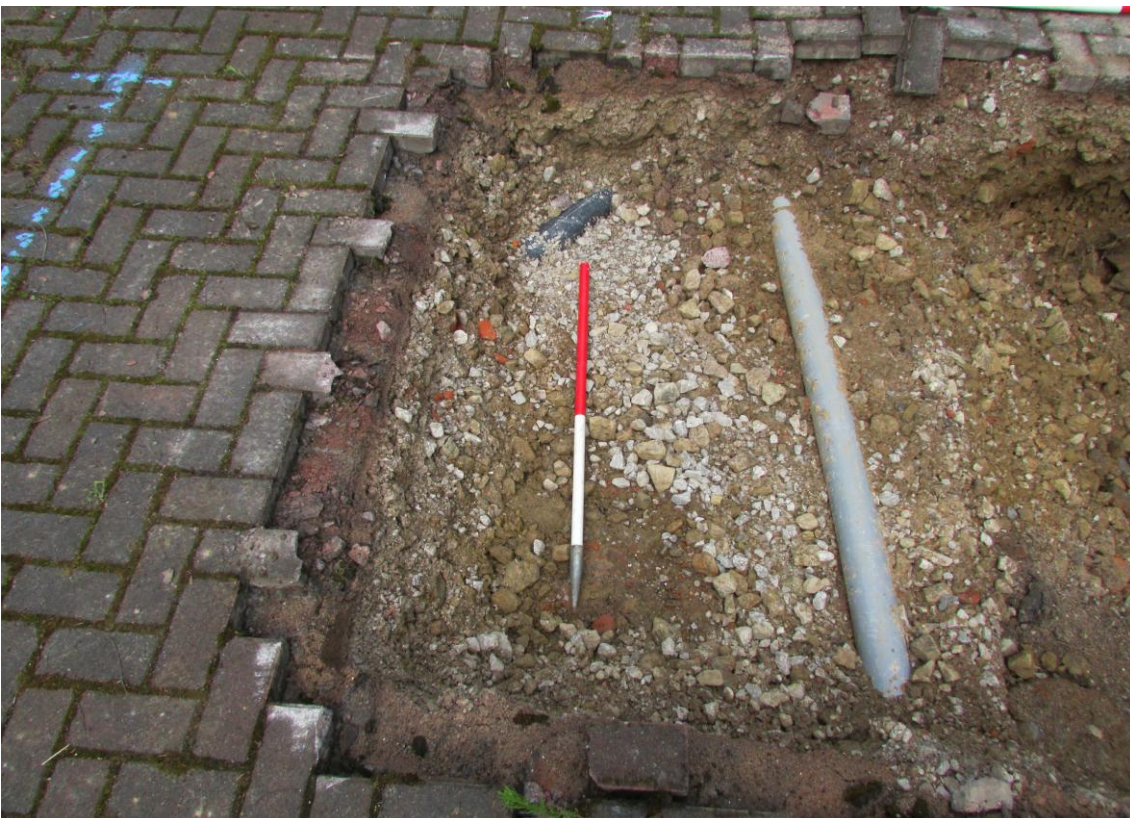
below **Figure 38.** Shot of modern services running through the south-west of trench 6.

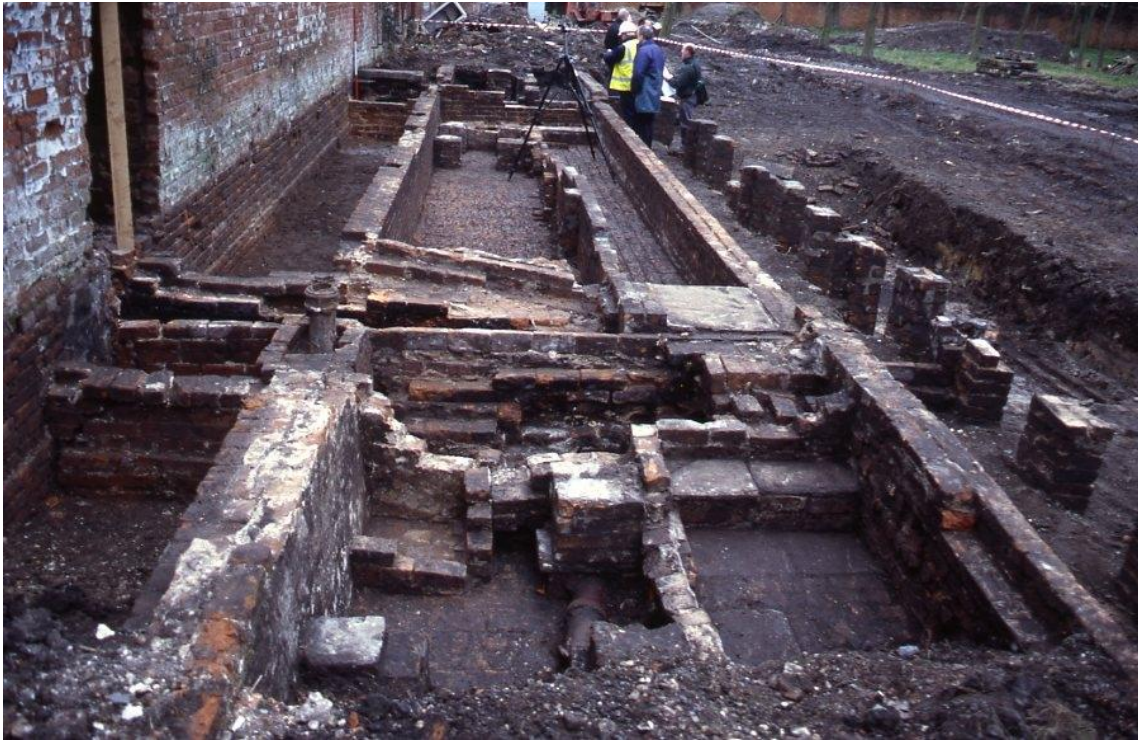
Figure 39. An example of an excavated 'Hot House' from the Winstanley Hall excavation 2001 (Provided by Norman Redhead).
