# **ANTARCTIC TREATY INSPECTIONS 2005**

**Report of Antarctic Treaty Inspections undertaken jointly by the United Kingdom, Australia and Perú in accordance with Article VII of the Antarctic Treaty and Article 14 of the Environmental Protocol.**

**Foreign and Commonwealth Office, London, UK  
Australian Antarctic Division, Kingston, Tasmania, Australia  
Instituto Antártico Peruano, Lima, Peru**

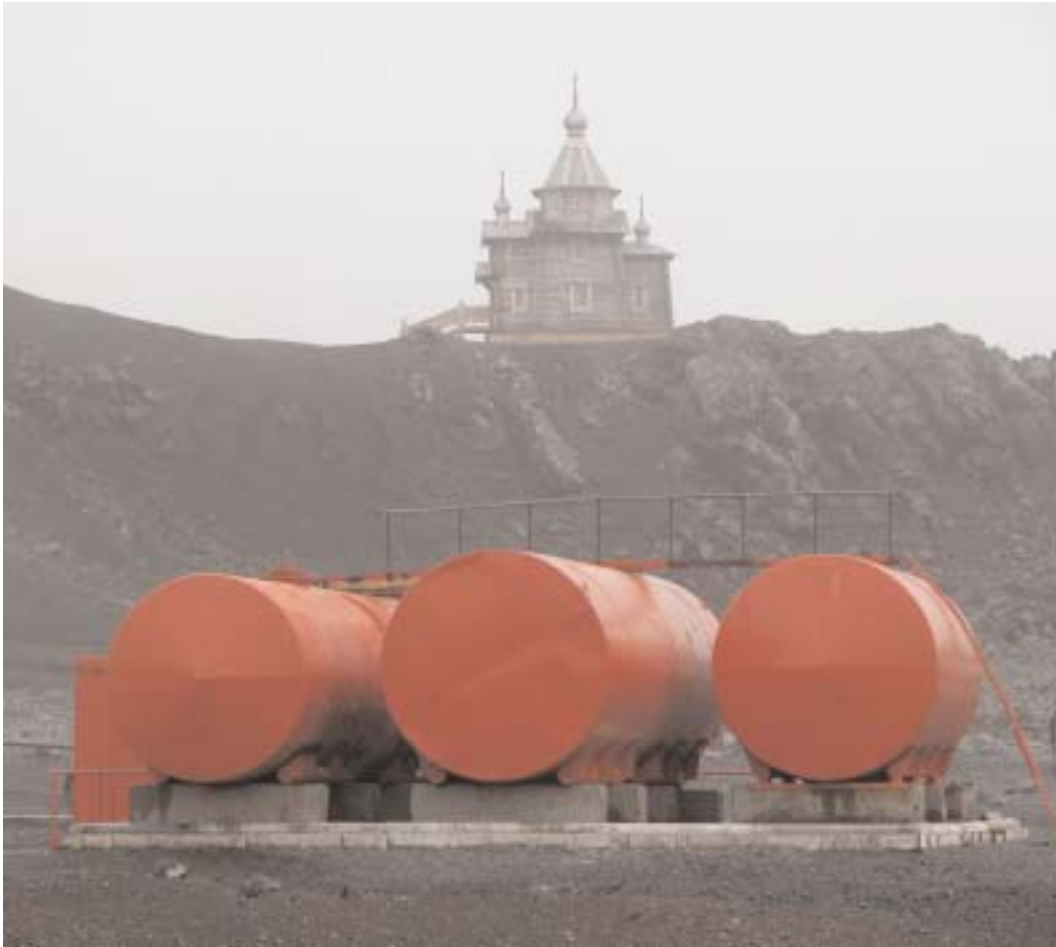
*The recently constructed Russian Orthodox Church at Bellingshausen, seen over some of the station's fuel tanks*

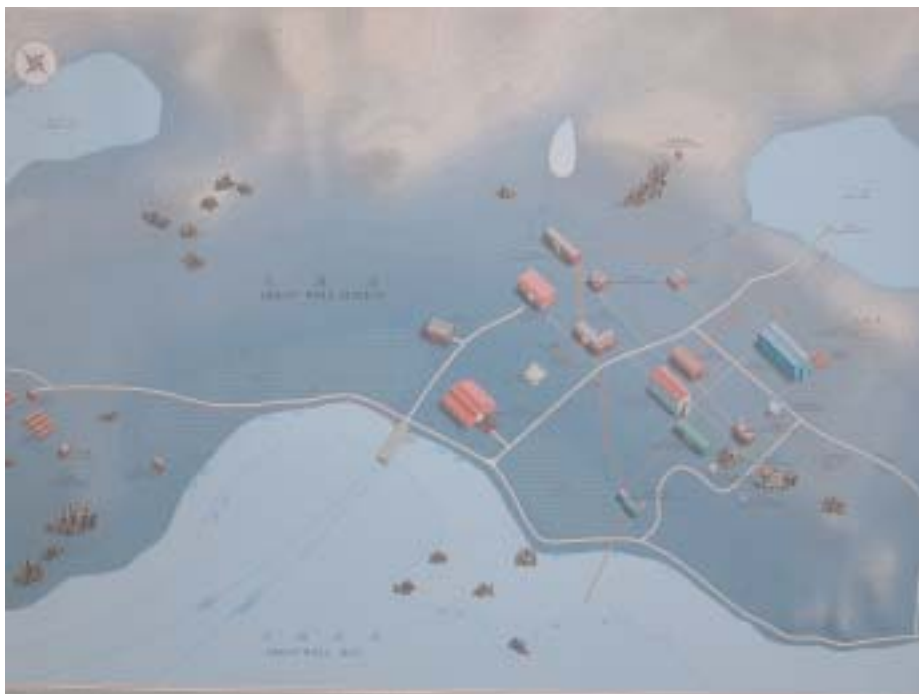
*A schematic map of Great Wall Station. The main fuel farm is to the left of the picture. The large blue building is the newly constructed generator house. The green building, formerly the Infirmary/Recreational rooms, has since been removed.*

Most, if not all, of the original buildings were showing extreme signs of corrosion and decay to the point that their structural integrity might be affected. The elevated concrete pier foundations of these buildings were severely decayed with, in some instances, the interior reinforcing rods completely exposed and the concrete crumbling. The external metal surfaces of these buildings were also very heavily corroded and the roofs in some buildings were no longer water-tight.

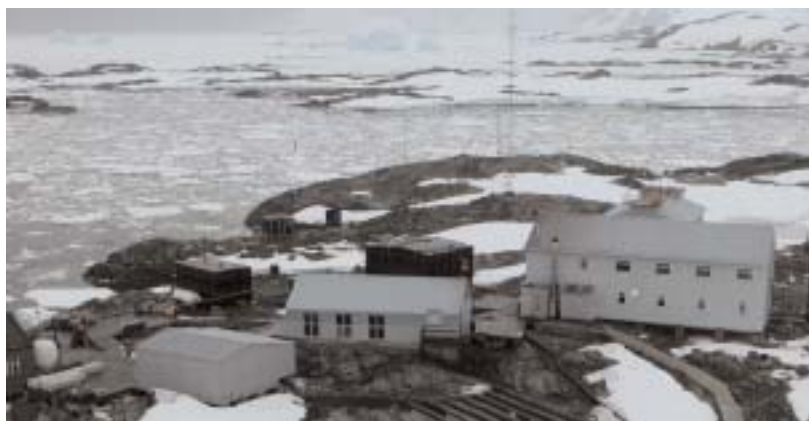
*Akademik Vernadsky from the air showing from left to right the main store, generator building and main accommodation block. The black “Braithwaite” fuel tanks can be seen behind the buildings. In the foreground are the foundation piers constructed in 1998 for new fuel tanks*

Fuel was stored in two "Braithwaite" tanks of 150 and 30 tonne capacity raised off the ground. The tanks are single-skinned, comprising bolted panels, and not banded. The Inspection Team was concerned to see these tanks still in operation eight years after the transfer of the station to Ukraine. "Braithwaite" tanks were designed primarily for water storage. Although these tanks have been fitted with liners, one steel and one neoprene, the integrity of these tanks, given their construction and age must be of increasing concern. Any loss of fuel from these tanks would flow straight into the sea. Clean up of the rocky terrain in the vicinity of the tanks would be difficult.

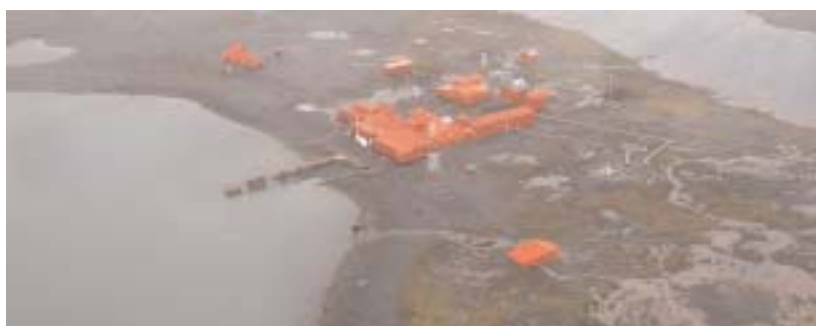
Capitán Arturo Prat Base was visited briefly by helicopter. The station is located on the eastern shore of Discovery Bay, Greenwich Island, South Shetland Islands at Lat. 62° 30’S; Long. 59° 41’W. It was unoccupied. The doors were locked and sealed, and windows boarded up. From external appearances of the buildings it would appear that they had not been occupied for at least 2-3 years. Paint was peeling off the walls and some wind damage was evident with a door torn off the ramp-shaped building to the north of the station.

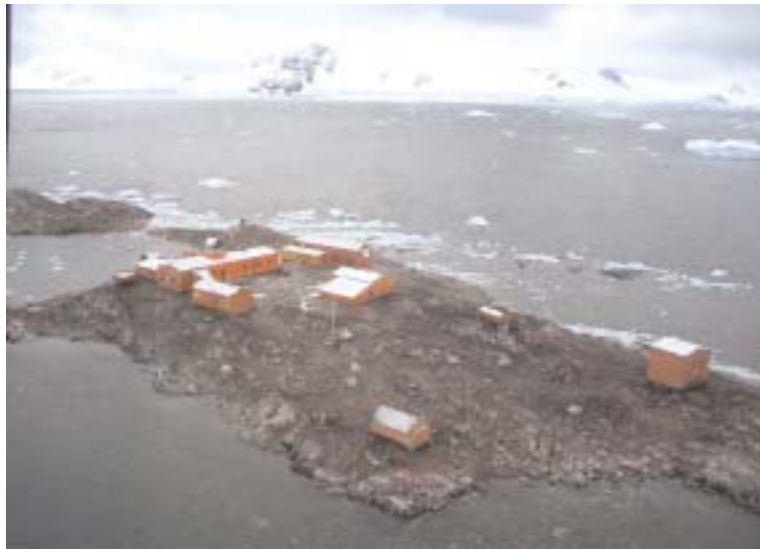
*Aerial view of Presidente Gabriel Gonzalez Videla station*

The station includes two unbunded bulk fuel tanks, estimated at 20,000 litres each. No signs of fuel spills or leaks were discernible. Four aerial masts were present, but no aerial wires were visible.

There were no signs that the station had been occupied recently (at least for the past three-four years). However, the buildings and other infrastructure showed no signs of damage.

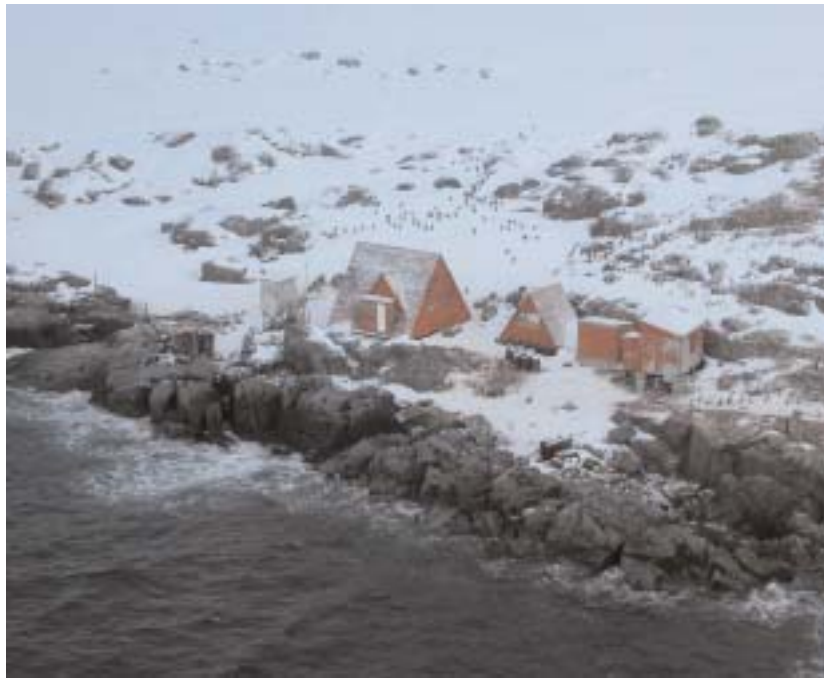
*Yelcho from the air. Note the density of nesting penguins.*

Although the station was unoccupied, none of the windows had been boarded up. How long Yelcho had been unoccupied was not clear. There was no evidence of any storm damage.

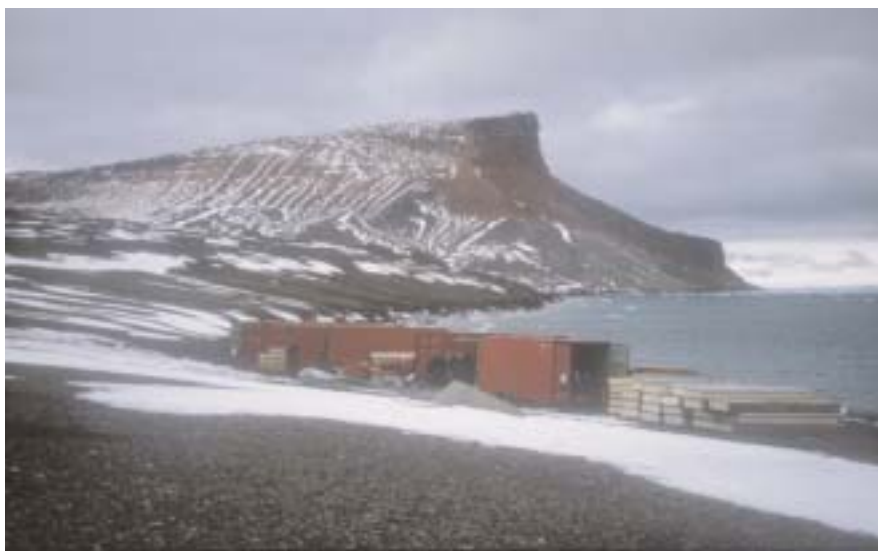
*Containers offloaded on the beach for the construction of the new Czech Station on James Ross Island. Looking west towards Bibby Point.*

Eight 20' ISO containers had been brought ashore by landing craft from the *Viel*, and positioned two to three metres above the shoreline. Cargo was being unloaded, and preparations were underway to set up a temporary messing tent for the construction team. Polystyrene insulated plywood sandwich panels, from which much of the station will be constructed, were stacked on the beach – some had been damaged in transit.

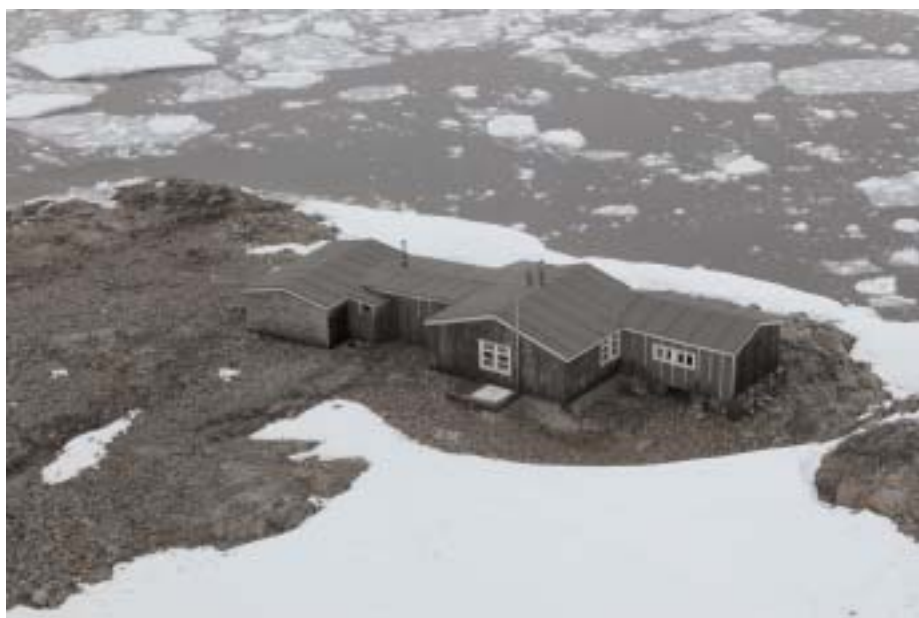
*Wordie House (Base F) from the air.*

The station was generally in good condition, although significant moisture at three locations in the hut suggest that the roof is no longer sound and requires immediate attention. The Team understood that a small British Antarctic Survey field party would spend a week at the site in mid-March 2005 to undertake remedial works.

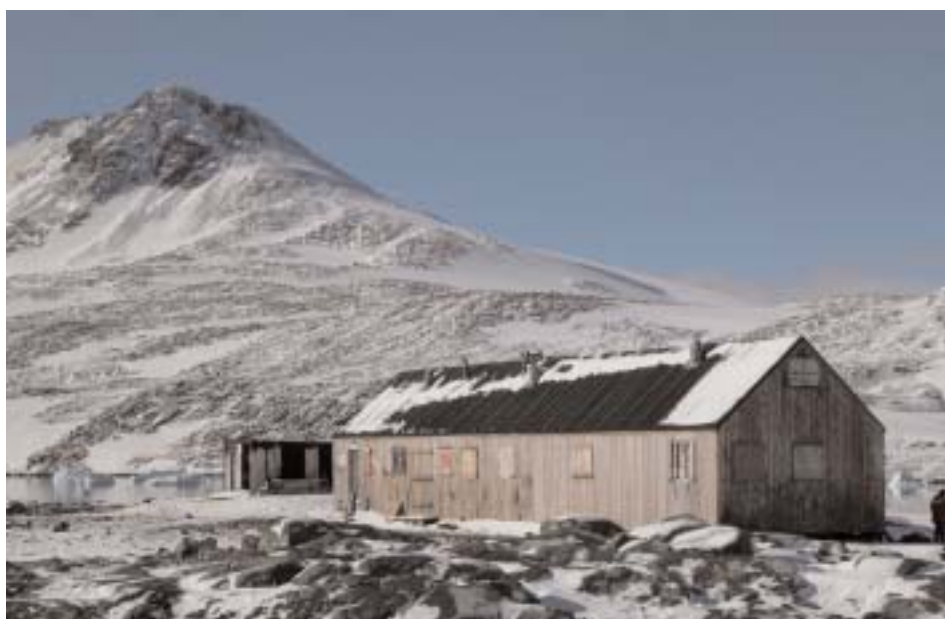
*A general view of Horseshoe Island (Base Y)*

'Base Y' was found to be generally in good condition. The ruberoid roofing felt was intact and securely battened down. Internally, the hut was dry and the numerous artefacts were present in an orderly fashion. Part of the roof-space had been sealed off with thick polythene sheeting and marked as 'Dangerous-Asbestos'.

Externally, the timber walls had been stripped bare of paint by wind and ice blast. Four of the windows were missing wooden shutters, and some cracks were evident in the external window panes. Two guy wires secured the generator shed and the east end of the building. A guy wire formerly attached to the middle section of the main roof span was broken and lay at the foot of the building. No guy wires were evident at the west end of the building.

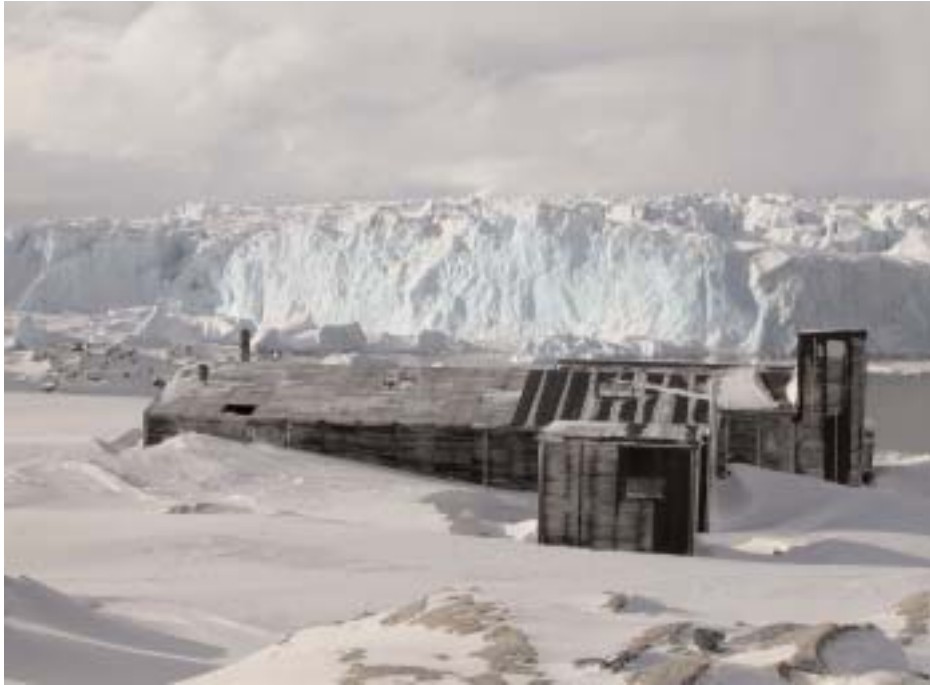
*A view of East Base, Stonington*

Stonington East Base was designated as HSM No 55 in 1987 by means of Recommendation ATCM XIV-8. The site includes two buildings and a further two smaller huts, from the US Antarctic Service Expedition (1940-41) and the Ronne Antarctic Research Expedition of 1947-48. The entrance to the southernmost of the two buildings was open with significant snowdrift into the building. Approximately one third of the roofing felt was stripped bare, and holes were apparent in the timber roof. The northern building, which included a three-storey tower, had one window open and un-boarded, also allowing snow to accumulate inside.

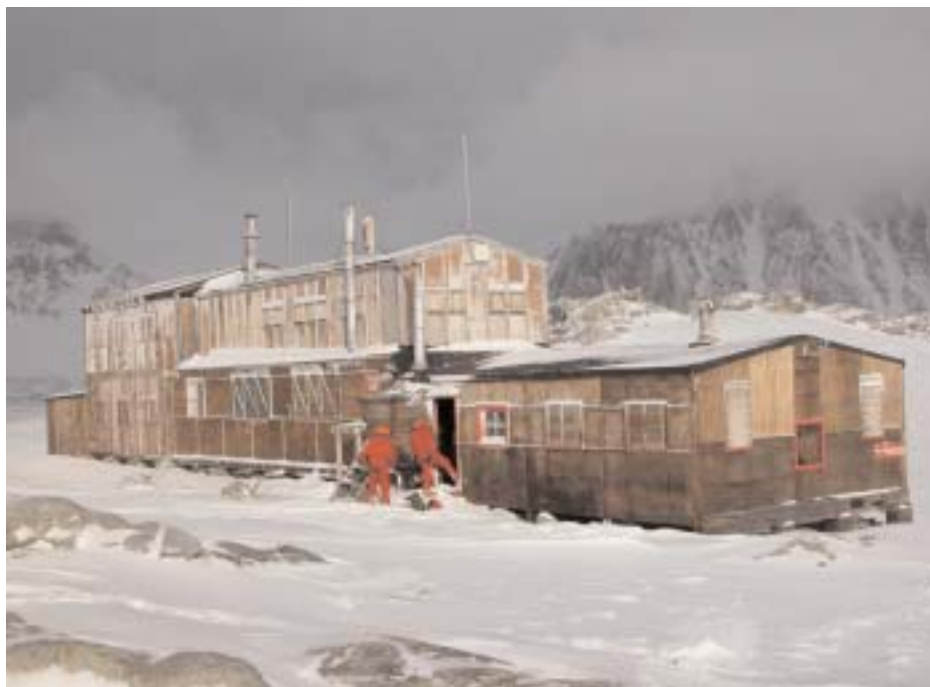
*‘Base E’ Stonington Island*

During the brief visit, the Inspection Team were able to confirm that the buildings and dog pens were secure and in relatively good condition. Internally, little remains from when it was occupied.
