Unexpected Consequences of a Well-Intended “Fix”

The Problem

In preparation for the 2004 Joint Commission triennial survey, we noticed that there was a pattern of clean supplies being stored under the sinks in patient care areas. This was a violation of infection control standards.

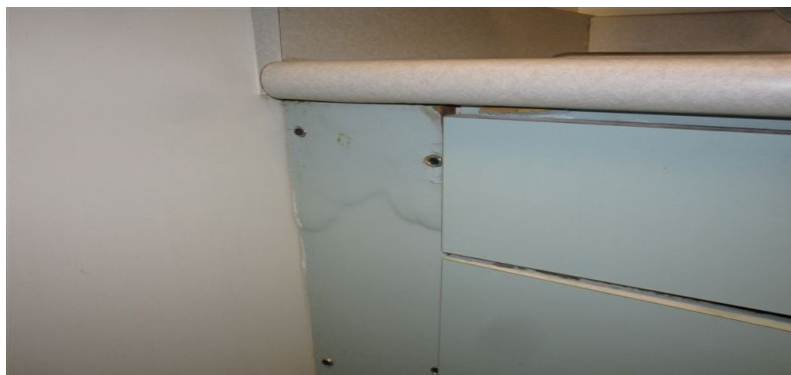
- The Joint Commission prep team made a decision to bolt down all of the cabinets to prevent under sink storage.
- All cabinets under the sinks were bolted down

Example of Bolted Cabinets underneath sinks in patient care areas

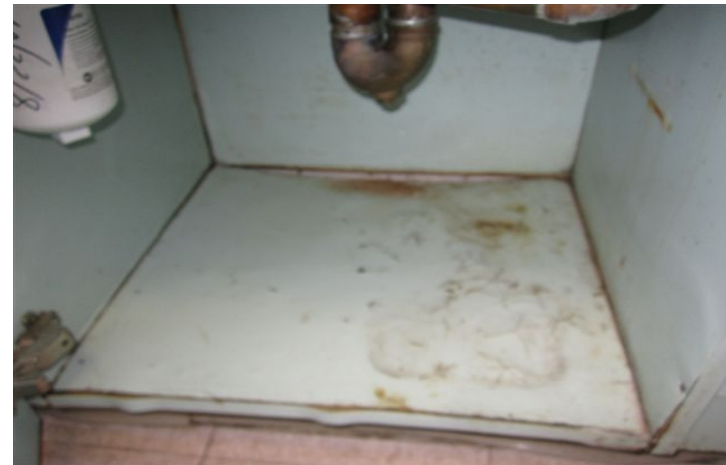
- BIDMC had three successful Joint Commission visits - with no findings related to under sink storage.
- We also began to notice that we were unable to clean under the sinks or to respond in a timely fashion to leaks and that when we did – there was an apparent build up of mold under the sinks behind the bolted doors! We did not anticipate this!

Leaks under sink and mold build up inside cabinet

We are bolting all of the cabinets and cleaning/repairing the areas under the sinks. We are working with our staff to reinforce the reasons for not storing supplies under the sinks.
