FORM B - BUILDING

GRN.45

692 Main Road

Name Dr. Austin Scott House

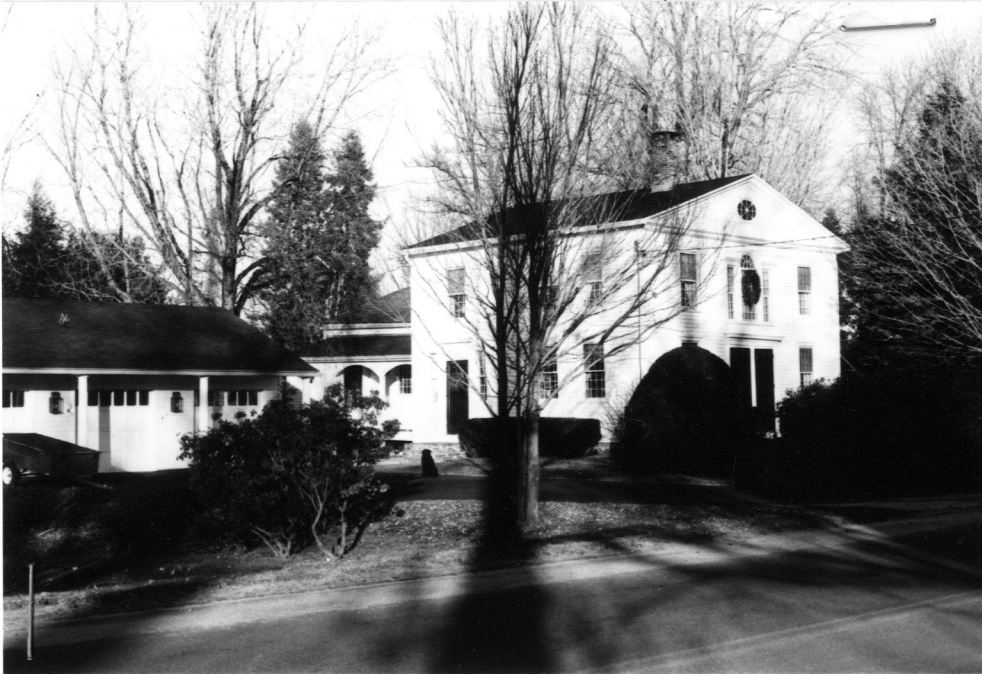
A stylized triglyph pattern is found on this building similar to those found on #48, and #61. The 2-story, 3-bay structure features a symmetrical south facade with a center 2-door entry over which a Palladian window hangs. A side gable (west) entry surrounded by half sidelights and a cornice might indicate that the south facade door was ornamental. The house is highly ornamented with classical motifs, such as the triglyphs at the roof cornice and modillions in the cornices above the doors and on the Palladian window.

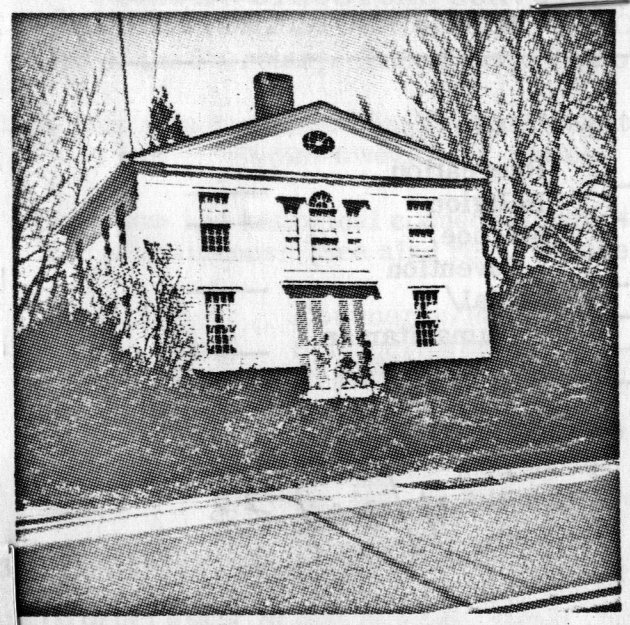
Photo CVHM I-27

The Scott House - c. 1817 Granville

Whether this is the design of the same "Granville" architect is difficult to say, but the cornice motif + the general feeling of the house seem from the same hand. An outside influence, perhaps that of Asher Benjamin or the advent of the Federal style, has changed the style of this house. The gable end of this Georgian house has been turned toward the street in pediment fashion, the main entrance is under the porch, which is a later addition. The street facade is an exceptional variation. The double doors give entrance to two separate rooms. The Palladian window is larger than most, though this is off-set by a smaller window in the pediment.
