Figure 62. Front Hall with restored raised panels, turned rails and details on stair treads, parallel to front façade. Daniel Rose House. Camera facing north. September 2019.

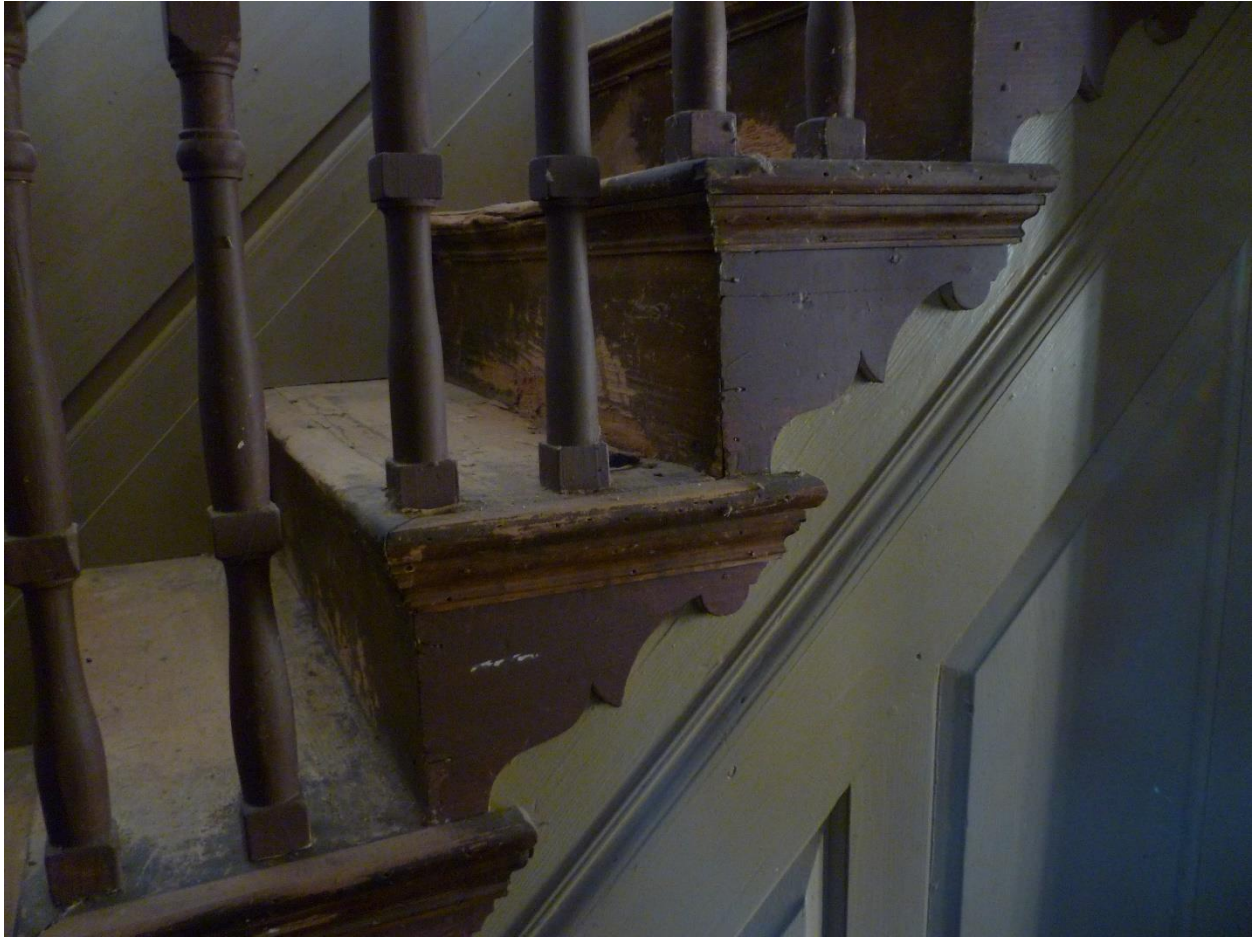
Front Hall - Here is a balustrade single landing staircase which remains with raised panels under.

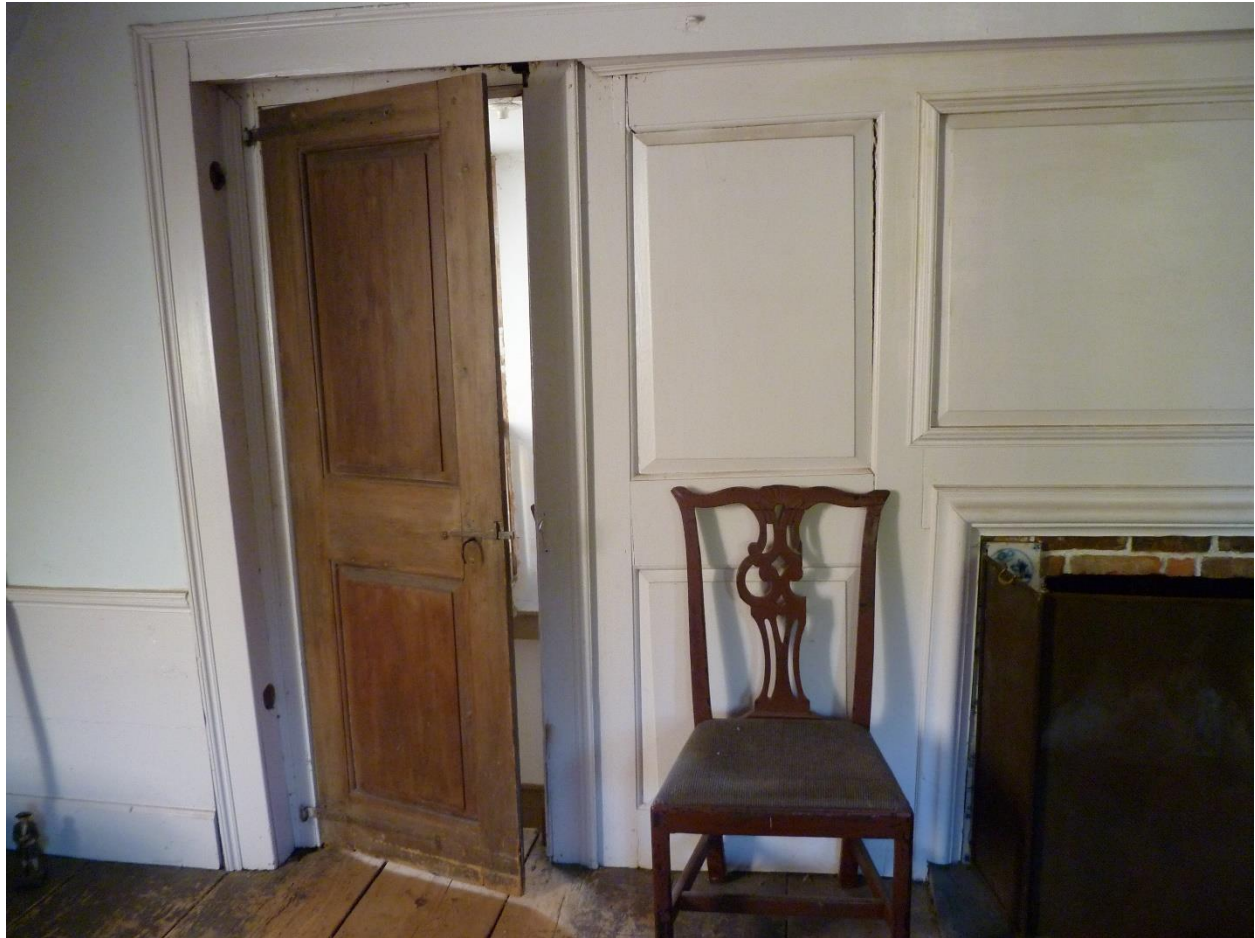
Figure 63. Front Southeast Bedchamber and Ballroom chimney breastwall with fielded panels, Daniel Rose House. Stairway and landing are through the doorway. Camera facing southwest.

Ballroom - Fireplace breastwall features fielded panels. Fireplace door to right and left, floor is original pine. Ceiling is plastered and barrels upward to a height of 12 feet. Two board dado completes rest of the walls with evidence of a bench under windows. The room runs the entire width of the house. Double windows in Photo #8502-4-2 indicates ballroom on second floor. The surrounding area on second floor is unfinished showing house structure.

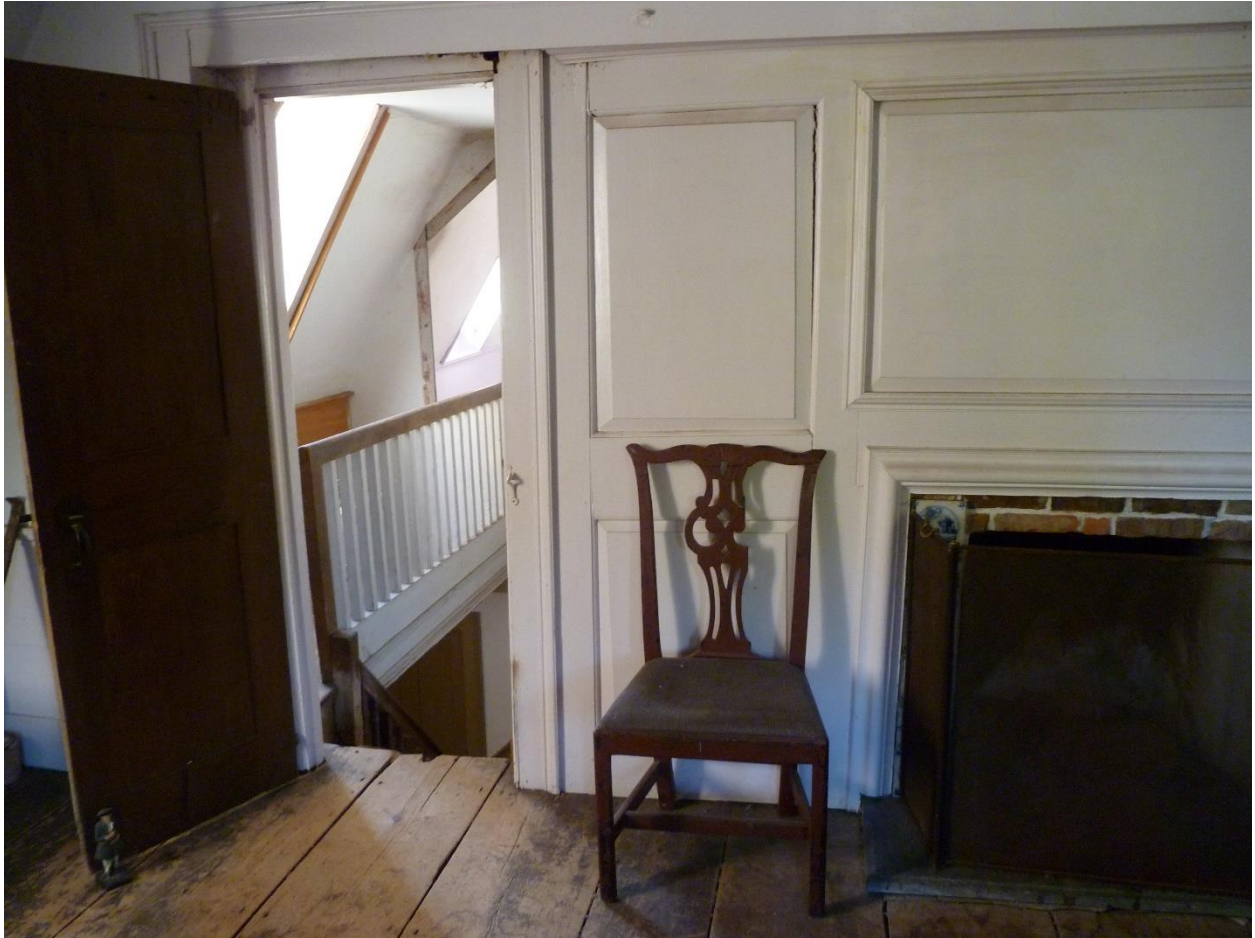
Figure 64. Front Southeast Bedchamber chimney breastwall with fielded panels, Daniel Rose House. View to Stairway and landing at front entryway. Camera facing southwest.

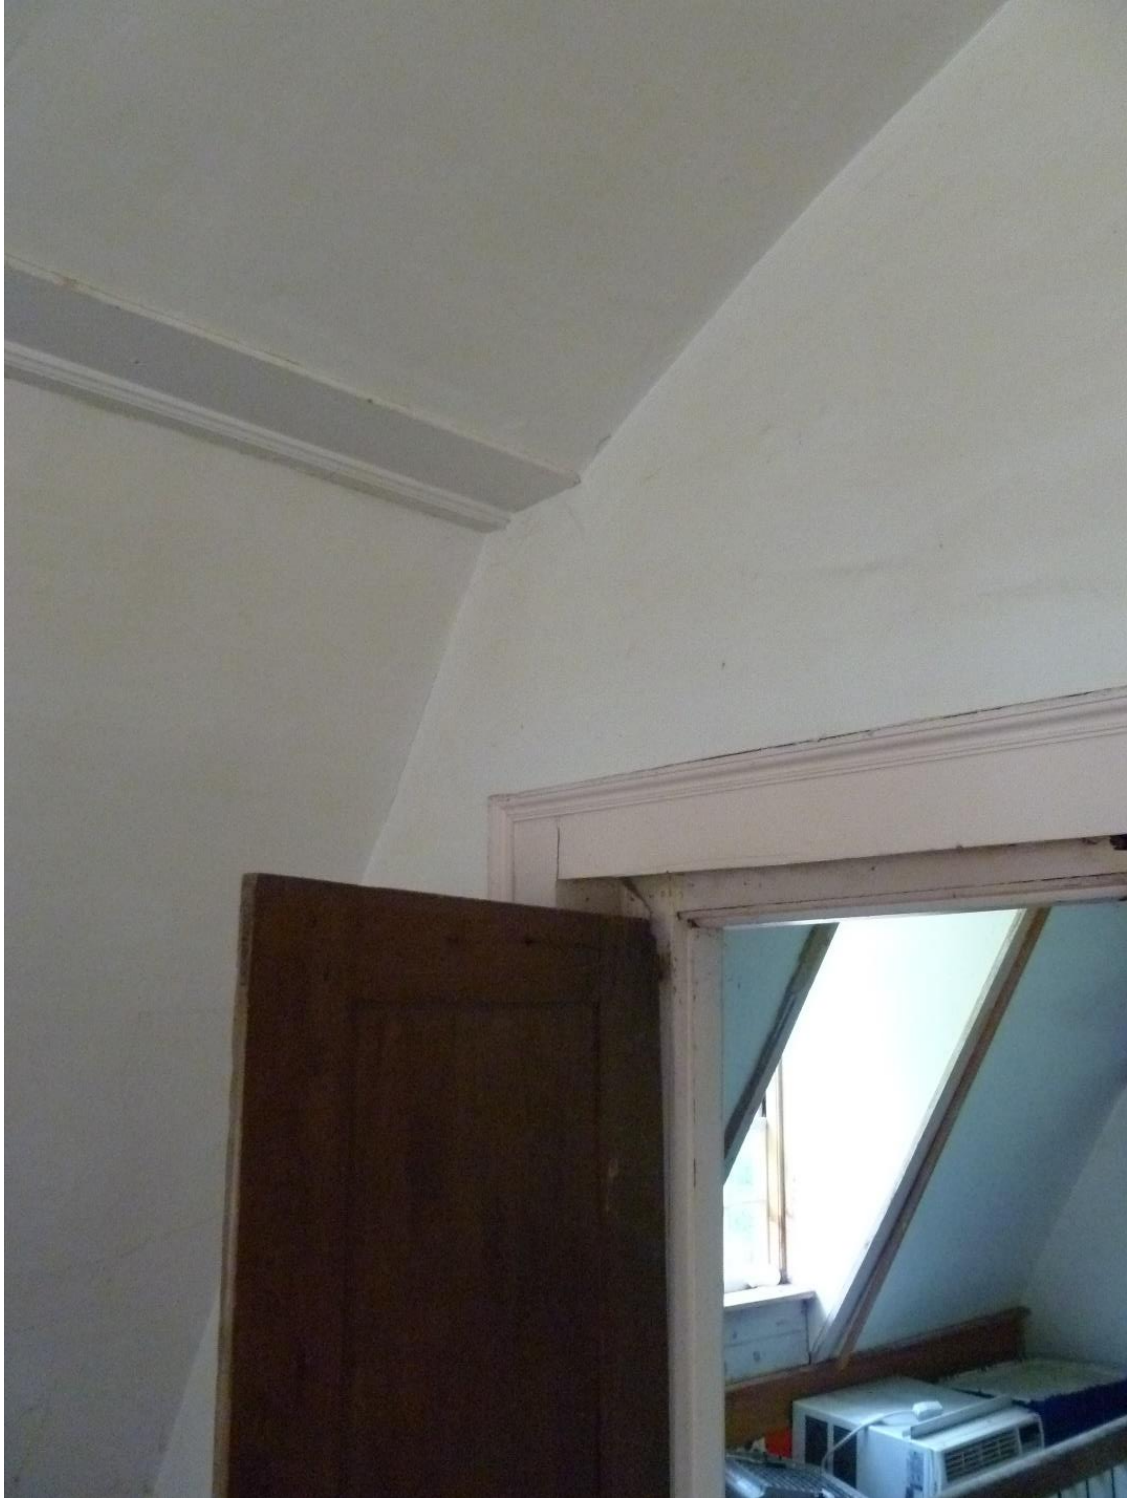
Figure 65. Front Southeast Bedchamber Ballroom with barrel vaulted plaster ceiling, restored, ascending to twelve feet, Daniel Rose House. View to Stairway enclosure, center gable window and landing above front entryway. Camera facing southwest.

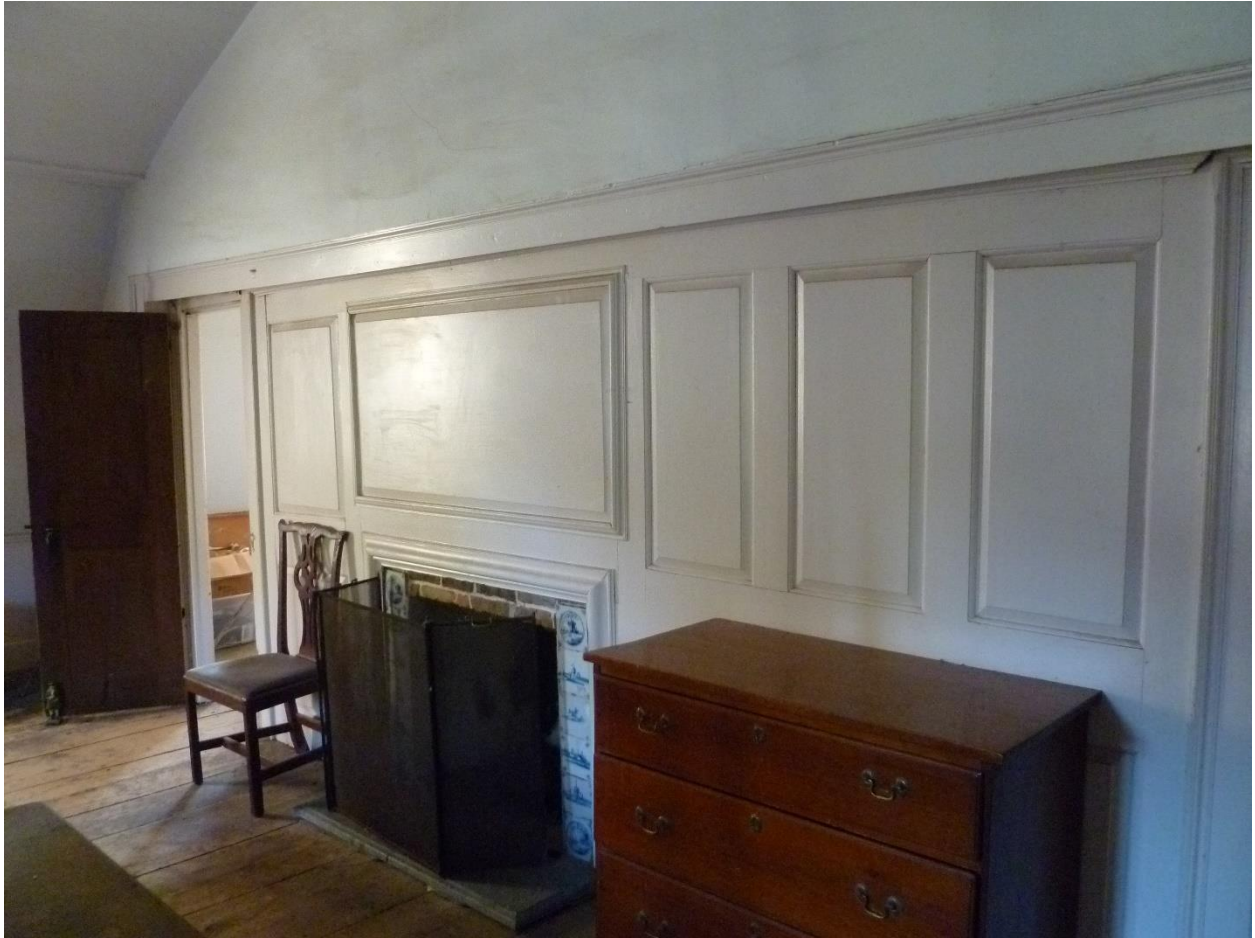
Figure 66. Front Southeast Bedchamber chimney breastwall with fielded panels restored by Bill Phelon, Daniel Rose House. During restoration, there was evidence of blue paint on remaining original wall-to-ceiling plaster. View to Stairway and landing at front entryway. Camera facing southwest.

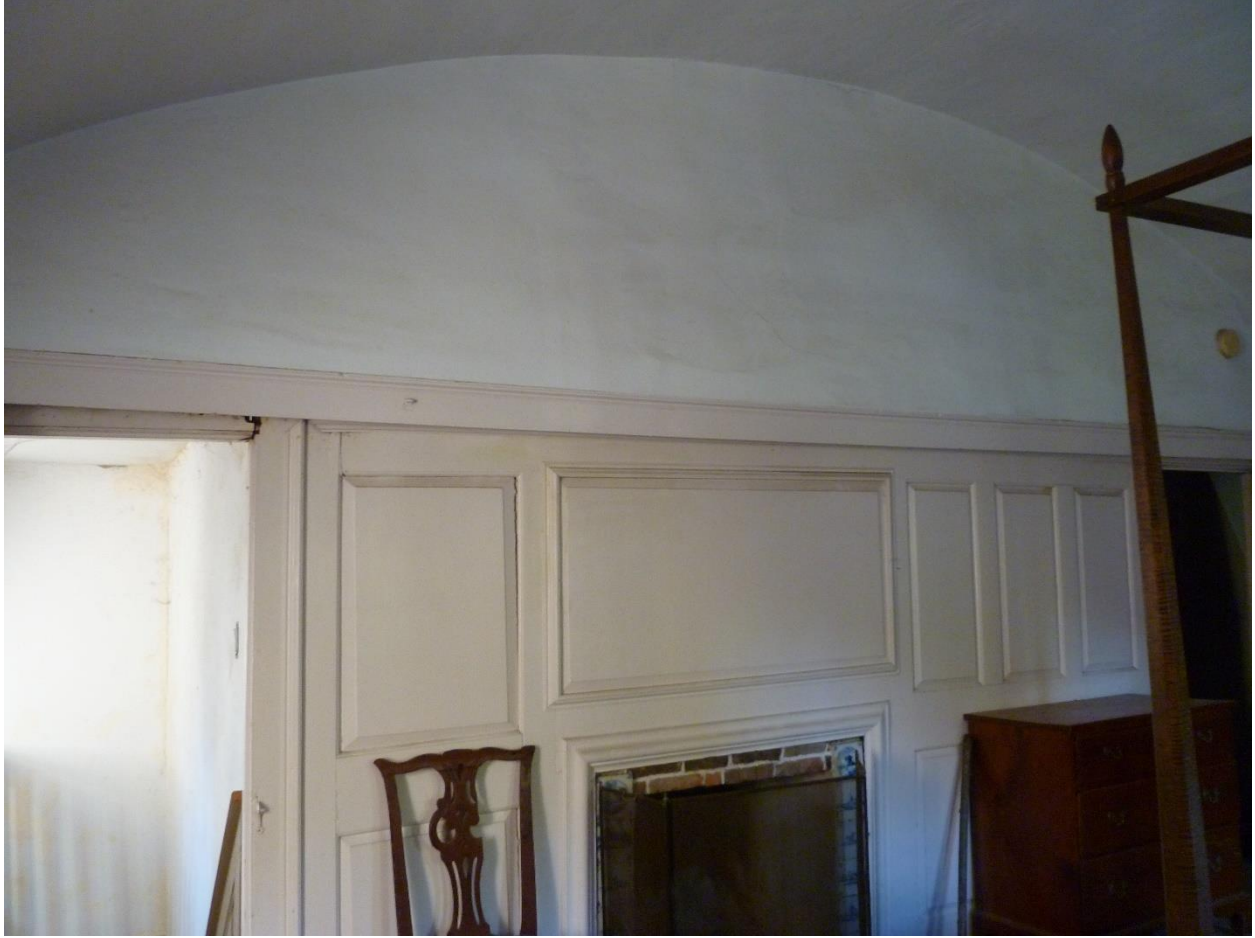
Figure 67. Front Southeast Bedchamber vaulted ceiling twelve feet high and chimney breastwall with raised panels, Daniel Rose House. View to Stairway and landing at front entryway. Camera facing west.

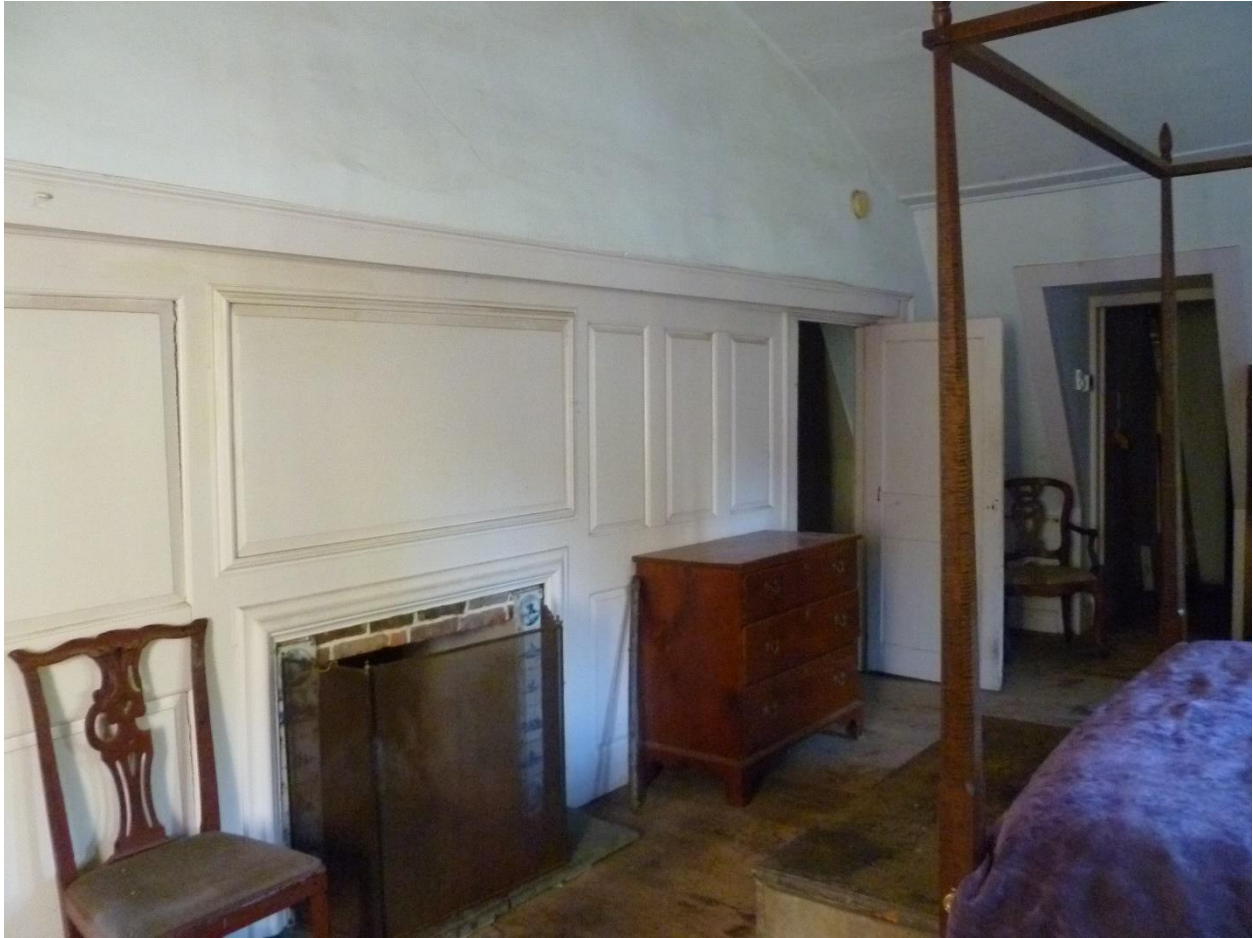
Figure 68. Front Southeast Bedchamber chimney breastwall with fielded panels, Daniel Rose House. View toward interior landing (Figure 40) and stairway to Keeping Room and hallway to potential Docent Wing. Camera facing northwest. September 2019.

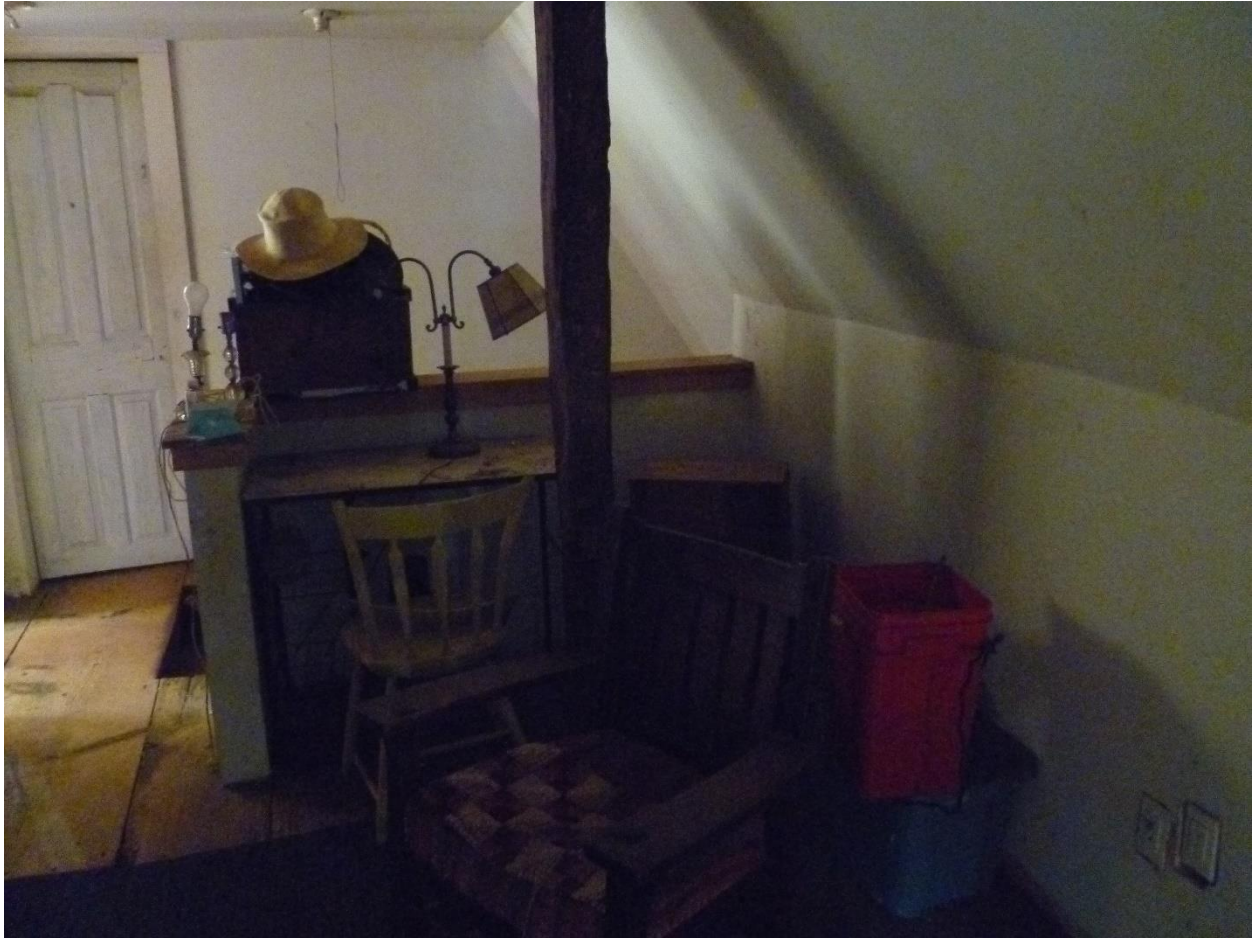
Figure 69. Interior structure is evident in unfinished landing at center of house, second floor, Daniel Rose House. The following Bedchamber is to the left. Stairway beyond this partition leads down to Keeping Room. Hallway to potential Docent Wing with second floor bath and bedroom is behind the camera. Camera facing west.

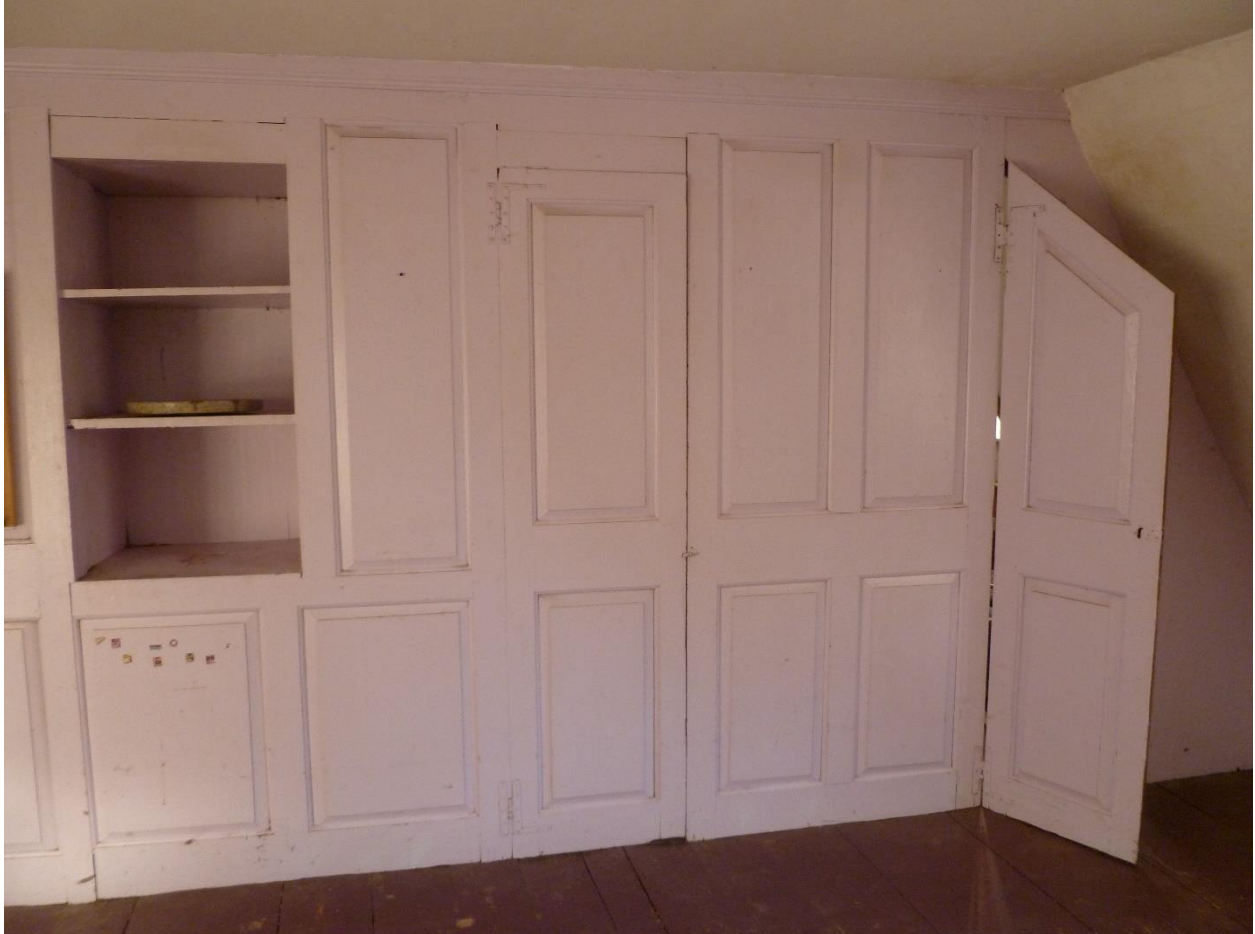
Figures 70. Bedchamber, second floor breastwall with closet revealing flat stone structure of center chimney, Daniel Rose House. Note "original white pine wide board floor" according to the MACRIS database inventory. Camera facing east. June 2019.

Bed Chamber - Field raised panels on breastwall with closet. Original white pine wide board floor. Two board dado encircles remaining three walls, ceiling plaster.

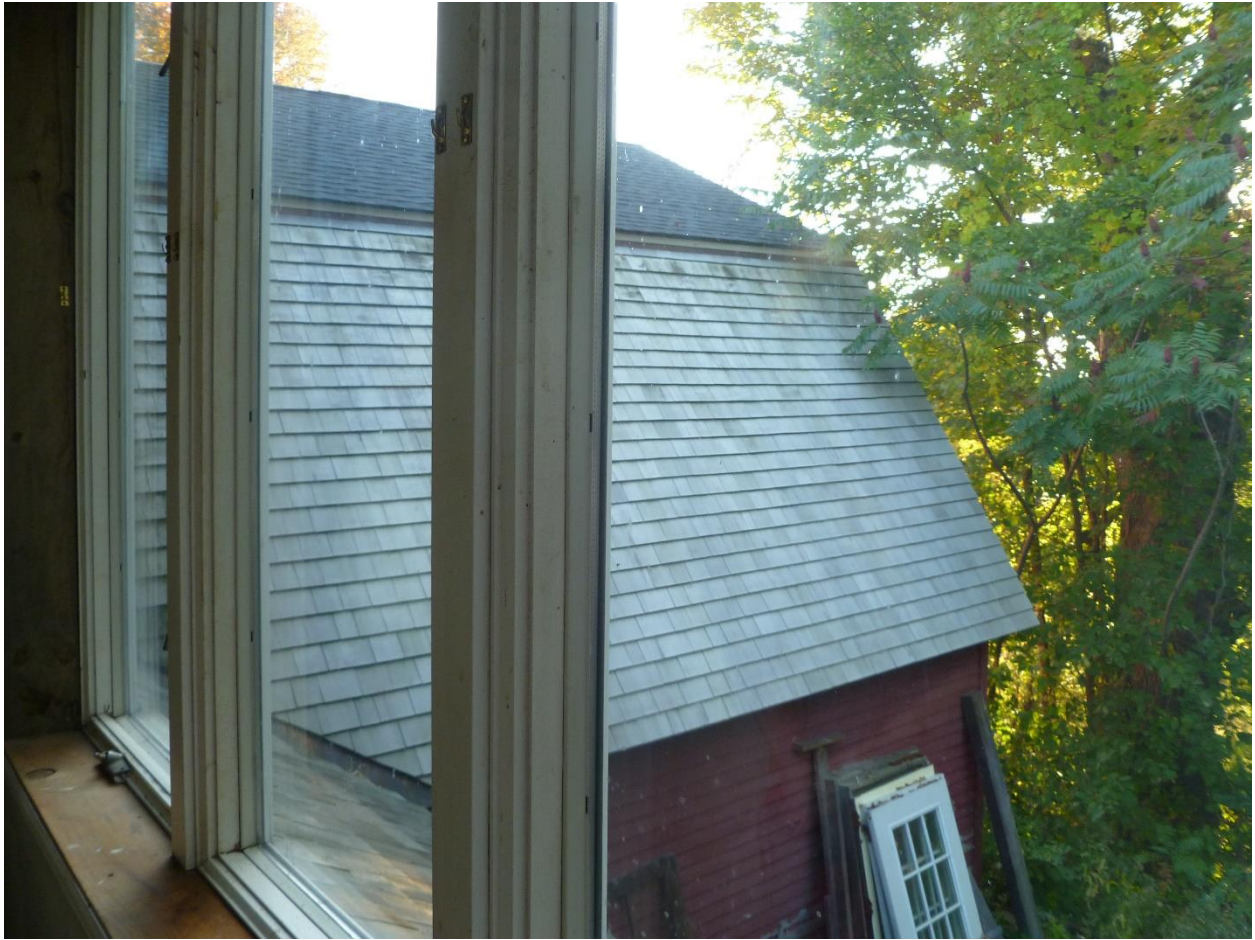
Figures 71. View of western side of main house from second floor hall updated windows of the potential Docent Wing two-story extension ca. 1900, 1930 housing upstairs bath and bedroom; and downstairs kitchen and sitting room. Camera facing southwest. September 2019.

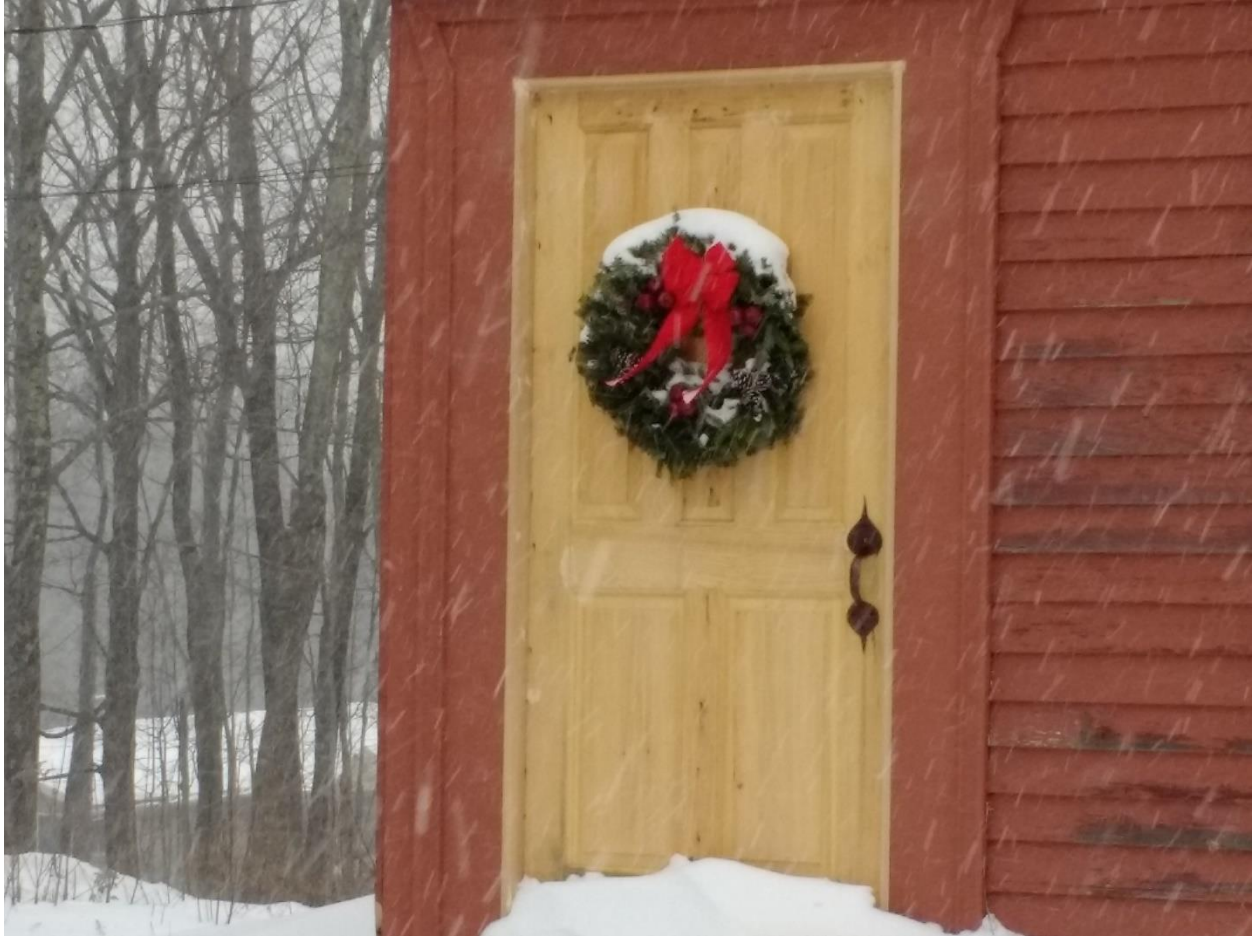
Figures 73. Reconstructed east coffin door. Daniel Rose House. Camera facing southwest. January 2018.

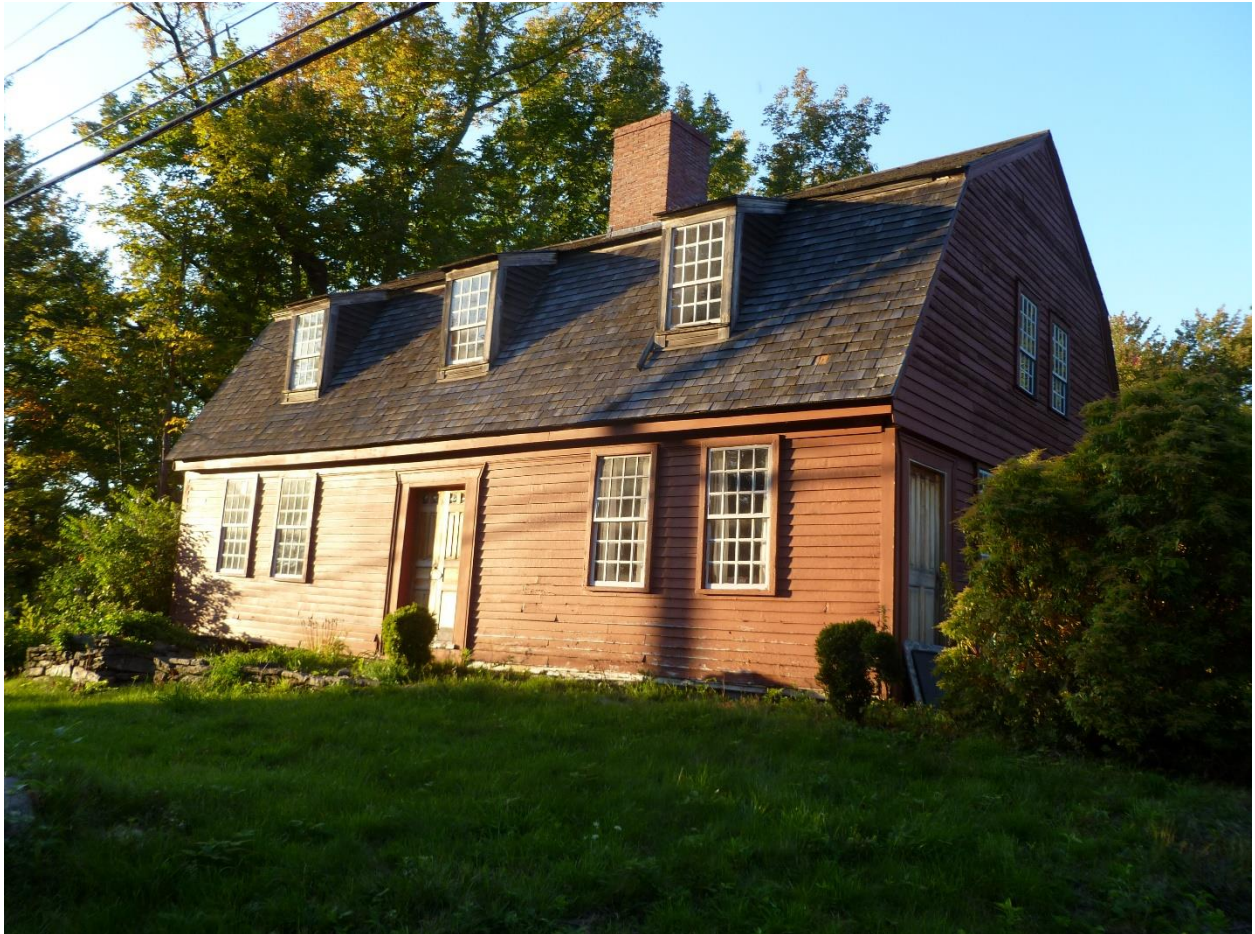
Figures 74. Daniel Rose House, West Granville National Register Historic District. Perspective view, camera facing northwest. September 2019.
