LOWELL CULTURAL RESOURCES INVENTORY

IDENTIFICATION BOOTT MILLS--foot of JOHN STREET MAP SHEET # 8
1) CURRENT OWNER Boott Mills OWNER OCCUPIED yes
2) HISTORIC NAME Boott Mills--#3
3) CURRENT NAME Boott Mills--Building #3
4) PROPERTY TYPE mill structure 5) ZONING CLASSIFICATION B3
6) TAXES: PAYMENTS current STATUS clear
7) WITHIN BOUNDARIES OF LNHP, LHPD, Locks and Canals HD

ADDRESS BOOTT MILLS--foot of JOHN STREET (MILL #3)

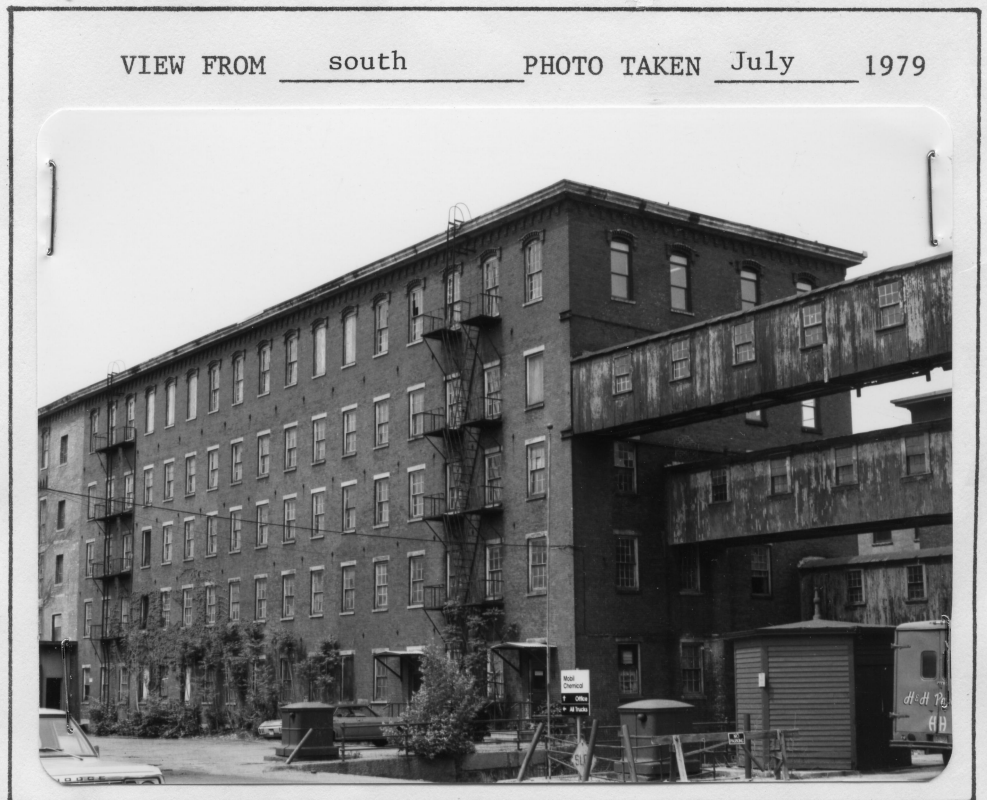
1) ARCHITECTURAL STYLE Fed/ Greek Revival
2) PRESENT USE:
GF warehouse
UF warehouse
3) NO OF STORIES 5
4) PROP SQ FT part of 246,563
5) PLAN rectangular
6) ROOF very low pitched
7) STRUCTURAL SYSTEM load-bearing masonry
8) OUTBUILDINGS none not visible
9) MATERIALS:
FOUNDATION not visible

FACADE all sides: red brick in common bond (7/1)
TRIM hammered granite
10) NOTABLE SURFACE & LANDSCAPE ELEMENTS slope allows 6 stories at rear

- 1) CONDITION OF BUILDING FABRIC. needs minor repair
- 2) IF DETERIORATED, CAUSES lack of maintenance
- 3) INTEGRITY OF HISTORIC BLDG FABRIC: GF intact with minor changes
UF intact with evolutionary alterations
- 4) SURROUNDING LAND USES commercial, industrial
- 5) INTEGRITY OF PROP'S HIST SETTING intact with minor intrusions &/or losses
- 6) IMPORTANCE OF PROP TO HIST SETTING integral to character
