LOWELL CULTURAL RESOURCES INVENTORY

<u>IDENTIFICATION</u>	Corner of JACKSON and REVERE STREETS MAP SHEET # 11			
1) CURRENT OWNER	James T. LichoulasTrustees of OWNER OCCUPIED no			
	Appleton Realty Trust

2) HISTORIC NAME	No. 5 ExtensionAppleton Manufacturing Company			
3) CURRENT NAME				
4) PROPERTY TYPE	mill structure 5) ZONING CLASSIFICATION 1-A			
	delinquent since 1970 STATUS land court

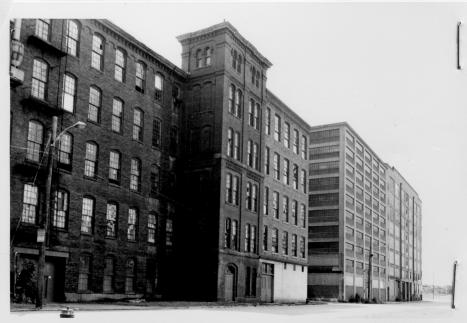
1)	CONDITION OF BUILDING FABRIC	needs minor repair
2)	IF DETERIORATED, CAUSES	lack of maintenance, vandalism
3)	INTEGRITY OF HISTORIC BLDG FABRIC: GF	intact original fabric
	UF	intact original fabric
4)	SURROUNDING LAND USES comme	rcial, industrial, railroad, canal frontage
5)	INTEGRITY OF PROP'S HIST SETTING	moderately disrupted historic setting
6)	TMPORTANCE OF PROP TO HIST SETTING	integral to character

No. 5 Extension is a manufacturing building 54 feet wide on Jackson Street and 153 feet long on Revere Street. The ground floor is of reinforced concrete, and the upper floors of red bricks, many of which are mottled with black.

The building's plan has a chamfered corner at the Jackson and Revere Streets intersection, with original double doors at the ground level. A corbelled cornice tops the structure.

View from the northeast of No. 5 Extension, between No. 5 Mill and the reinforced concrete Building No. 7. Photograph taken August 1979, by SBRA.
